AGENDA

Board of Historic and Architectural Review

January 14, 2019

2. 1136 Seaboard Avenue

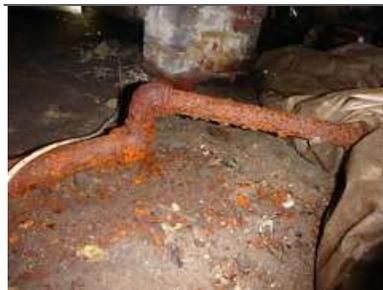
Inspect the heavily rusted gas line in the crawl space and repair/replace as needed.

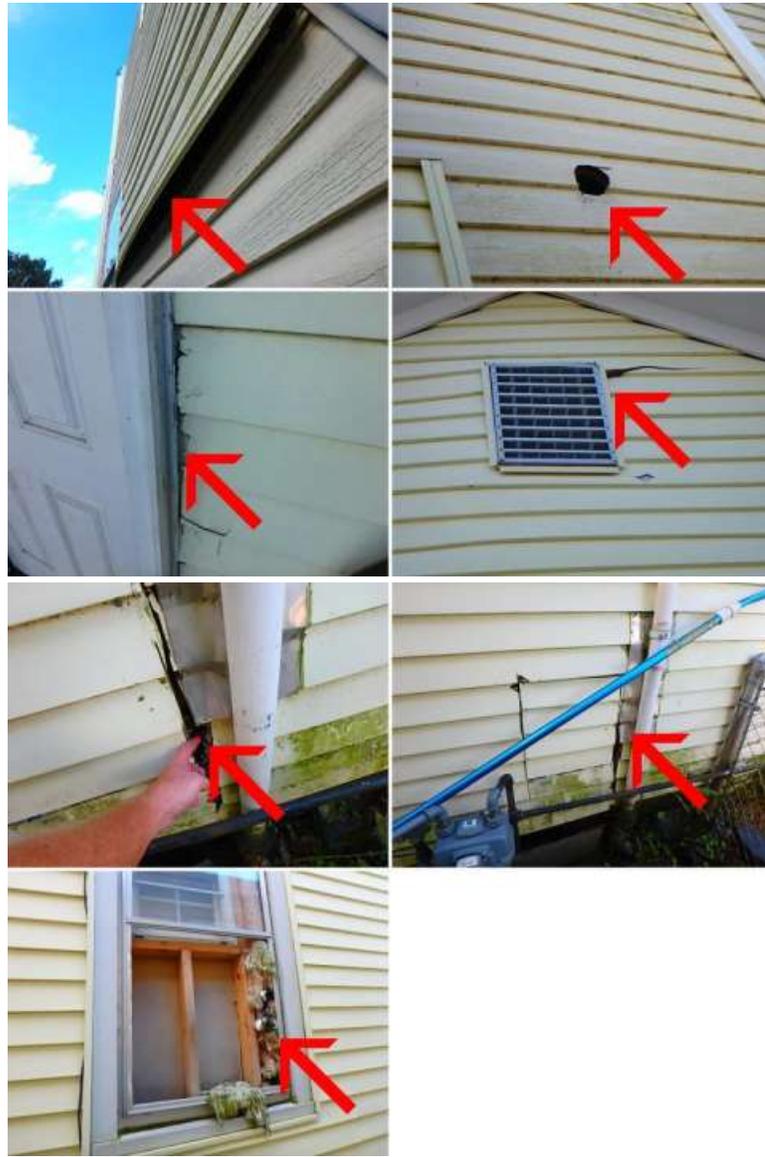
Missing exterior vents are noted around the home.

Many repairs/replacements needed at the siding.

Repair the siding at the right side of the house and replace the moisture damaged framing.

Repairs are needed at the kitchen window, signs of rodents entering the insulation.

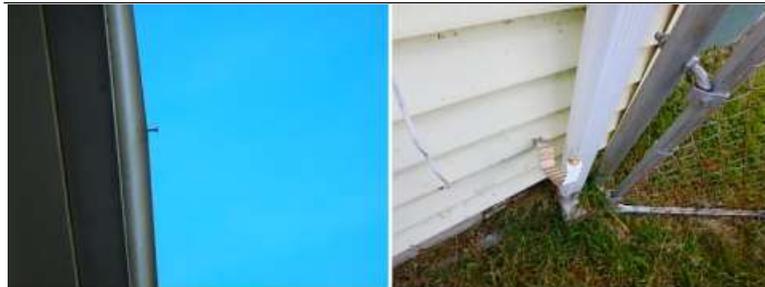
Replace all damaged fascia boards as needed around the home.

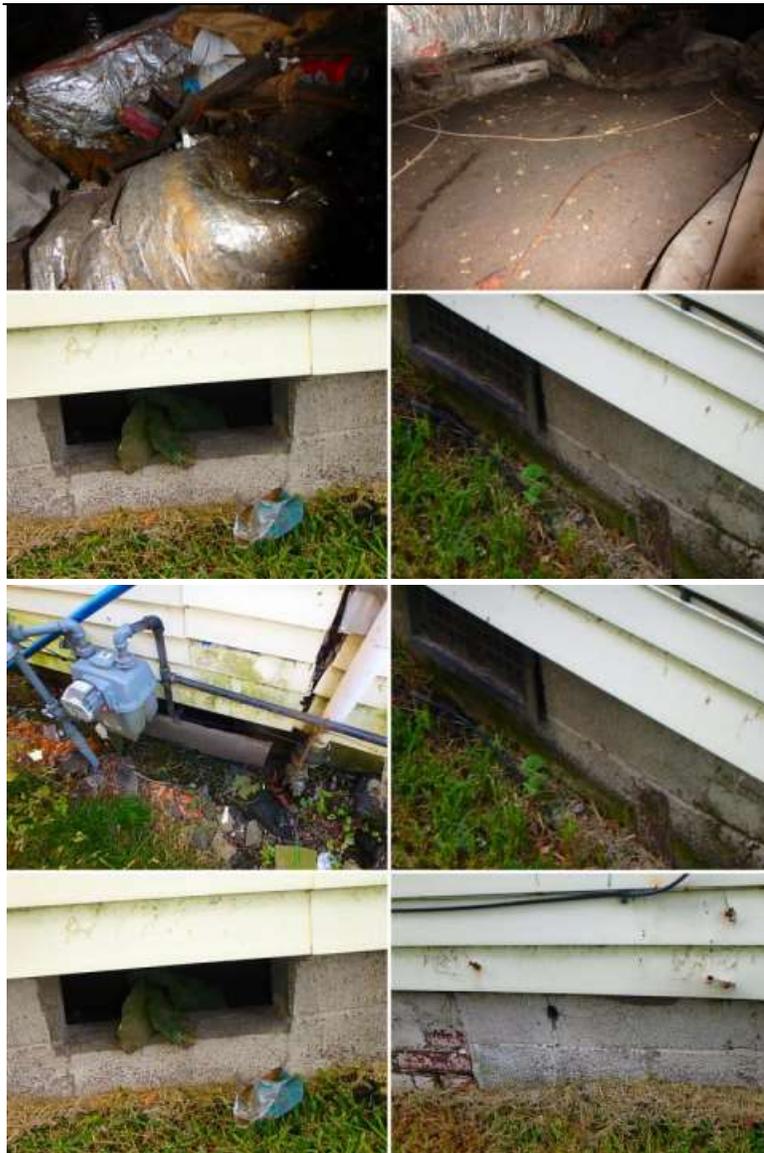
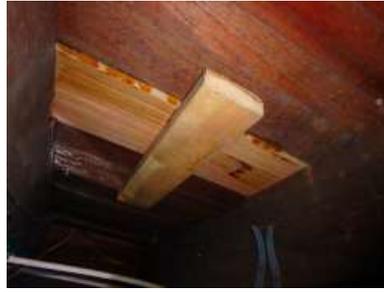
There is debris noted in the crawl space at time of inspection. It is recommended to have removed to avoid insects and minimize safety hazards.

The crawl space needs installation of moisture poly barrier to prevent moisture from entering the air and causing issues. More ventilation is needed for the attic space.

The crawl space door is deteriorated and rusty. It is important to have the access door made of stable exterior material and properly secure door to the foundation wall.

Missing/loose/damaged foundation vents are noted, secure/repair/replace as needed.

Seal all holes and gaps as needed at the foundation.

Non-professional repairs are noted at the foundation.

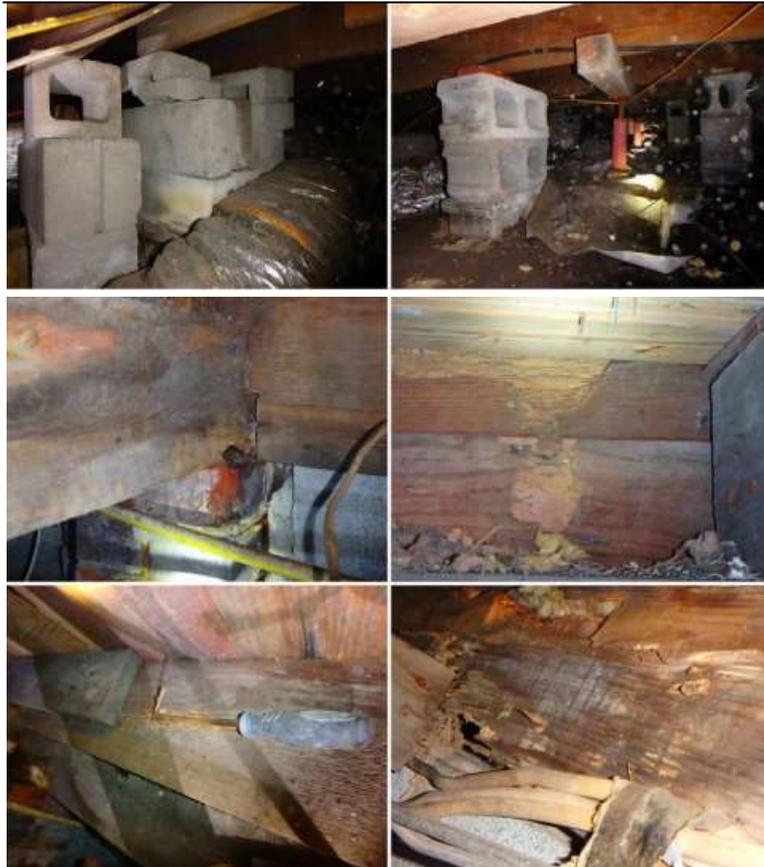
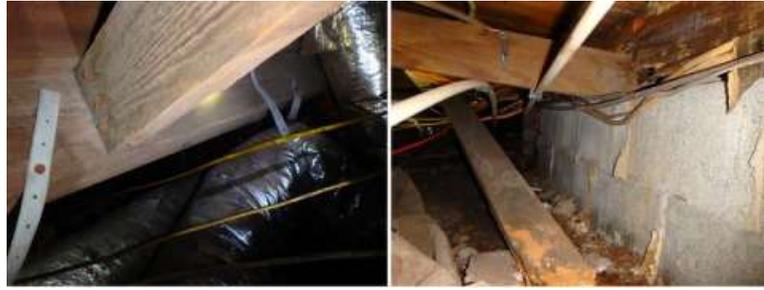
**Replace all termite damaged floor joists/beams and band boards as needed.
There are missing piers under the floating floor joists support.**

**Replace all non-professional repairs at the support beams and improper piers with proper materials and piers.
Have a licensed and insured contractor evaluate and make any further recommendations or repairs as needed to the foundation and/or the crawl space area of the home.**

Have a licensed and insured contractor evaluate and make any further recommendations or repairs as needed to the foundation and/or the crawl space area of the home.

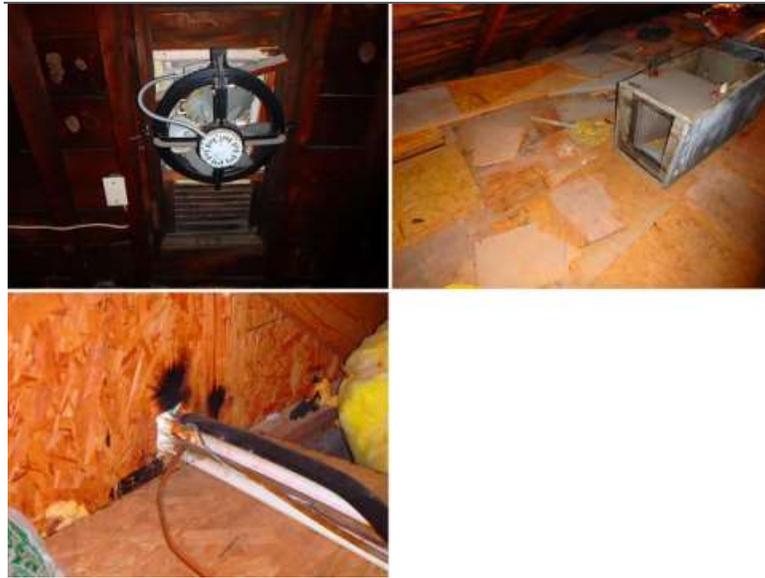
The power fan is not on during inspection.

There is debris and/or personal belongings noted in the attic. Due to this we may have been unable to view all areas. Seal the gaps at the AC lines at the gable wall.

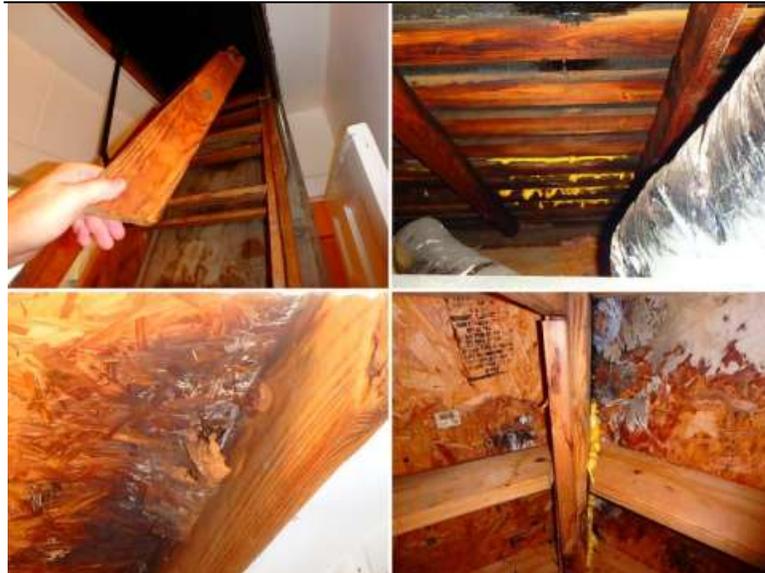
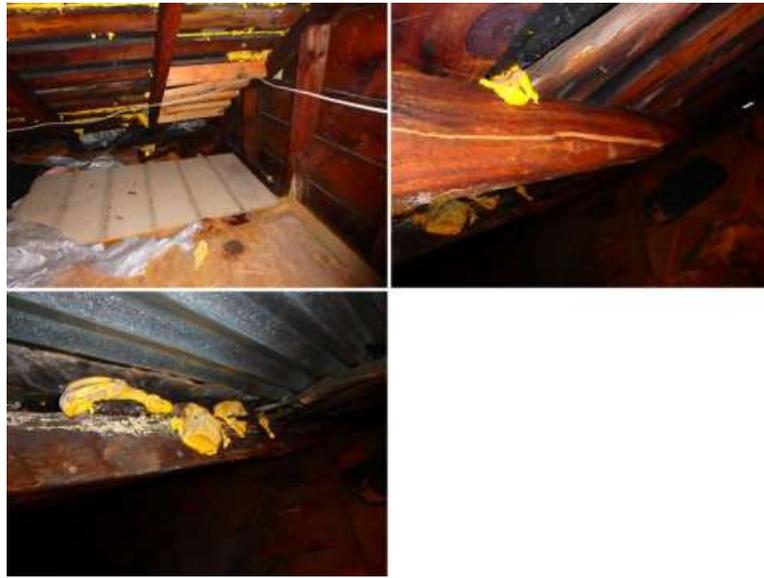
Replace the damaged pull down stairs as needed.

Replace all moisture damaged roof sheathing.

Replace the cracked roof rafters at the right side of the attic.

A contractor licensed and insured contractor should evaluate and make any recommendations or repairs as needed to the attic.

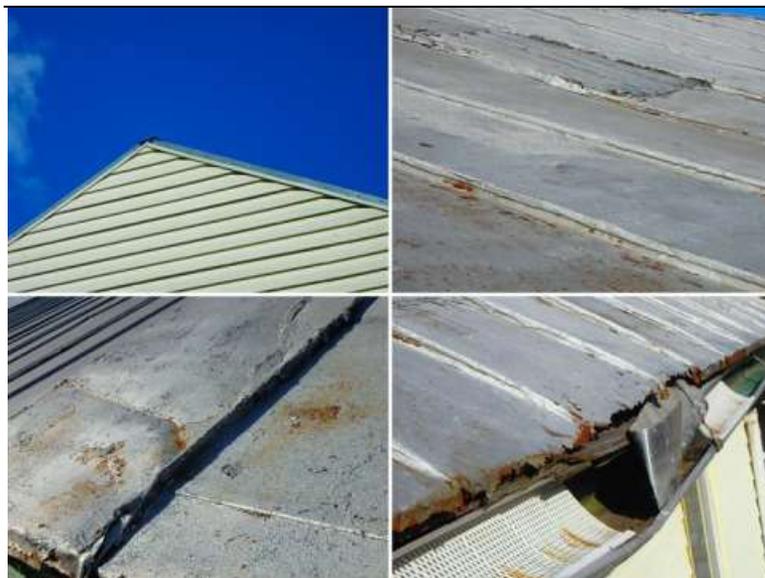
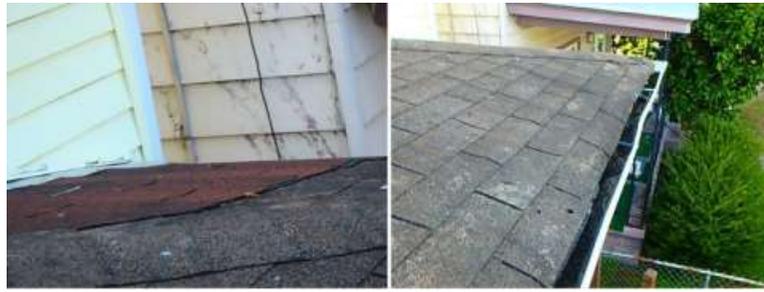
**Extend the rear gable roofing over the siding.
The metal roof is in need of replacement.**

Replace the shingles over the front porch.

Have a licensed and insured roofing contractor evaluate and make any further recommendations or repairs as needed to the roofing system.

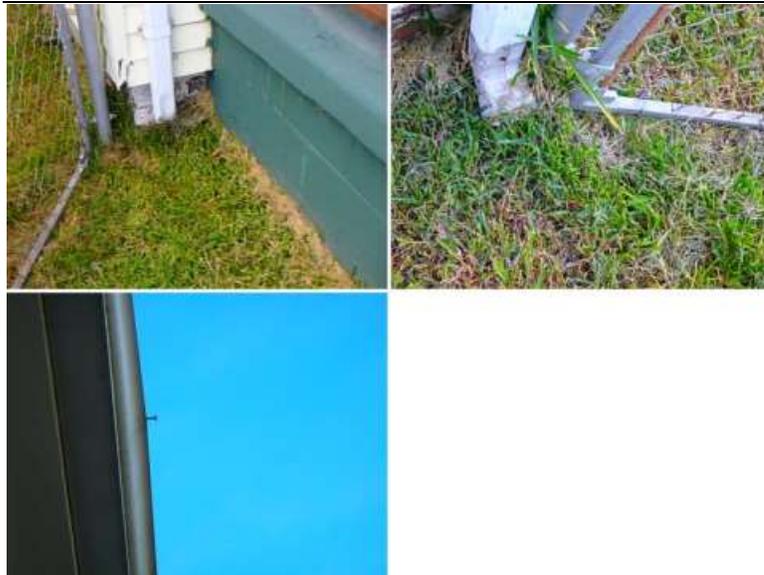
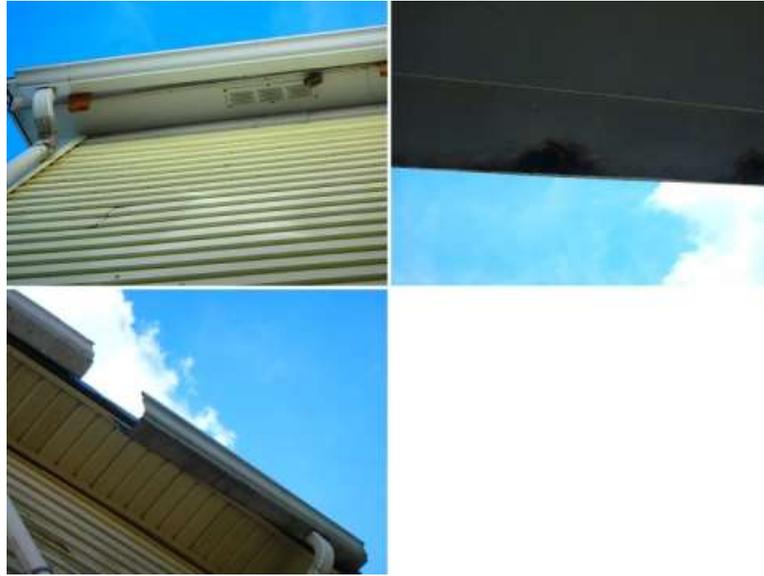
There are portions of the gutter system that are loose at time of inspection. Secure the gutters and/or downspouts to the house as needed to ensure proper function.

There are some parts or pieces missing or damaged around the house. It is recommend to have all parts and pieces in place for proper operation.

Repair/replace the gutters as needed around the home.

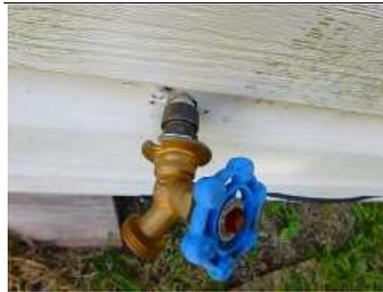
The hose faucet needs to be secured to the house and sealed.

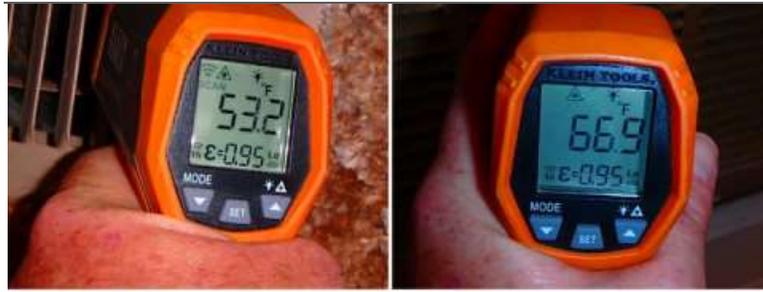
The differential noted for the unit at time of inspection is not sufficient. Recommend having a licensed professional to evaluate, make recommendations/repairs, provide maintenance/service as needed to the unit.

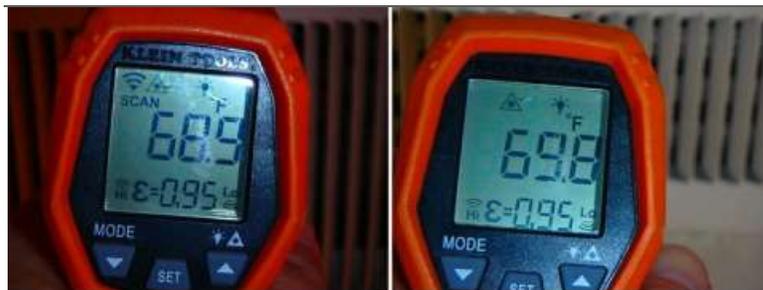
The differential noted for the unit at time of inspection is not sufficient. Recommend having a licensed professional to evaluate, make recommendations/repairs, provide maintenance/service as needed to the unit.

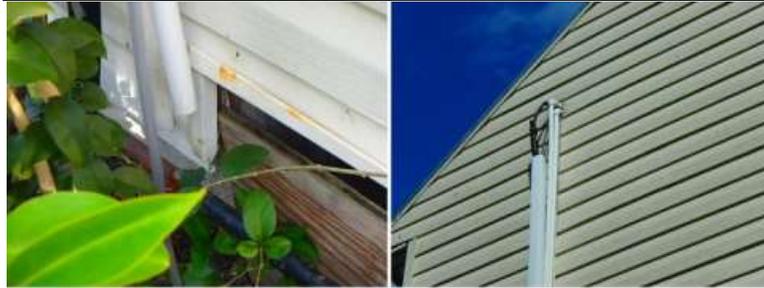
Have the A/C lines re-insulated where missing to reduce condensation and for a proper thermal barrier.
Extend the primary drain condensate line away from the foundation to keep water from entering the crawl space.

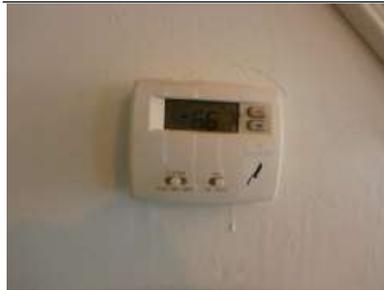
The thermostat is old and questionable, consider having replaced.

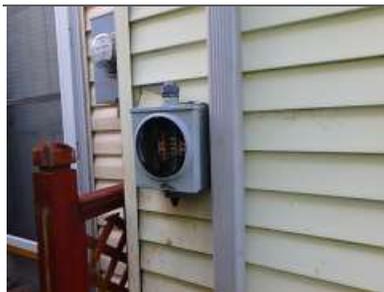
Remove the unused meter base from the home.

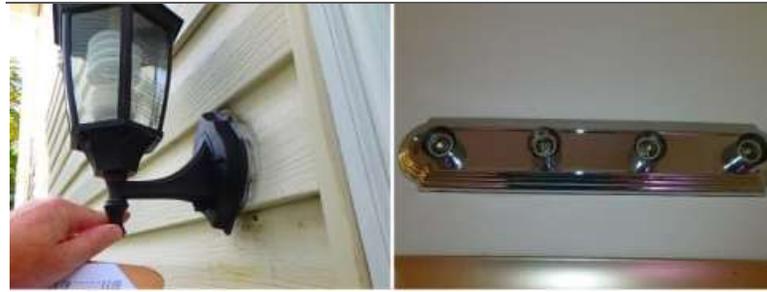
There are some missing or blown bulbs throughout the home. Replace the bulbs and retest to ensure of operation. Secure the exterior light fixture as needed.

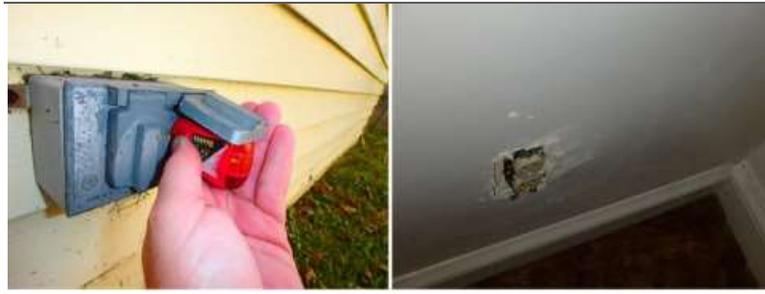
Switch or outlet plate covers around the house are missing or damaged, replace the covers as needed for safety.

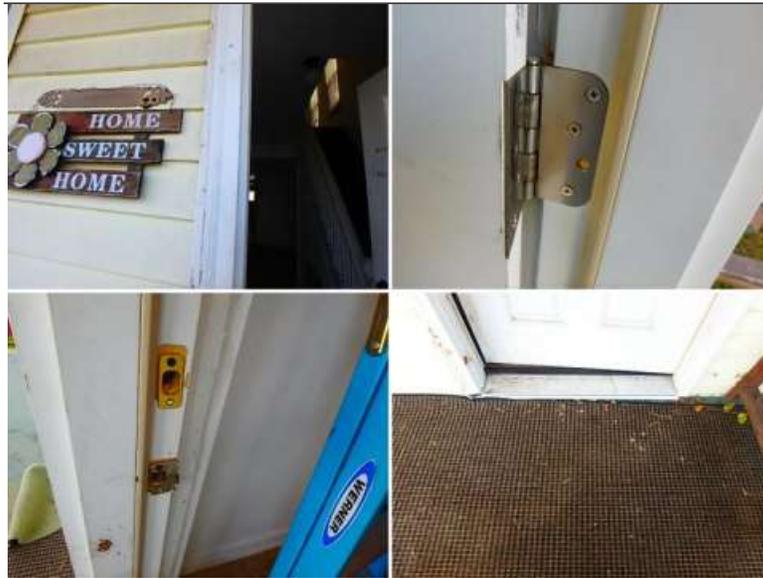
The strike plate is missing the screws and need to be replaced to allow for proper operation.

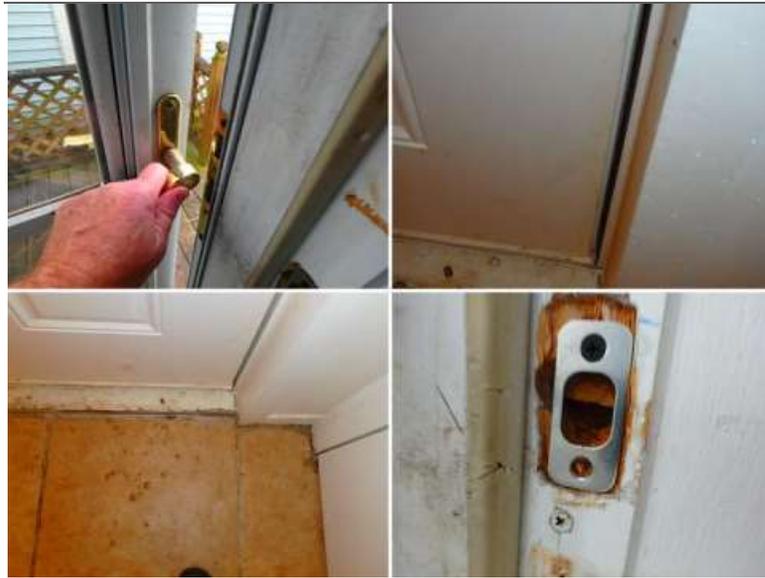
A door stop should be installed to the door to prevent damage to the door and/or wall.

Missing strike plate screws are noted.

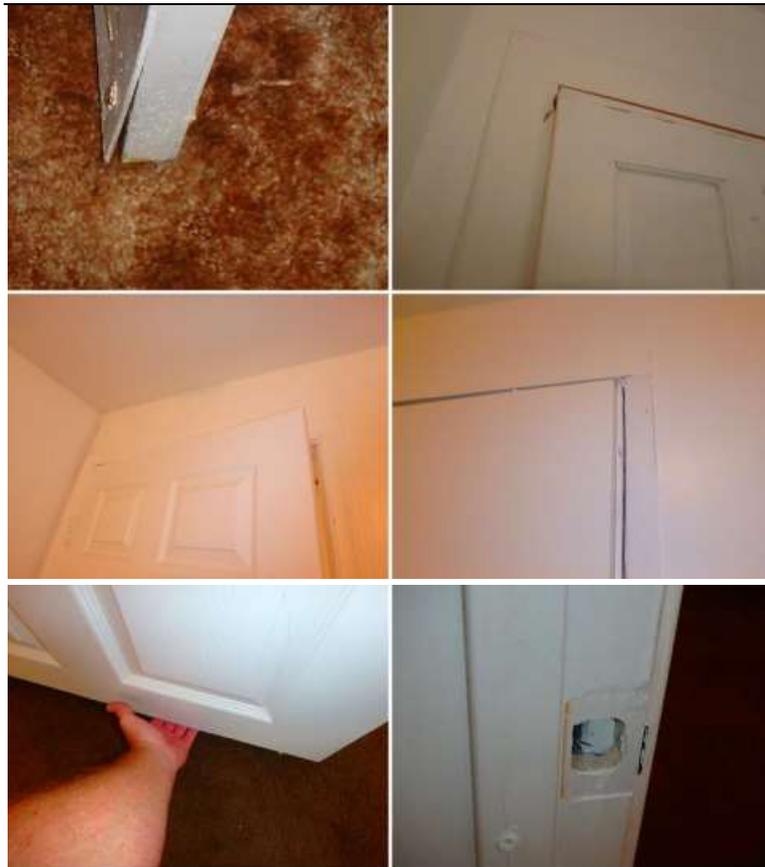
The filler strip is noted to be missing from door(s) inside the home.
Damage is noted to some of the doors have repaired or replace as needed.

The strike plate is missing and needs to be replaced to allow for proper operation.
Adjust any doors that are rubbing or sticking at the frame to operate properly.

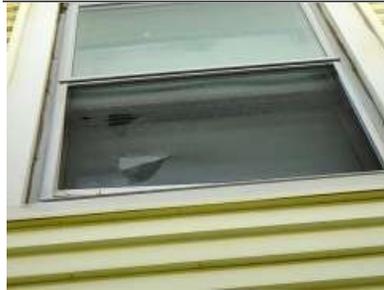
There are screen(s) that have holes or damage noted around the home. Have the screens repaired or replaced as needed.

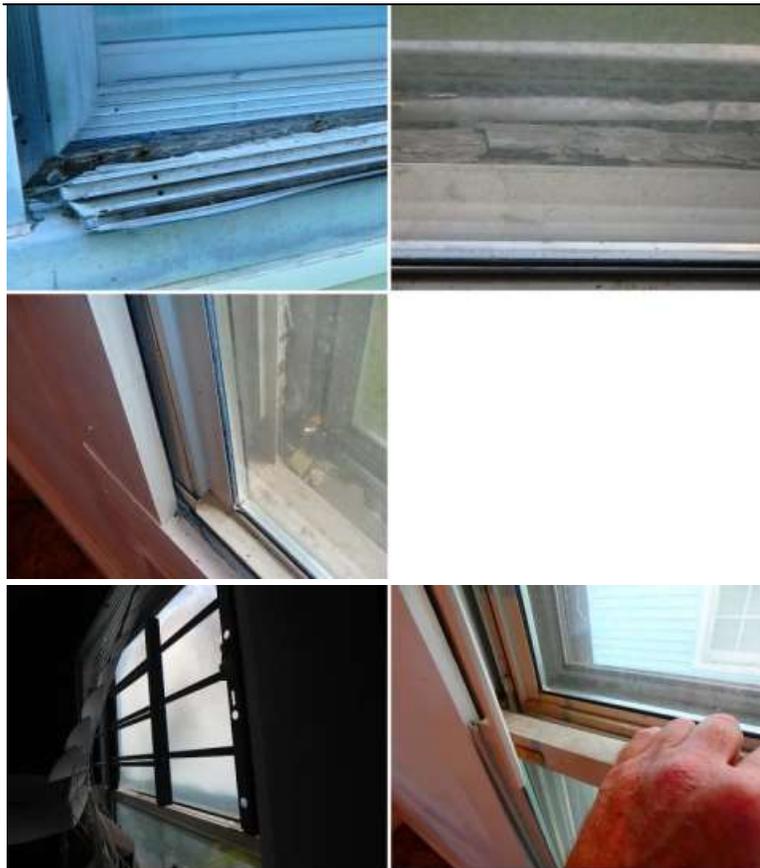
Damaged storm windows are noted.

Repairs are needed for proper function of the windows.

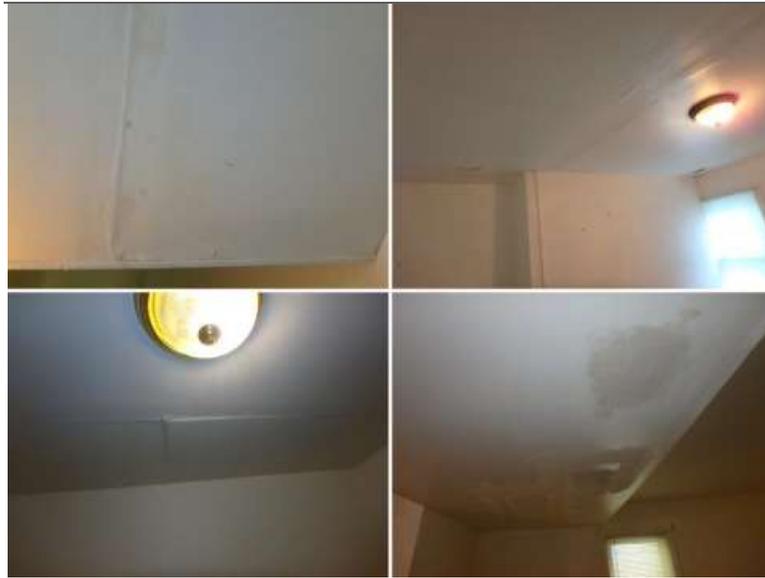
Due to some of the conditions viewed, for example damaged ceilings, holes, loose tape joints etc, repairs are needed to some of the ceiling around the home to prevent further damage.

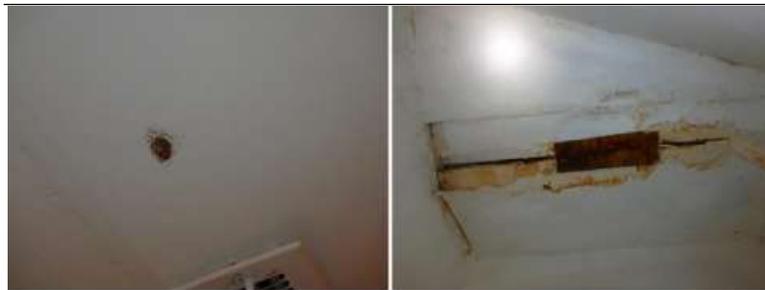
**Treat the ceiling for mold in the upstairs hall bathroom.
Replace the damaged ceiling in the upstairs closet.**

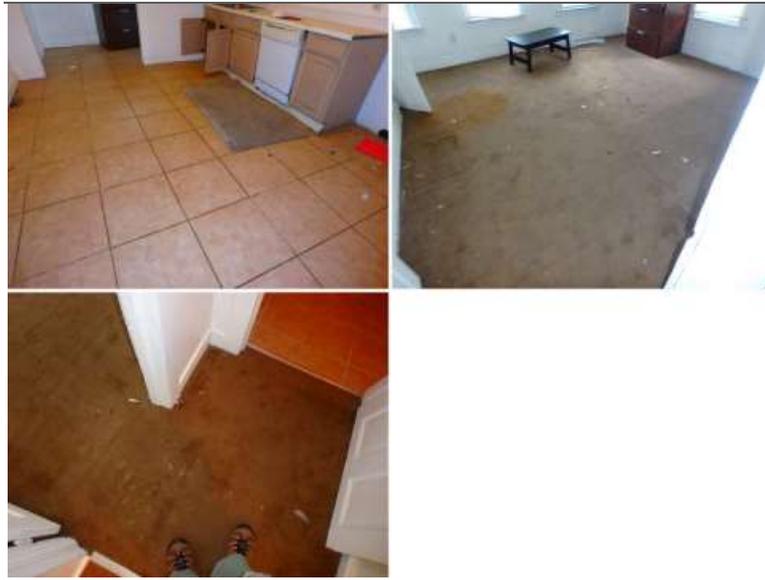
**It is recommended to replace the carpet floor coverings in the home due to the conditions viewed.
Uneven floors are not uncommon for this age home. Monitor.**

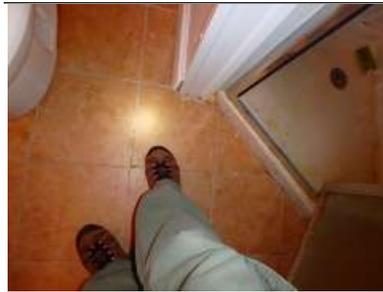
Repair/replace the loose tiles as needed.

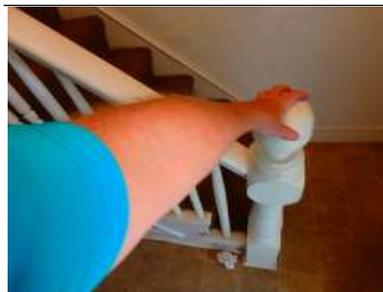
The handrails are noted to be loose at time of inspection. Have the handrails secured as needed for safety.

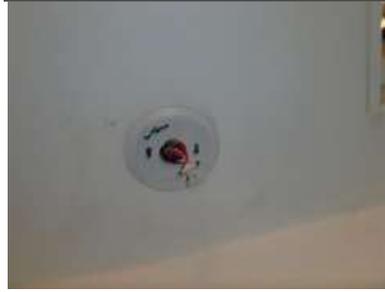
There are some units that are missing and need to be replaced, Smoke detectors should be installed in each bedroom and in both upper and lower hallways for maximum safety. Testing for proper operation and installation of fresh batteries yearly is recommended.

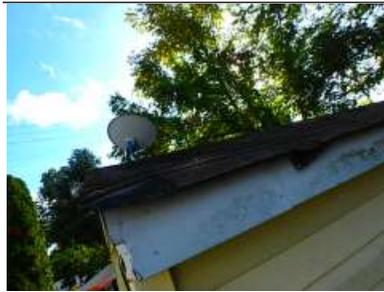
The shingles at the roof need to be replaced.

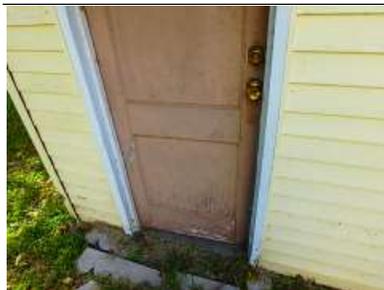
Repairs are needed at the service door.

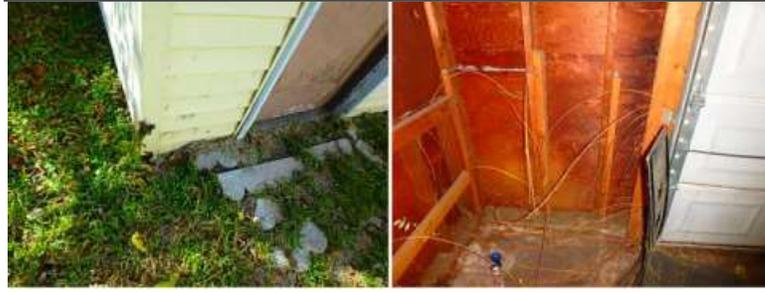
Install proper length studs as needed.

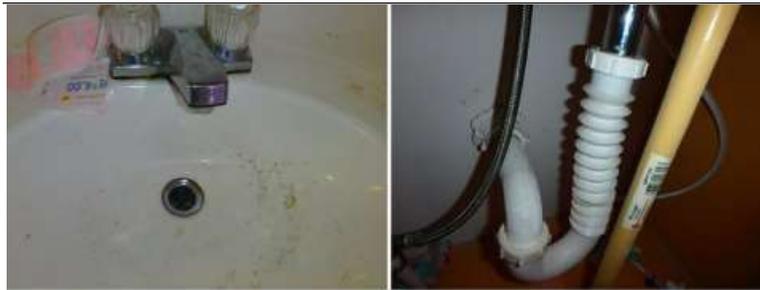
The stopper is missing at the sink in bathroom #1, replacement is needed for proper function.

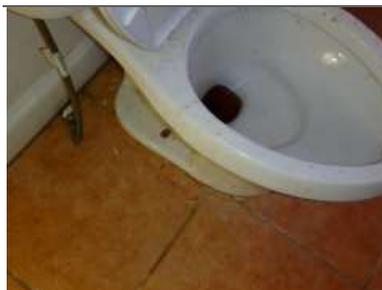
The toilet in bathroom #1 needs to have the wax ring replaced and toilet secured. This will ensure that there are no leaks, which can cause moisture damage that is hard to detect.

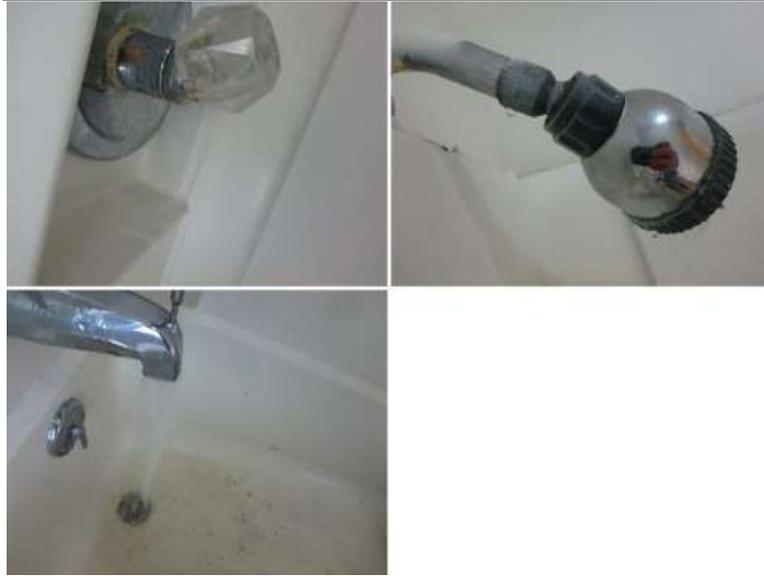
The tub/shower diverter is not functioning properly in bathroom #1 and should be repaired or replaced for proper function. The handles/fixtures are leaking at the tub/shower in bathroom #1, have repaired or replaced to ensure proper function.

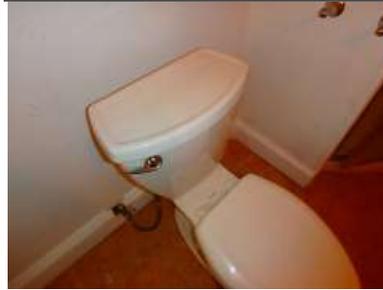
The toilet in bathroom #2 needs to have the wax ring replaced and toilet secured. This will ensure that there are no leaks, which can cause moisture damage that is hard to detect.

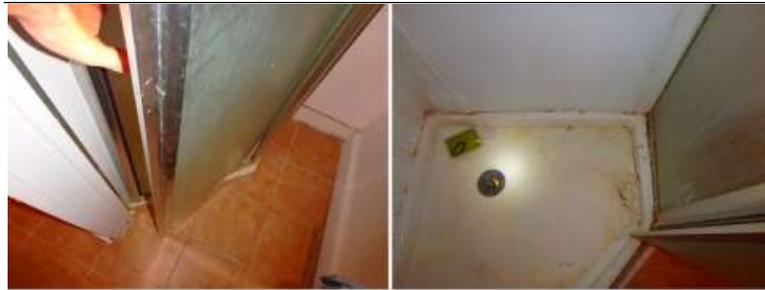
Repair/replace the shower door framing at bathroom #2.

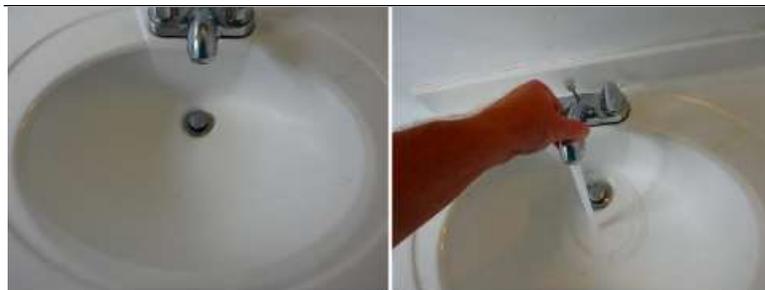
Secure the sink faucet kit to the sink at bathroom #3.

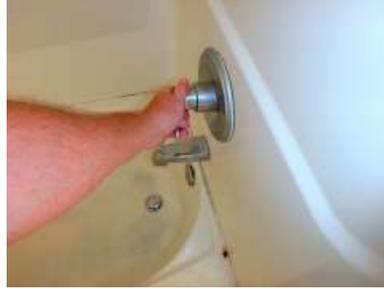
Secure the tub fixtures to the tub surround and caulk at bathroom #3.

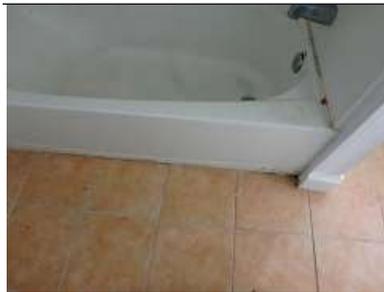
Caulking is needed at the tub to the floor in bathroom #3 to avoid moisture intrusion. It is recommended to clean the tub/shower walls in bathroom #3.

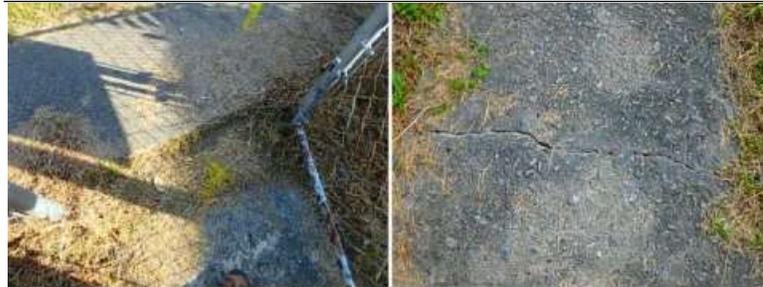
The walkway is noted to be raised or settled and as such can pose a tripping hazard. It is recommended to repair or replace the hazard area for safety.

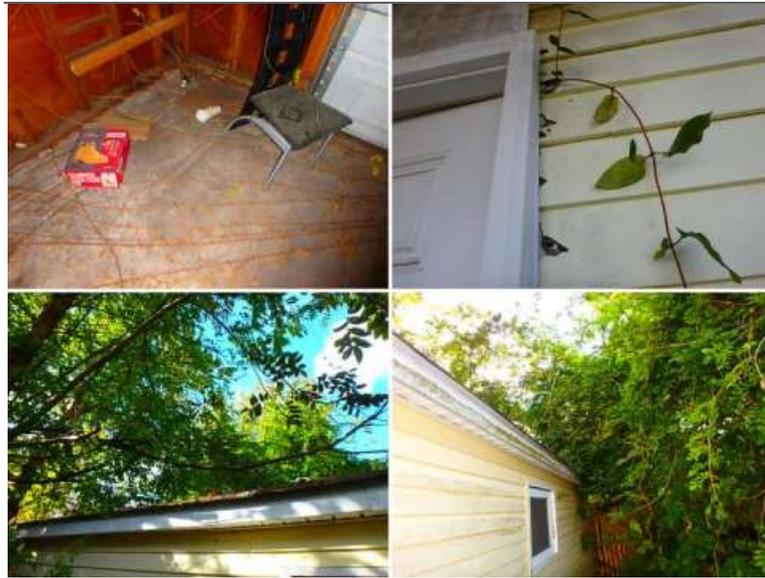
In regards to the landscaping, it is noted that there are trees and/or foliage touching the walls or overhanging the roof and damage is possible. Have the limbs cut away from the house to prevent future damage.

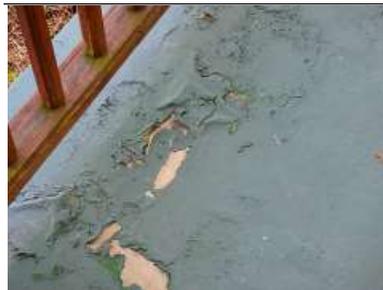
It is recommended to wash and seal the deck with a quality product for production and longevity.

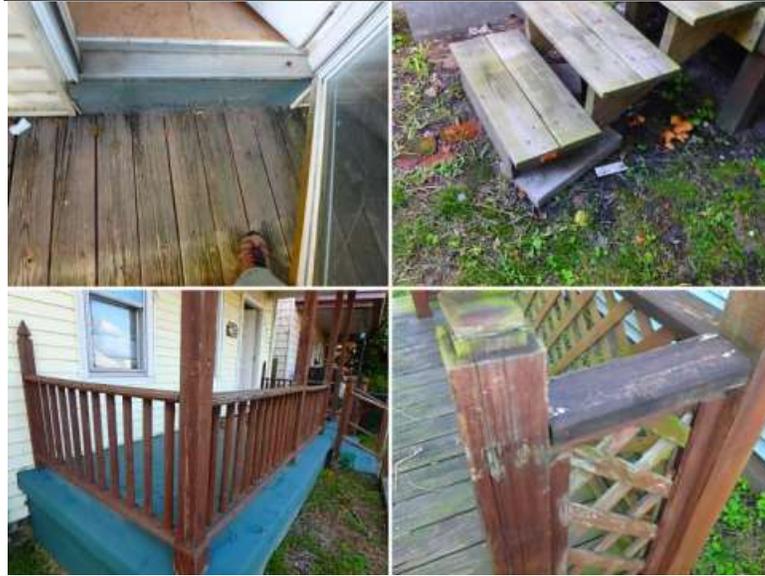
Repair or replace any moisture damaged steps, boards, posts and railings as needed to prevent further damage and safety. Install a step at the rear door as needed.

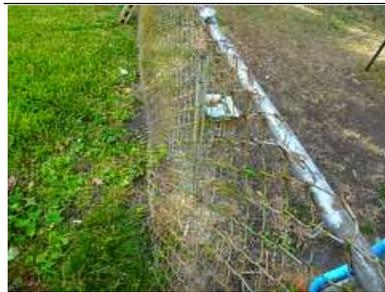
There are some repairs that are needed to the fence to ensure proper function.
