South Norfolk
Historic & Architectural Review Board

June 6, 2019

Home Inspections Plus, LLC

Home Inspection Report

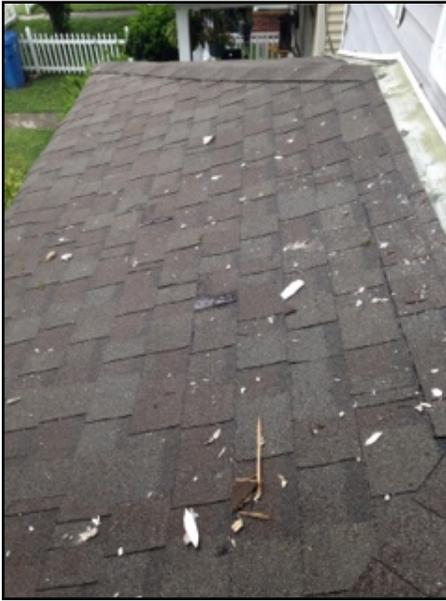
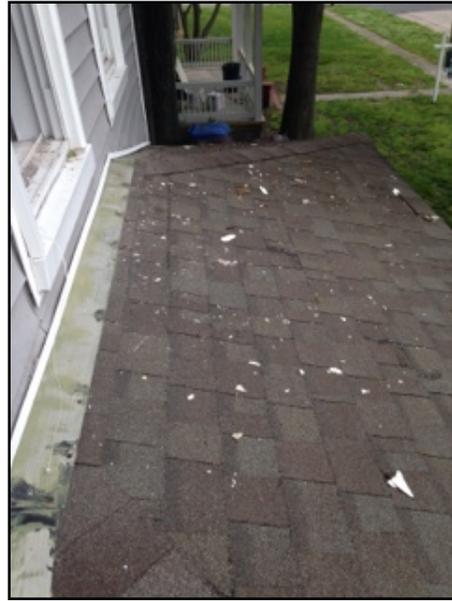
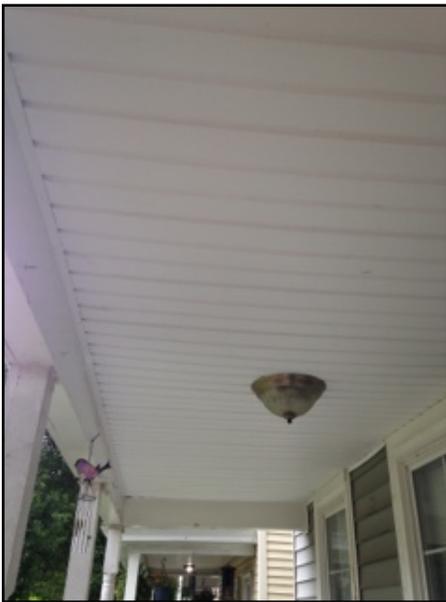
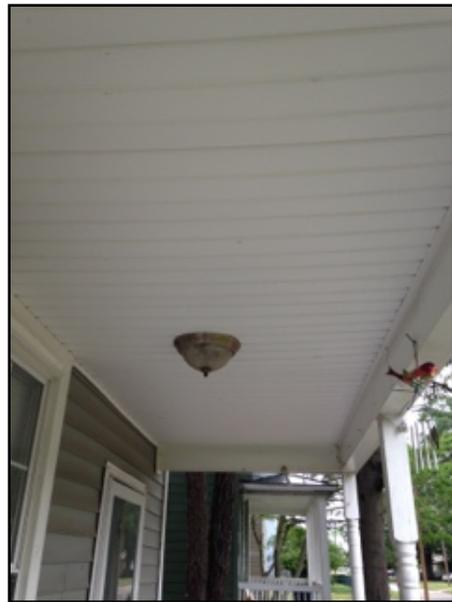
The roofing and flashing on the front porch appear serviceable. We did not observe any leaks despite heavy rains over the previous evening. We also did not observe any weak or sunken places in the decking. For these reasons, we do not feel that the roofing on the porch should be replaced.

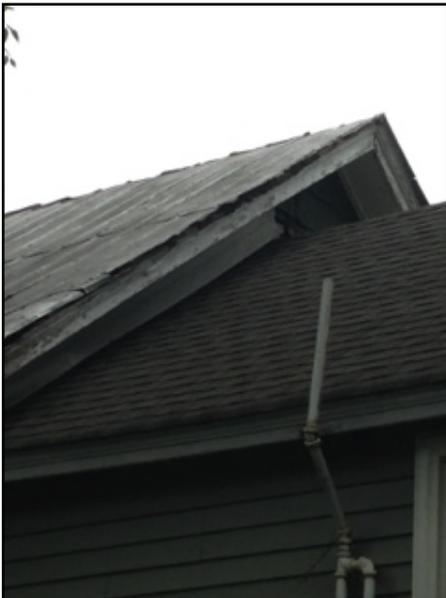
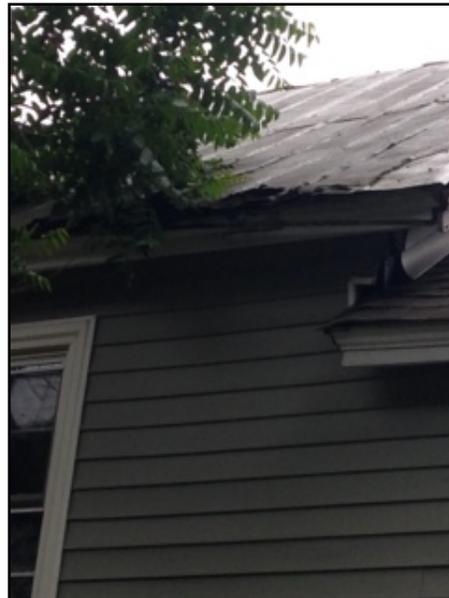
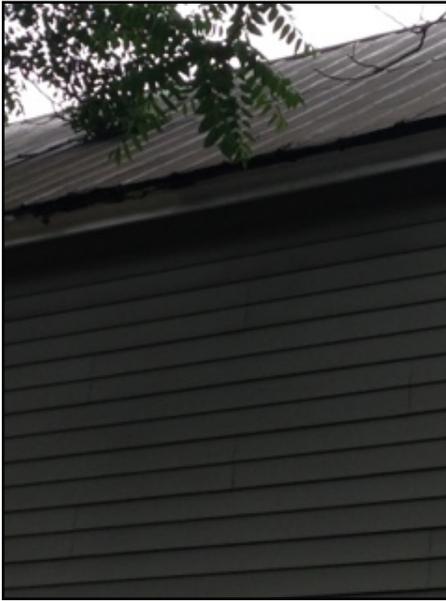
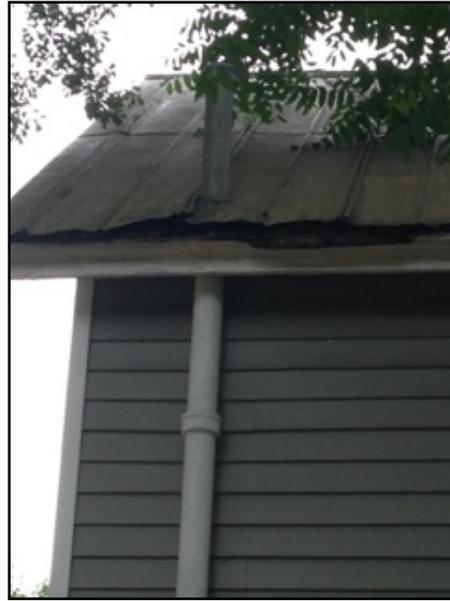
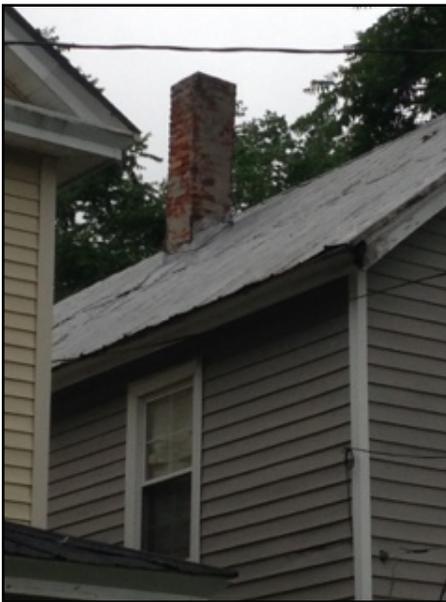
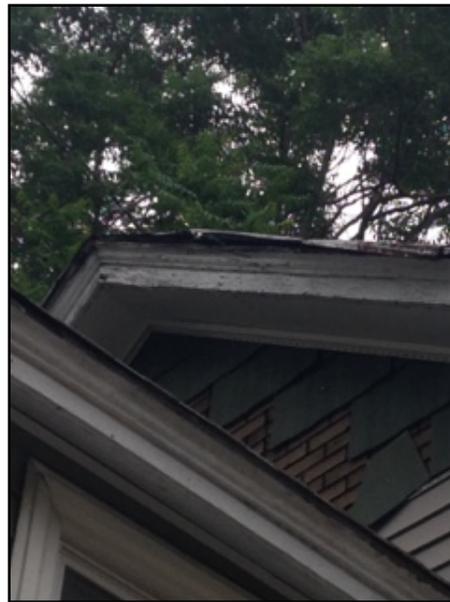
The second-story metal roof (located towards the front of the structure) has severe damage from trees rubbing against it and falling on it over a long period of time.

These photos depict the rear and right side of the home (when viewed from the front) and show damaged gable components from leaks and resulting wood rot. They also show severe damage in one area from long-term contact with tree limbs and damage to the edges (over the soffits) along the roof's entire length. There is also evidence of numerous attempts at repair, probably over a long period of time.

In our opinion, the roof cannot be salvaged and must be replaced.

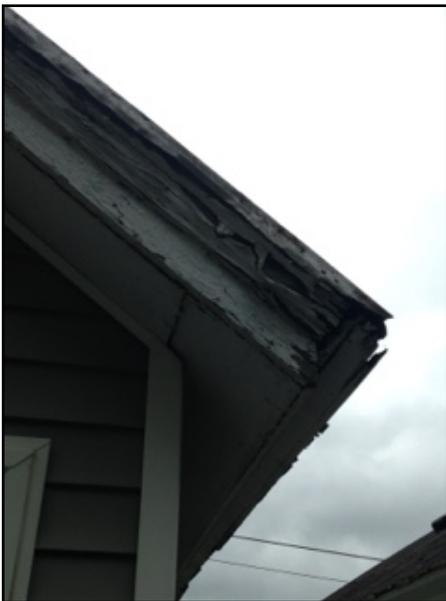
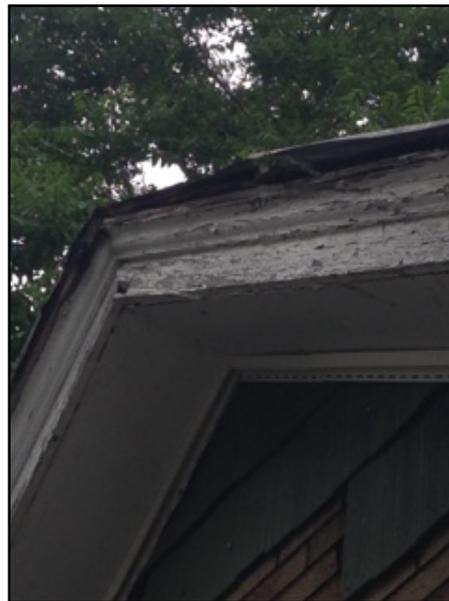
These photos depict the rear gables of the house. As is visible in one photo, there is a hole through which we could observe daylight. We also observed water damage along the entire gable due to the roof's failure to direct water effectively.

We know of no way to repair these issues utilizing the existing roofing materials. As on other parts of the roof, repairs were made (with varying degrees of workmanship and little long-term success.) Attempting to remove and re-install any of the roofing would also be impossible due to the amount of rust present and its lack of ability to lay flat once it is bent in any way.

We therefore feel that the only way to prevent further damage to the building is by replacing it in a professional manner.

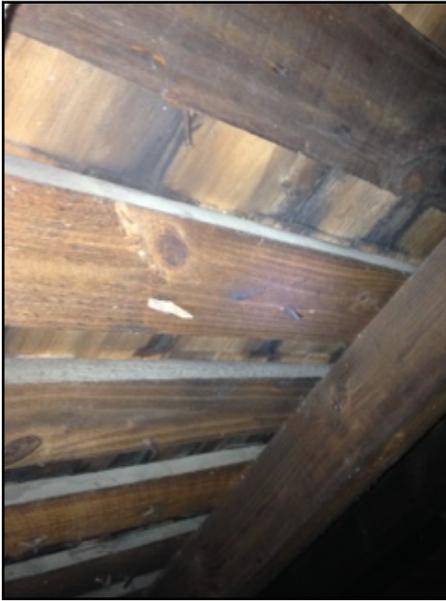
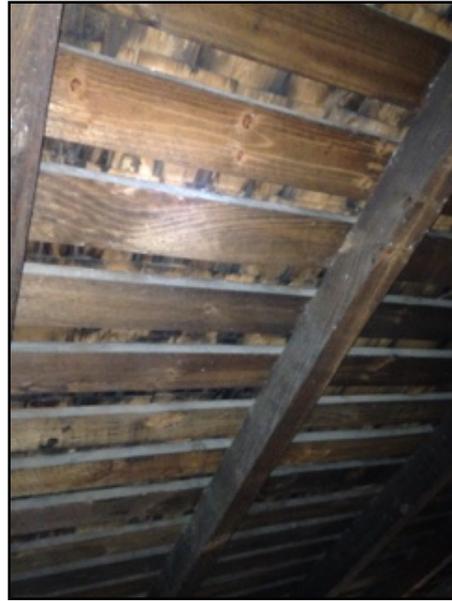
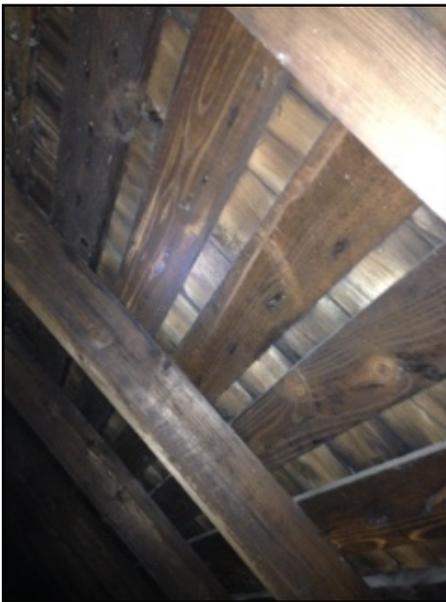
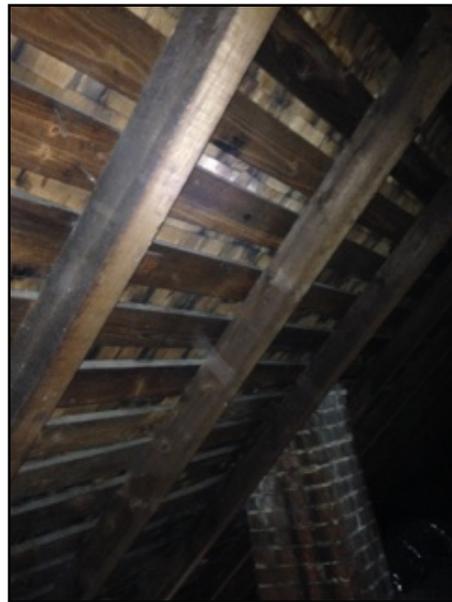
We initially assumed (incorrectly) that the metal roof was original to the home. However, the shingles visible here are underneath the metal roof and therefore, were installed before the metal roofing was added. If historical accuracy is something any interested party desires, we believe that material that resembles shingles, such as an architectural asphalt roof, would more closely match what was present when the home was built.

3) These photos were taken in the attic below the front roof (currently metal.) They show rows of shingles between the decking laths. These shingles are visible throughout the attic.

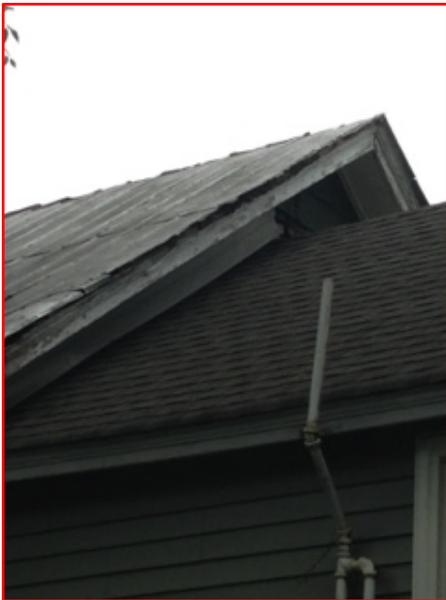
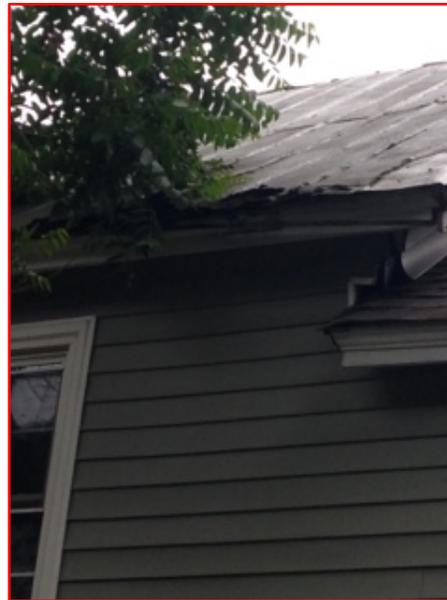
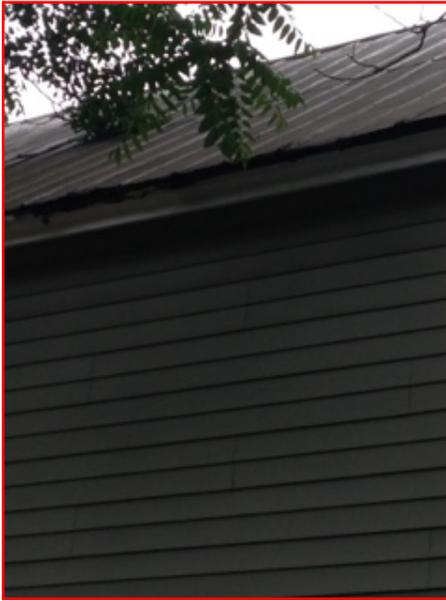
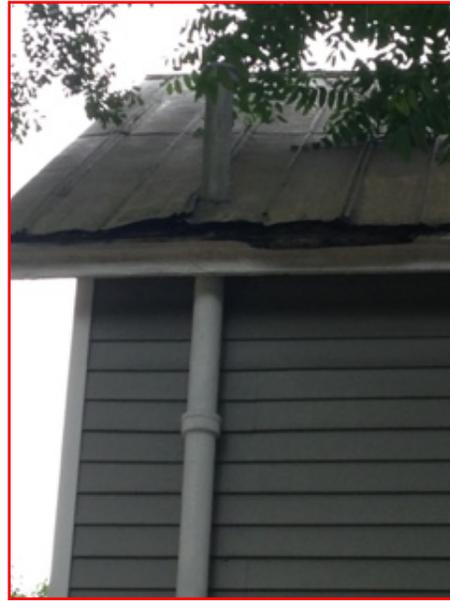
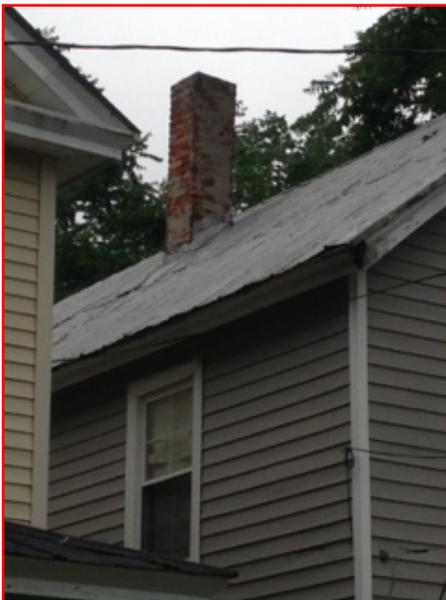
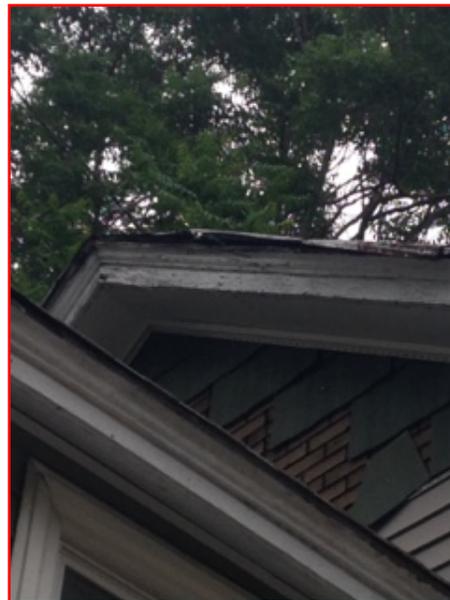
1) The second-story metal roof (located towards the front of the structure) has severe damage from trees rubbing against it and falling on it over a long period of time.

These photos depict the rear and right side of the home (when viewed from the front) and show damaged gable components from leaks and resulting wood rot. They also show severe damage in one area from long-term contact with tree limbs and damage to the edges (over the soffits) along the roof's entire length. There is also evidence of numerous attempts at repair, probably over a long period of time.

In our opinion, the roof cannot be salvaged and must be replaced.

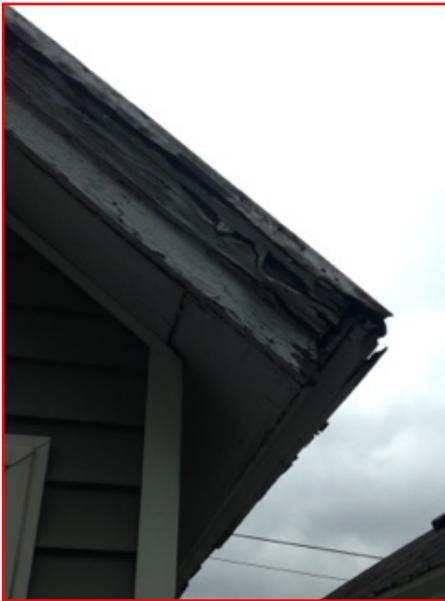
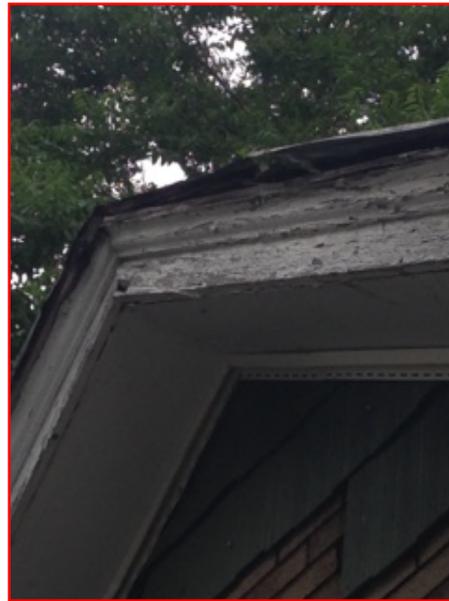
2) These photos depict the rear gables of the house. As is visible in one photo, there is a hole through which we could observe daylight. We also observed water damage along the entire gable due to the roof's failure to direct water effectively.

We know of no way to repair these issues utilizing the existing roofing materials. As on other parts of the roof, repairs were made (with varying degrees of workmanship and little long-term success.) Attempting to remove and re-install any of the roofing would also be impossible due to the amount of rust present and its lack of ability to lay flat once it is bent in any way.

We therefore feel that the only way to prevent further damage to the building is by replacing it in a professional manner.

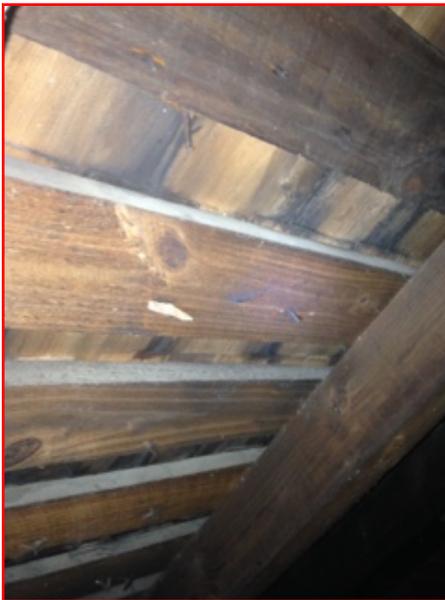
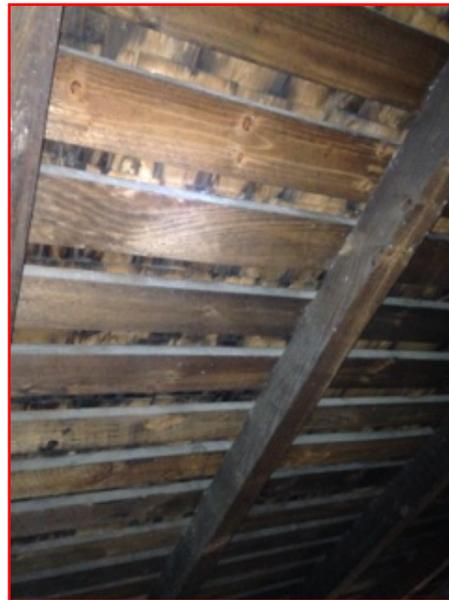
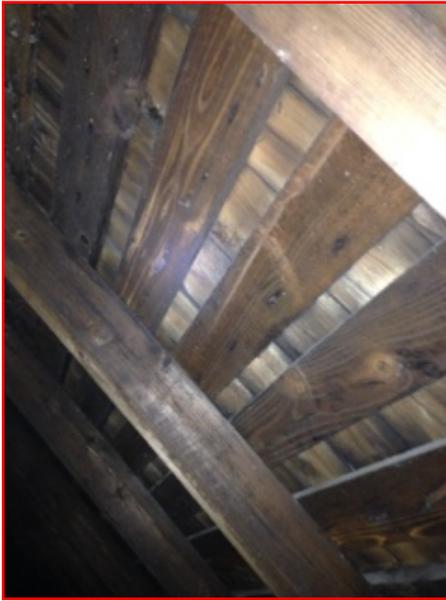
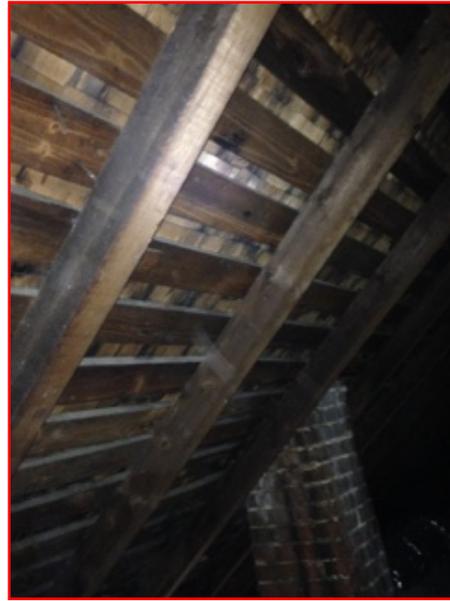
We initially assumed (incorrectly) that the metal roof was original to the home. However, the shingles visible here are underneath the metal roof and therefore, were installed before the metal roofing was added. If historical accuracy is something any interested party desires, we believe that material that resembles shingles, such as an architectural asphalt roof, would more closely match what was present when the home was built.
