South Norfolk
Historic & Architectural Review Board

November 7, 2019

Meeting Minutes
Historic and Architectural Review Board (HARB)
October 3, 2019
South Norfolk Memorial Library – 801 Poindexter St.

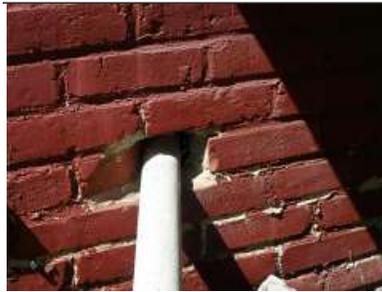
Remove the pipe and cap off the brick at the left side of the house.

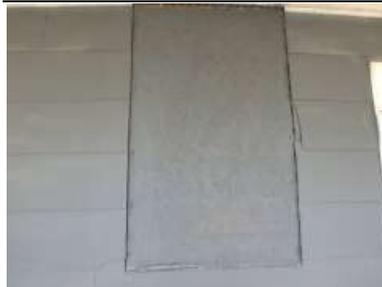
Replace the damaged siding tiles as needed.

Install proper siding at the rear of the house where the window has been removed.

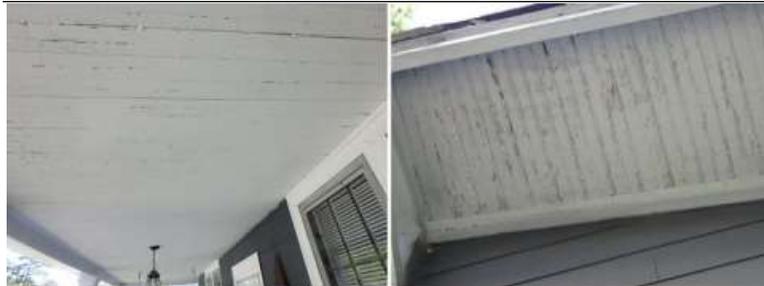
There is normal deterioration noted to the trim. The trim is due to be scraped, caulked, and/or painted as part of routine maintenance at the exterior walls/porch/soffits and to prevent future.

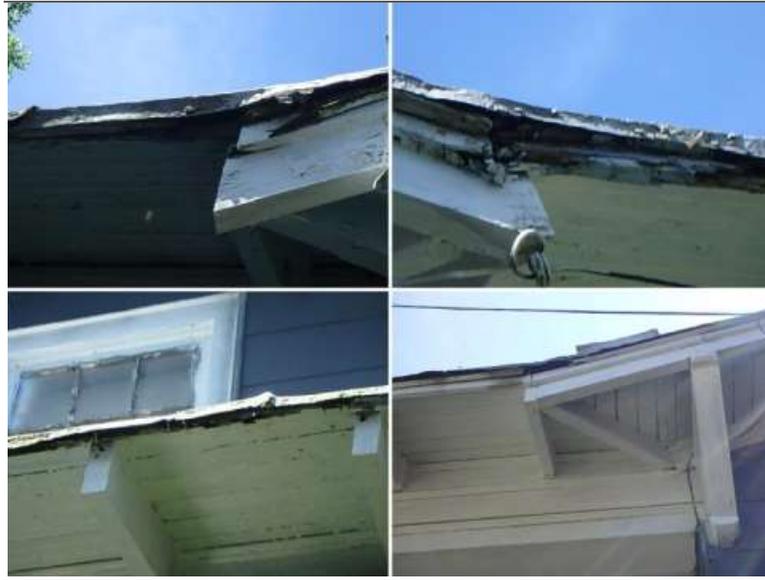
Inspect all exterior wood at the soffits and fascias/rake boards. Replace all damaged/missing areas.

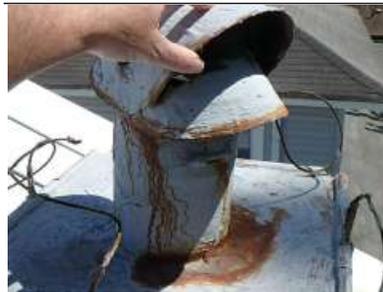
Any unused chimney should be capped off to keep water and animals from entering the home.

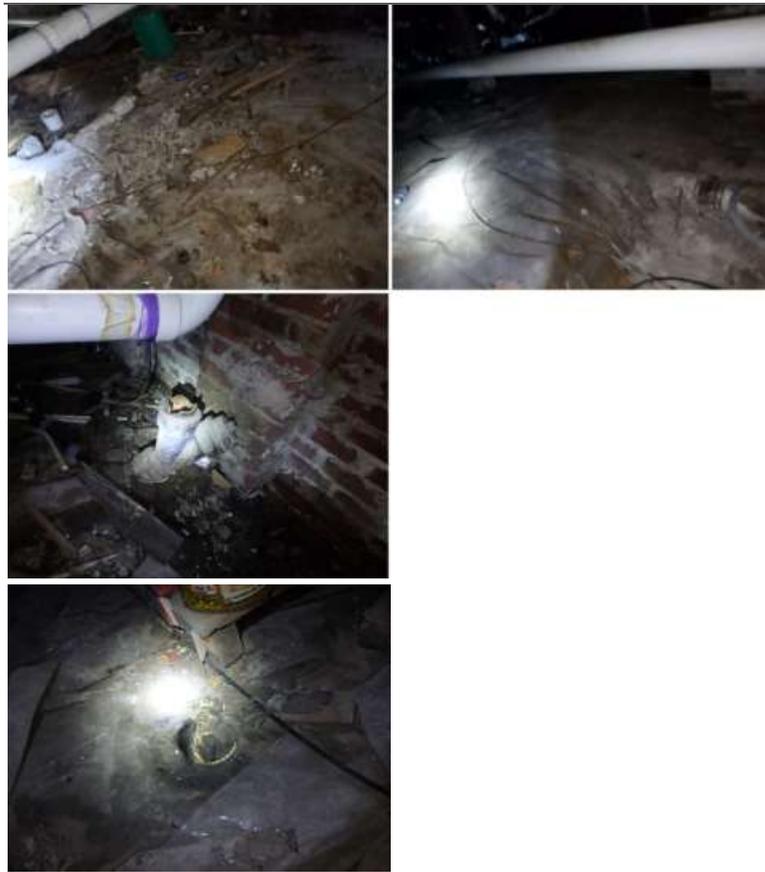
There is debris noted in the crawl space at time of inspection. It is recommended to have removed to avoid insects and minimize safety hazards.

The crawl space needs installation/replacement of moisture poly barrier where not covering the ground to prevent moisture from entering the air and causing issues.

Remove the dead rodent seen in the crawl space.

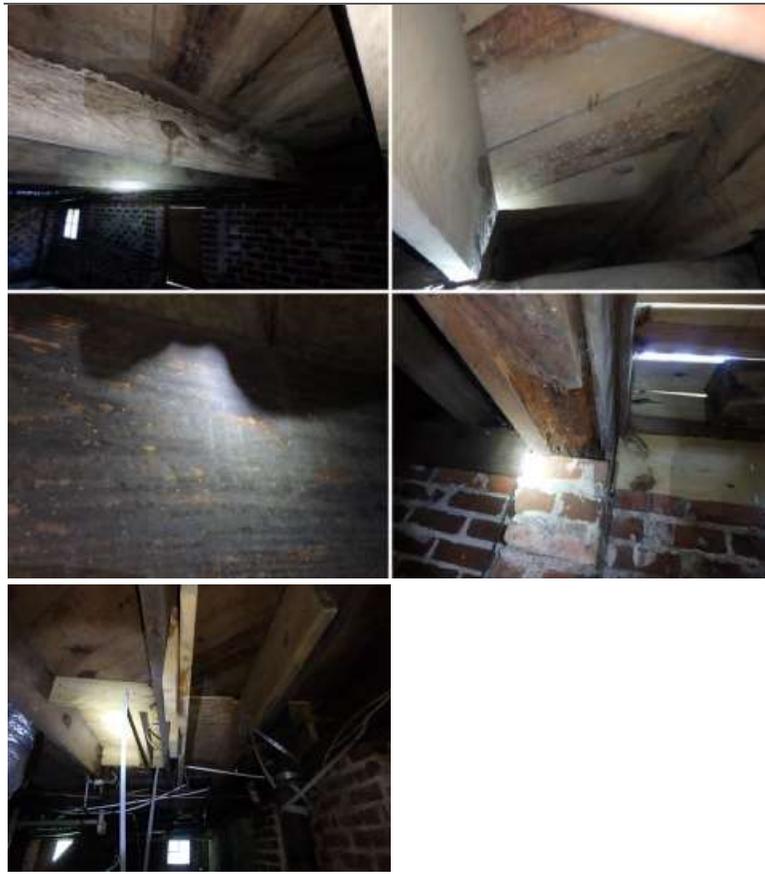
Fungus is noted in areas of the crawlspace. Have a licensed moisture/termite specialist to treat, evaluate and make recommendations or repairs to the entire area.

Replace the dry rooted beam at the front right corner of the crawl space.

Properly repair the sub-flooring and framing under the bathroom.

Have a licensed and insured contractor evaluate and make any further recommendations or repairs as needed to the foundation and/or the crawl space area of the home.

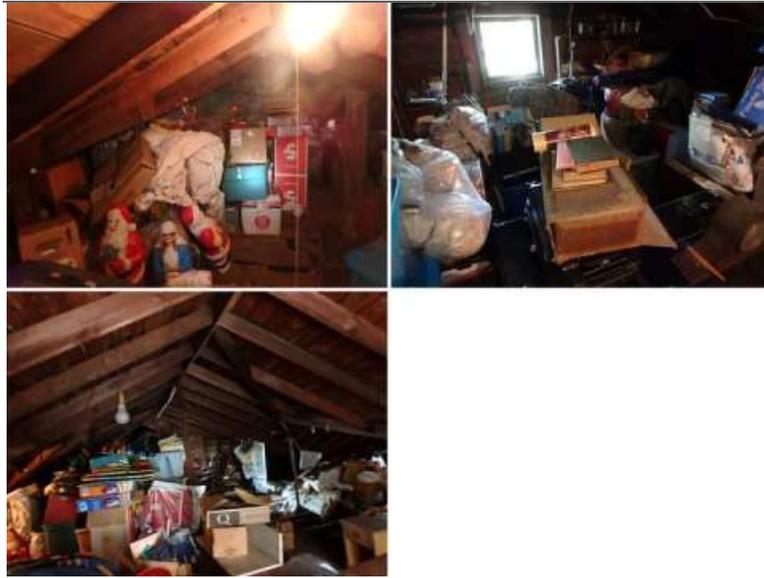
There is debris and/or personal belongings noted in the attic. Due to this we may have been unable to view all areas.

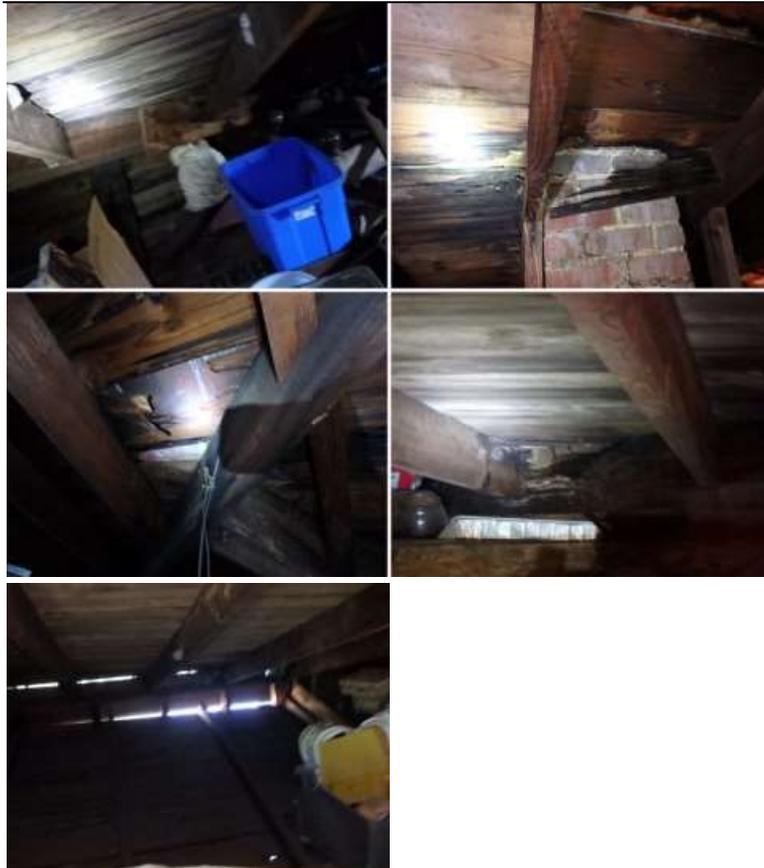
Inspect the entire roof framing, repair the roof planks and replace the moisture damaged ridge pole at the rear valley and replace the framing around the chimney. Seal all gaps in the attic at the soffits.

A contractor licensed and insured contractor should evaluate and make any recommendations or repairs as needed to the attic.

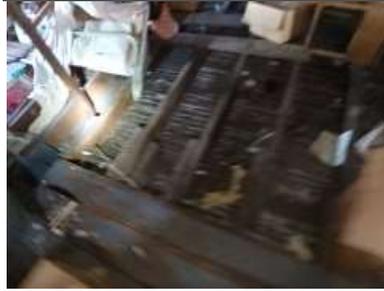
There is no insulation installed at time of inspection. It is recommend to add additional insulation in all areas for proper thermal coverage to modern requirements.

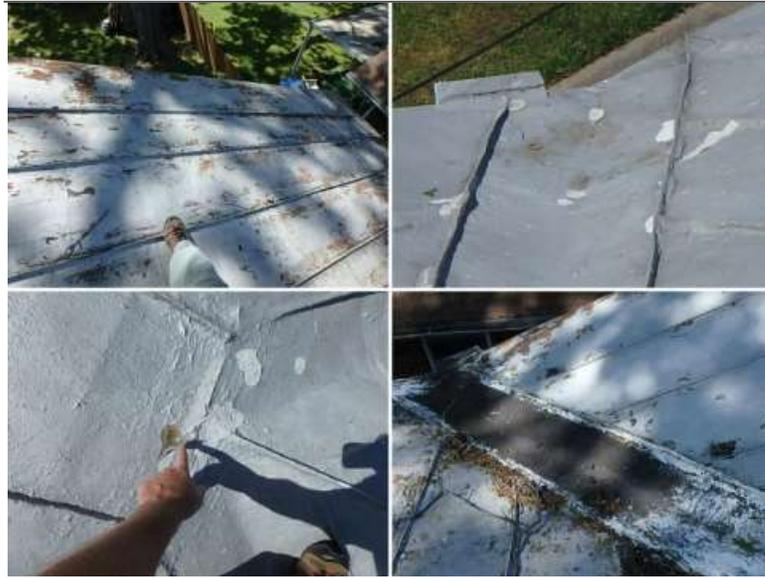
Have a licensed and insured metal roofing contractor further evaluate and make any further recommendations or repairs as needed to the roofing system.

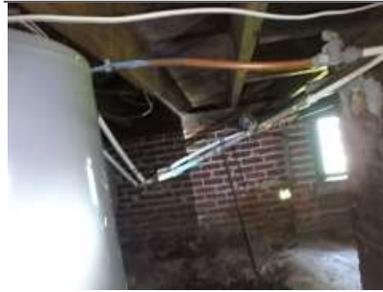
Secure the supply lines to the floor joists as needed.

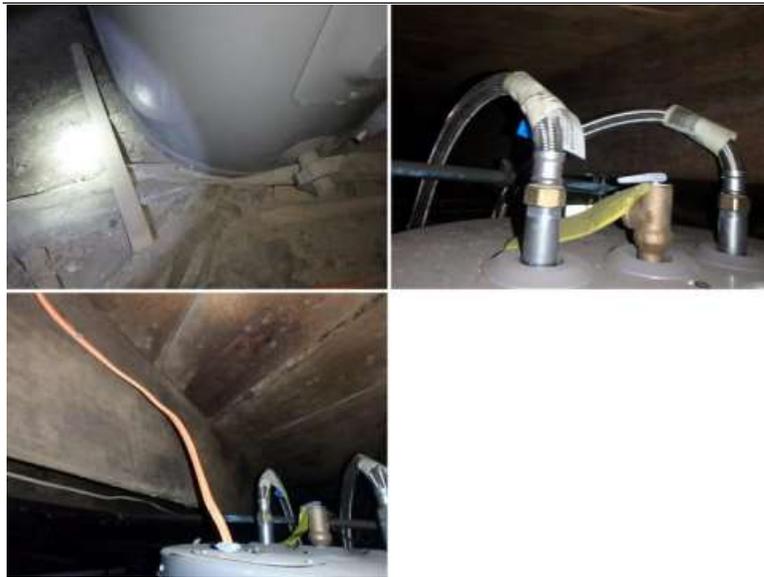
The pressure relief valve drain line ends prematurely, extend to 6" up off the ground as required to prevent accidental injury in the event of a discharge.

Have a licensed and insured plumbing contractor evaluate and make any further recommendations or repairs as needed to the plumbing system.

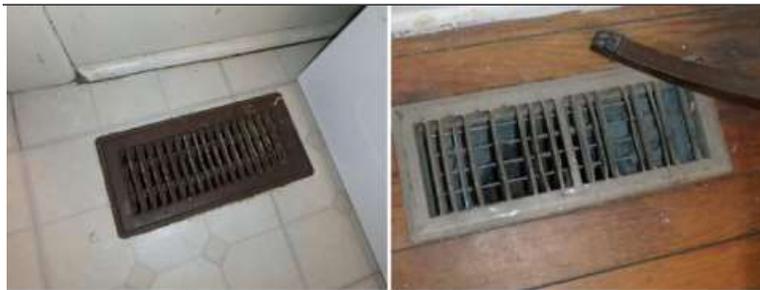
Replace the old damaged floor vent grills as needed.

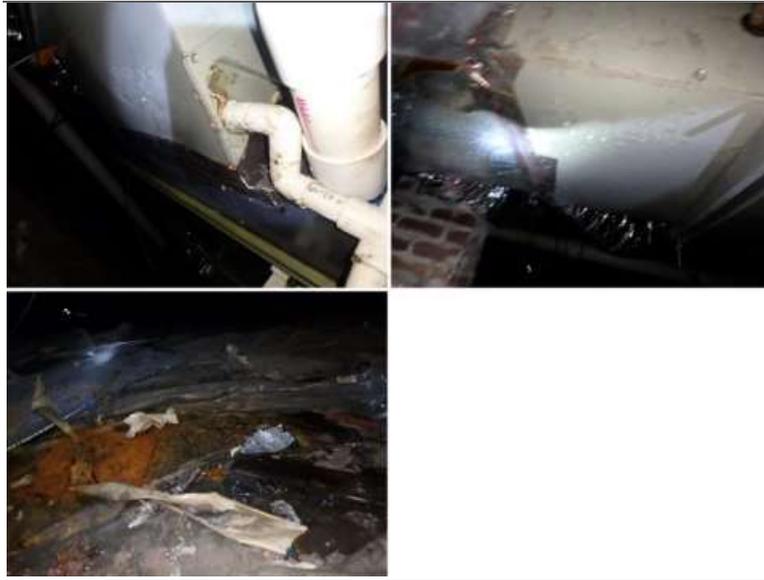
Inspect the air handler and condense lines, moisture is dripping and pooling on the soil in the crawl space.

The advanced age and/or condition of this unit is such that you will likely need to replace it in the near future. Have a licensed HVAC contractor to further evaluate, service the system and make any further recommendations on or prior to the PICRA.

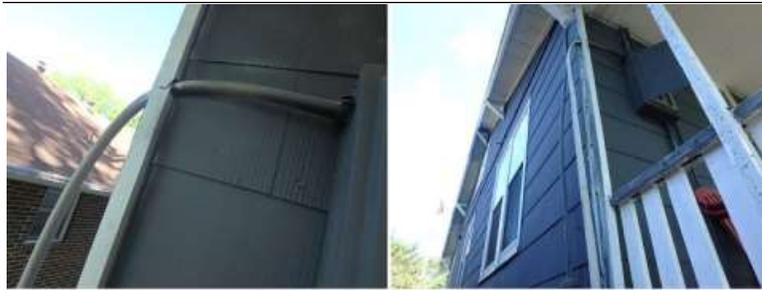
The service cable and cap are pulling away from the home.

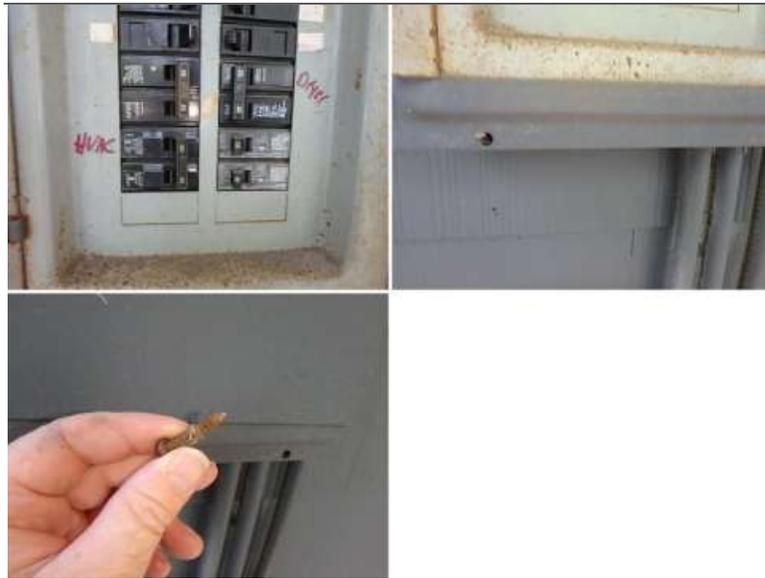
There are missing and/or improper sharp pointed screws in the panel cover, Have replaced to properly secure the panel to the wall and for safety.

The panel box is missing important information and needs to be labeled to determine what the breakers operate.

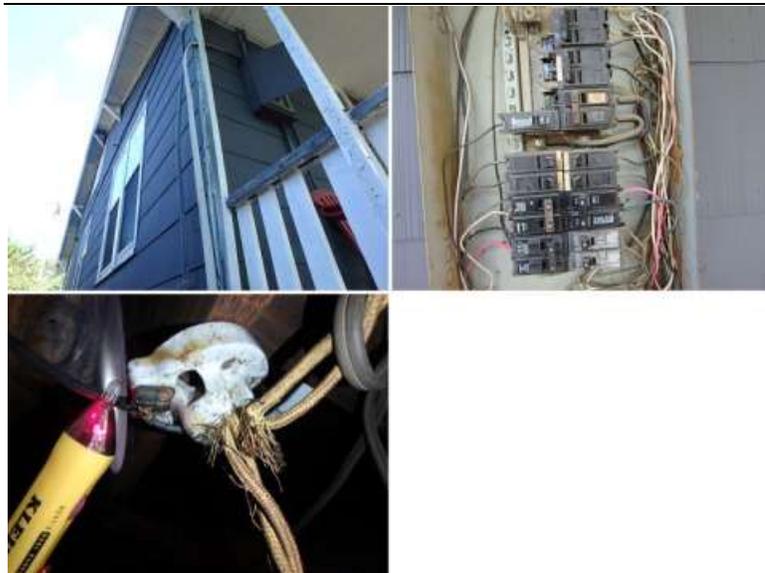
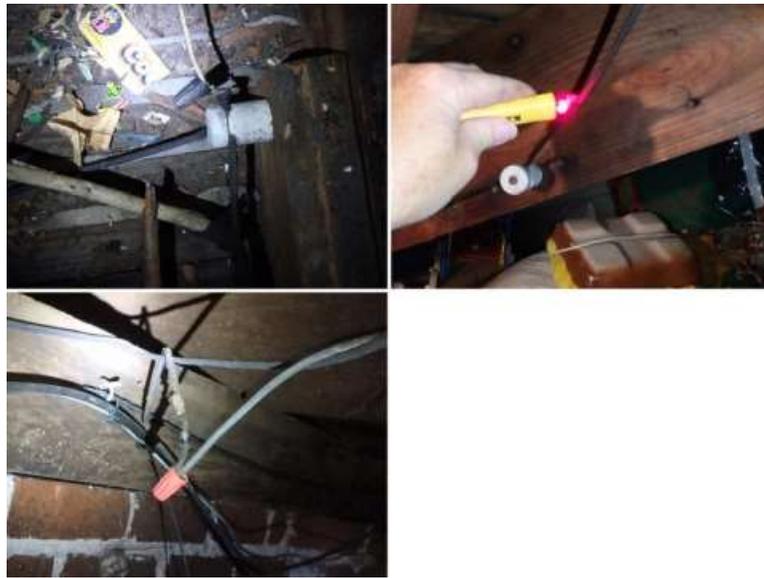
There are some elements of the old knob and tube electrical system noted at time of inspection and is still active throughout the home.

Have a licensed and insured electrical contractor further evaluate and make any recommendations and repairs as needed to the electrical system.

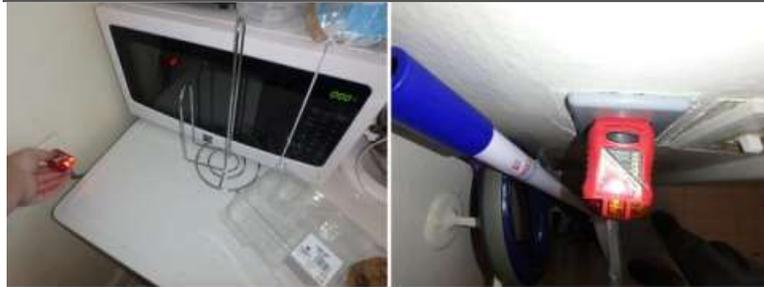
The outlets in the home appear to be the standard 3-prong grounded outlets. However, some of the 3 prong outlets in the home are not grounded. Have noted devices repaired by a licensed and insured electrician. It is recommended to upgrade the kitchen and bathroom outlets to GFCI outlets when remodeling or within 6 feet of a water source. Have a licensed and insured electrical contractor further evaluate and make any recommendations and repairs as needed to the electrical system.

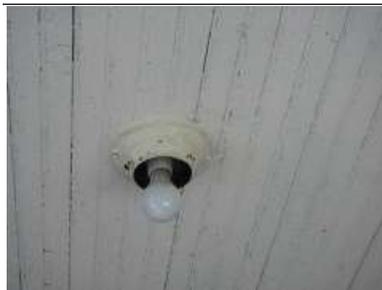
There are some light globes or covers that are missing throughout the house. Have replaced as needed as is standard at the exterior.

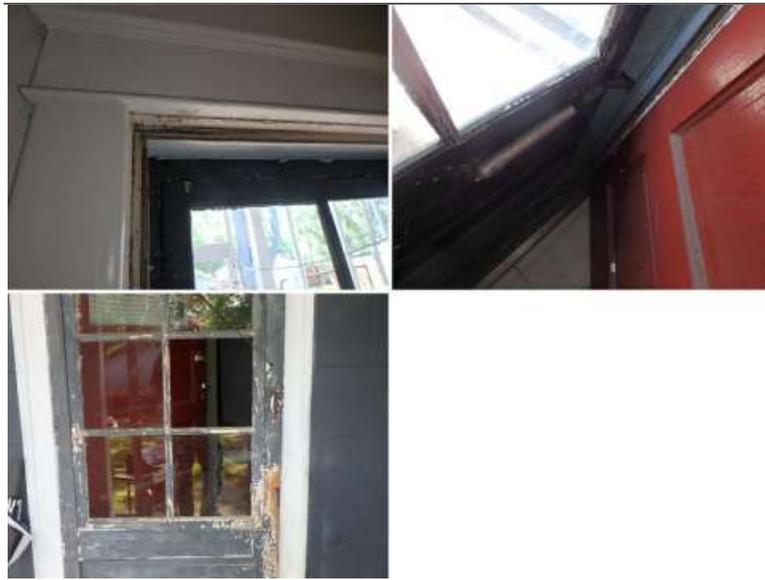
Have the storm door closure adjusted as needed for proper operation. The exterior door weather seals are damaged or deteriorated and should be replaced for a proper thermal barrier and so it is impenetrable to weather and insects.

Repair/replace the rear entry door as needed.

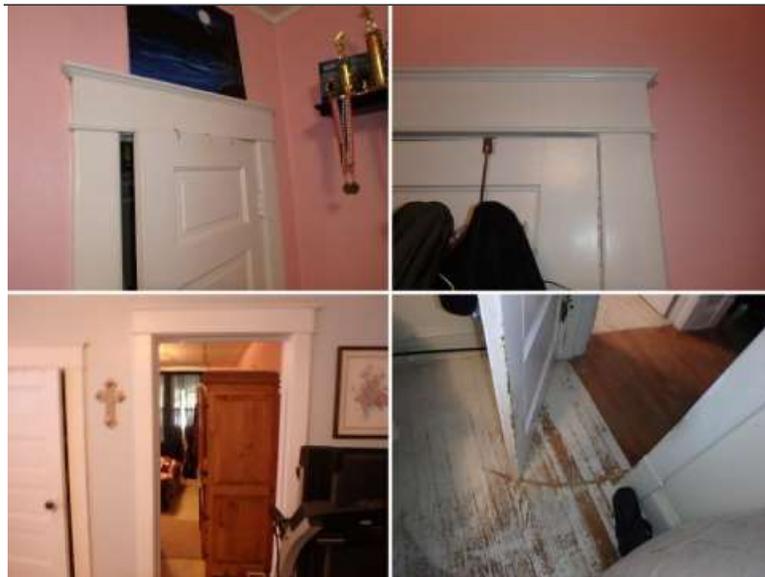
Adjust any doors that are rubbing or sticking at the frame to operate properly.

Have the door cut for a proper 5/8 inch airflow at the floor as is standard.

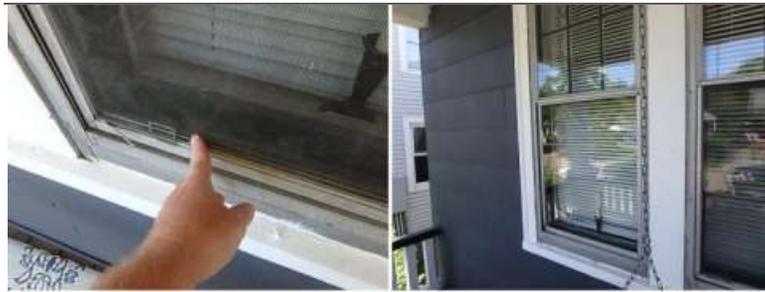
There are screen(s) that have holes or damage noted around the home. Have the screens repaired or replaced as needed.

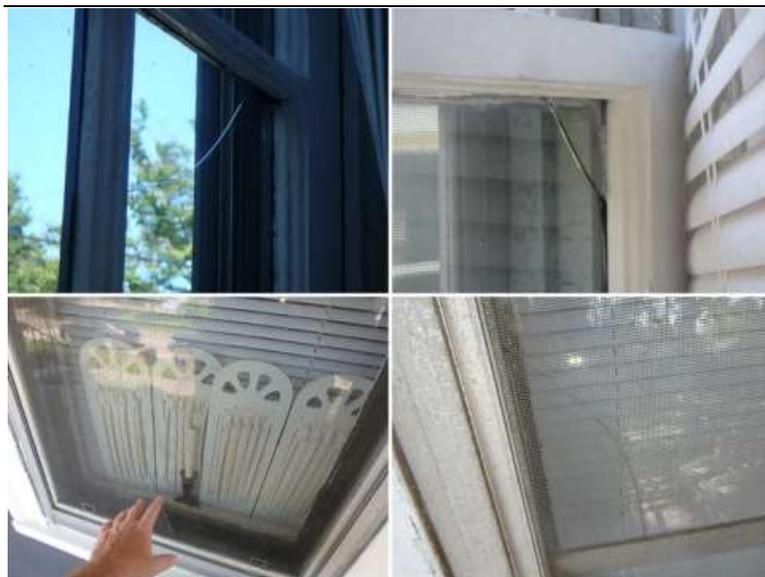
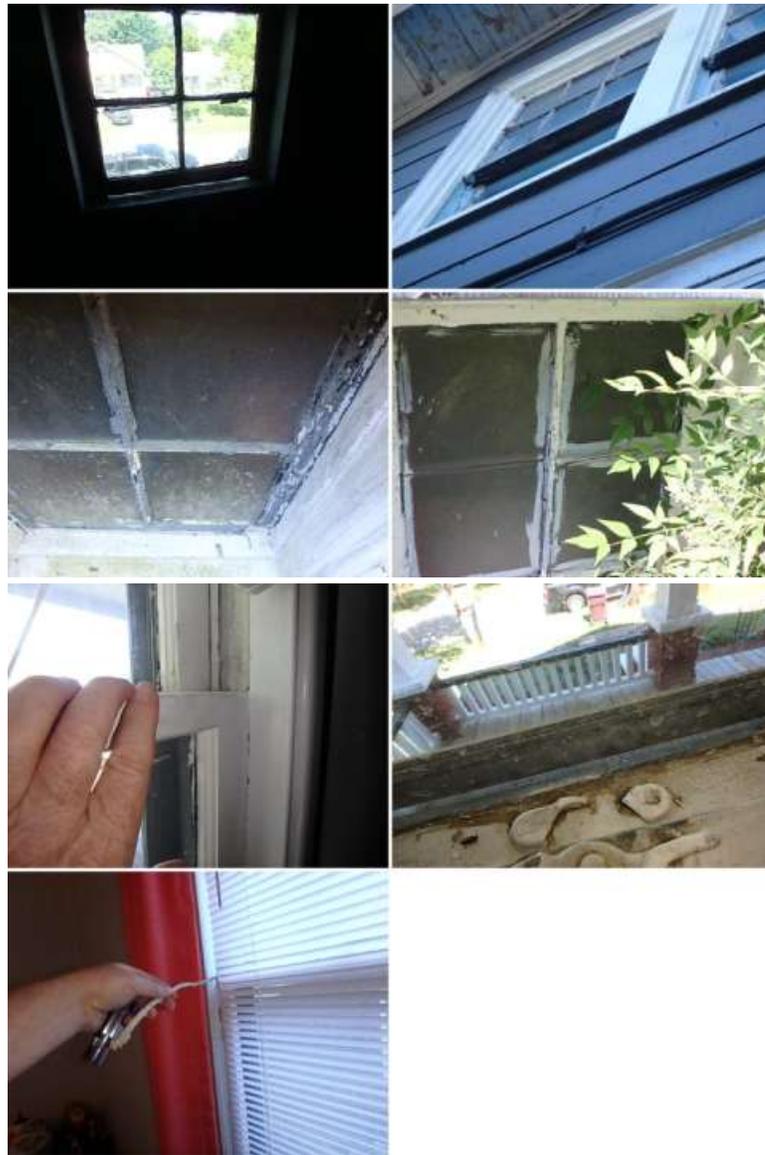
There are some windows in the home that are hard to operate. Have these windows further evaluated and repaired or replaced as needed and operational at the walkthrough.

A licensed and insured window expert should further evaluate and make any recommendations or repairs as needed the windows.

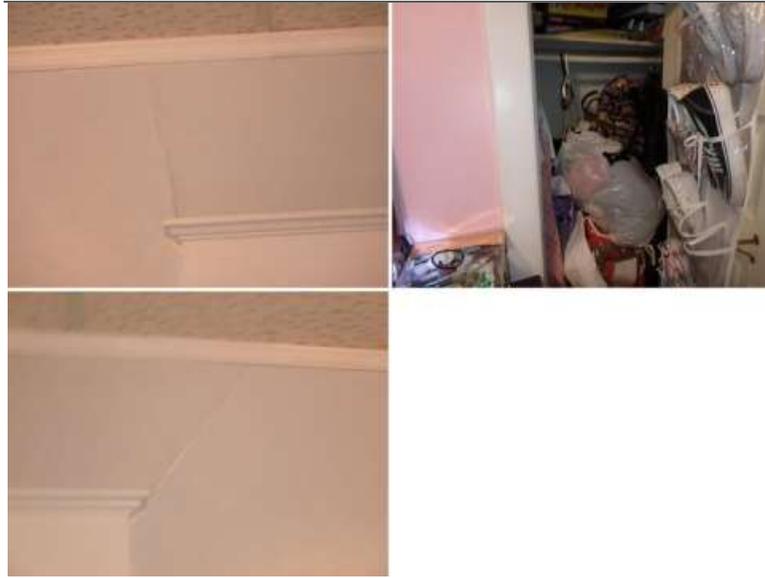
Unable to inspect the interior of all closets.
Settlement cracks are noted at the doors.

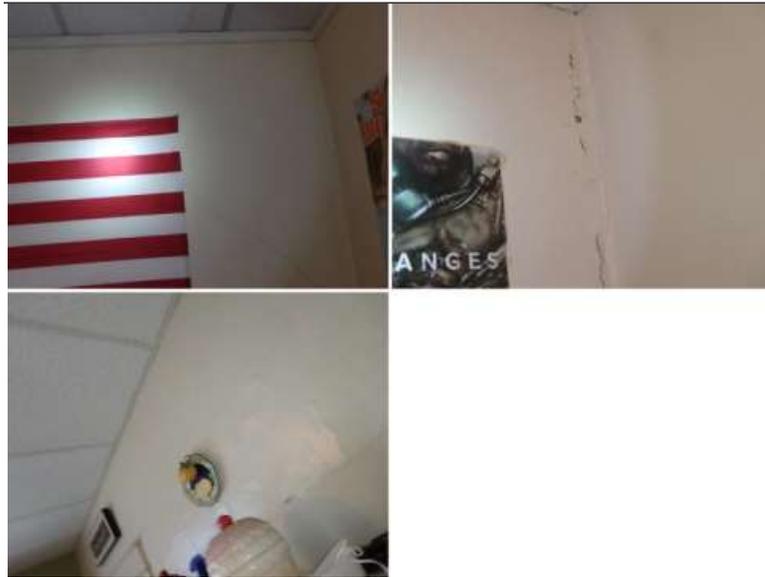
Have the large crack at the rear bedroom exterior wall further evaluated/repaired as needed.

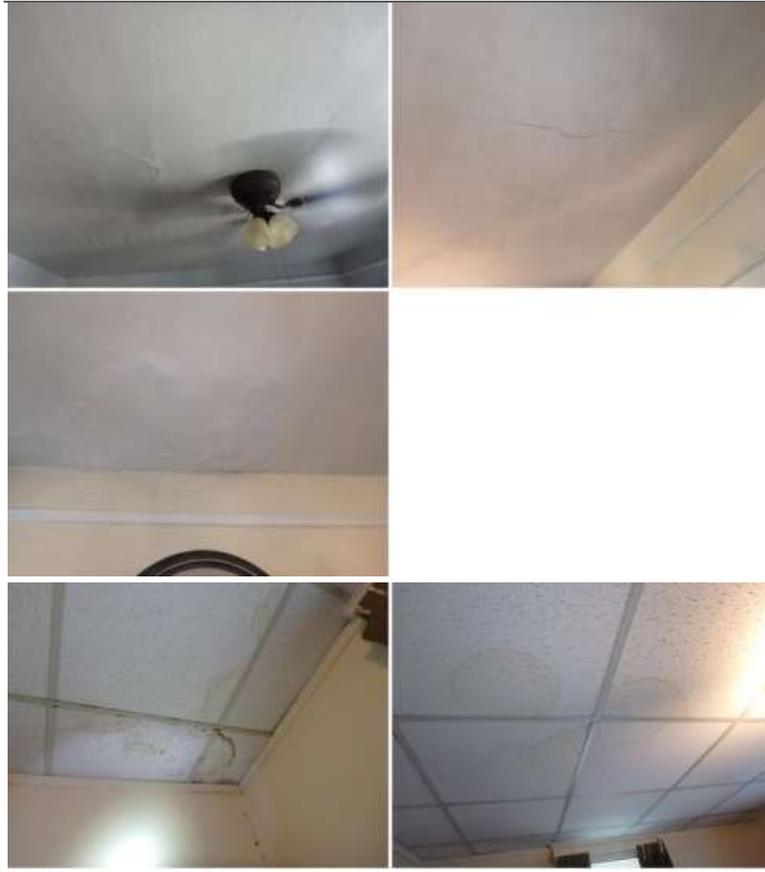
Due to some of the conditions viewed, repairs are needed to some of the interior walls around the home to prevent further damage.

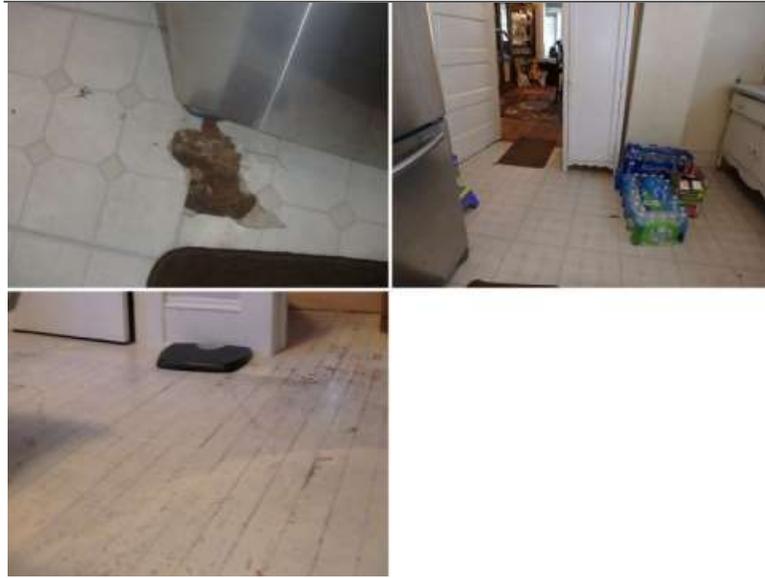
Due to the condition of the hardwood flooring it is recommended to refinish the floor to revitalize and protect. Damage and deterioration is noted to the tile. Have repaired or replaced as needed to ensure functionality. Uneven floors are not uncommon for a home of this age, monitor.

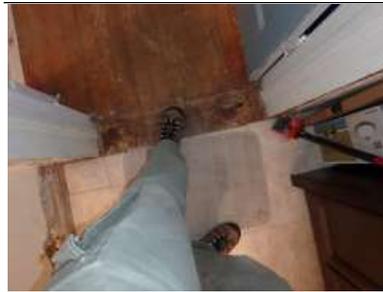
Secure the loose floor boards as needed within the home.

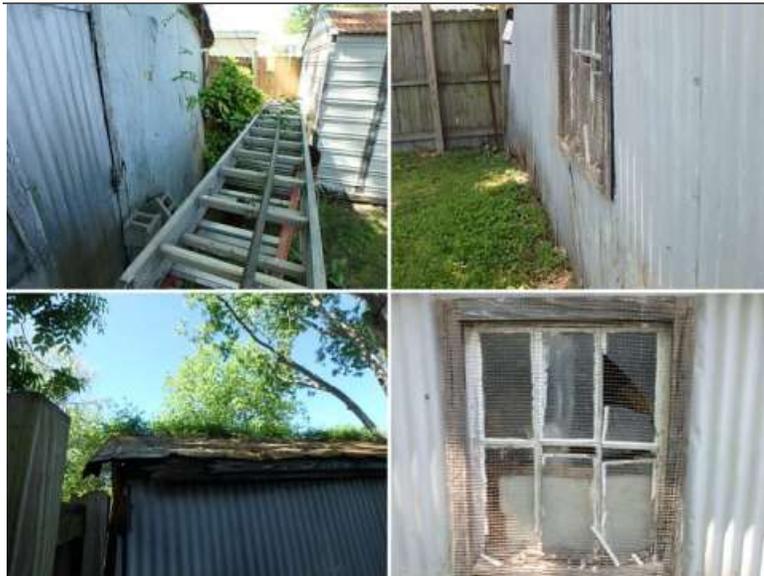
Major damage is noted to the shed structure. The damage is such that the shed should either be repaired or removed in order to prevent further damage and for safety. The shed is being phased in "AS IS" condition.

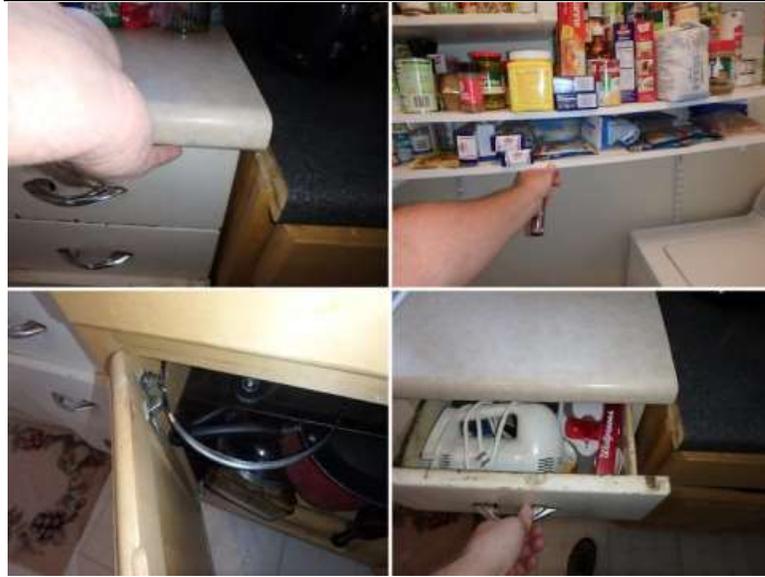
The interior components in the kitchen show typical wear at the counters and heavy wear at the cabinets. Secure the top to the cabinet as needed. Add support to the shelving as needed.

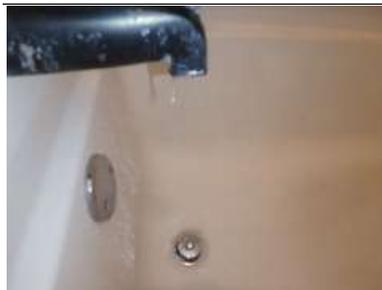
The tub/shower diverter is not functioning properly in bathroom #1 and should be repaired or replaced for proper function.

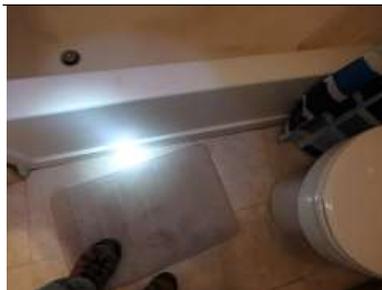
Caulking is needed at the tub to the floor in bathroom #1 to avoid moisture intrusion.

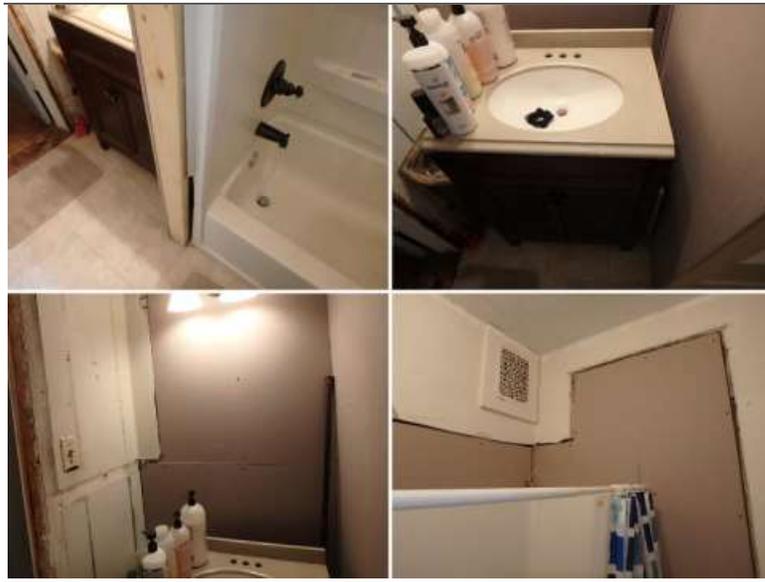
The entire bathroom needs to be renovated due to the many conditions viewed at time of inspection.

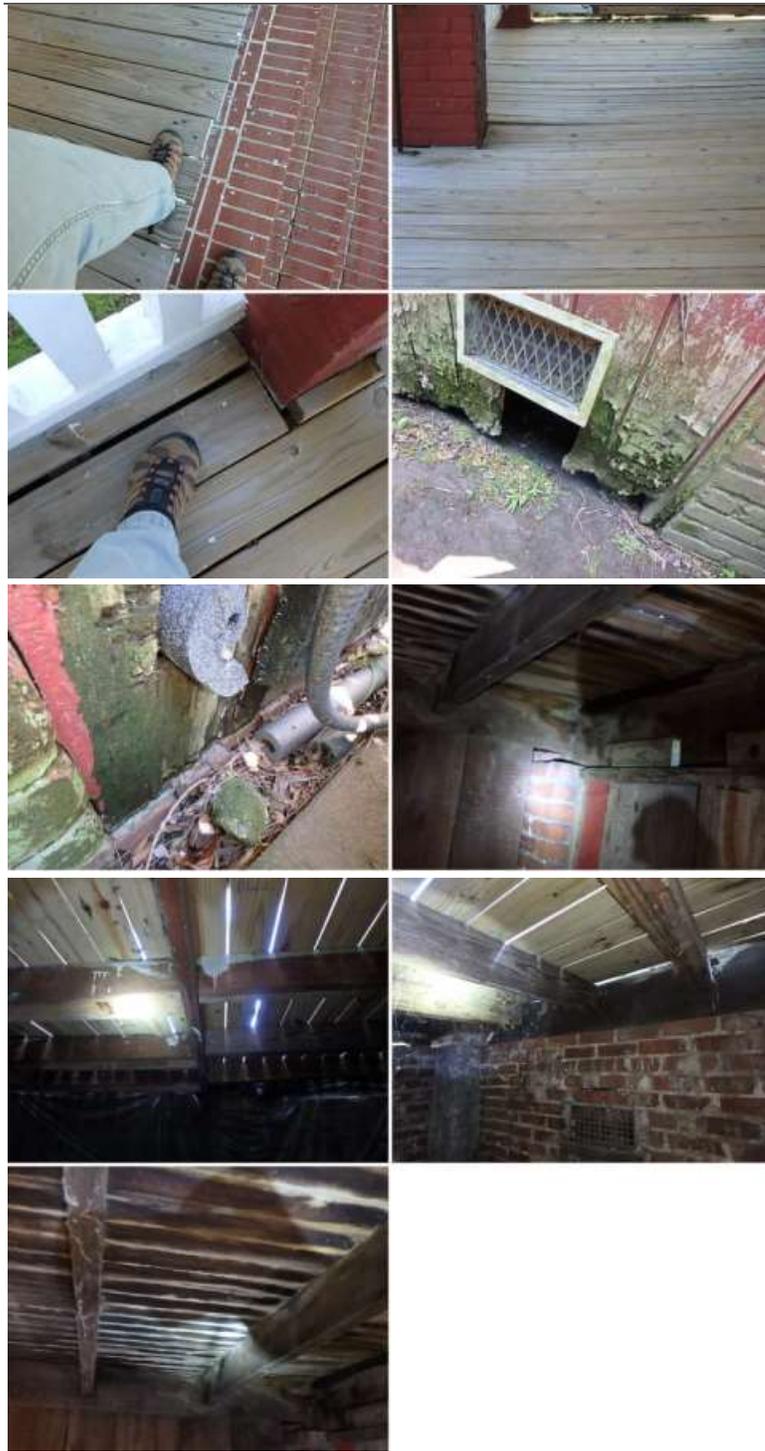
Repairs and supports needed under both front and rear porch.

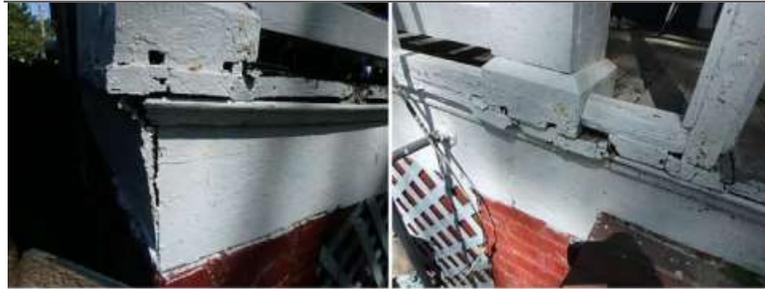
Signs of settling at the rear porch posts, have further evaluated and repaired as needed.

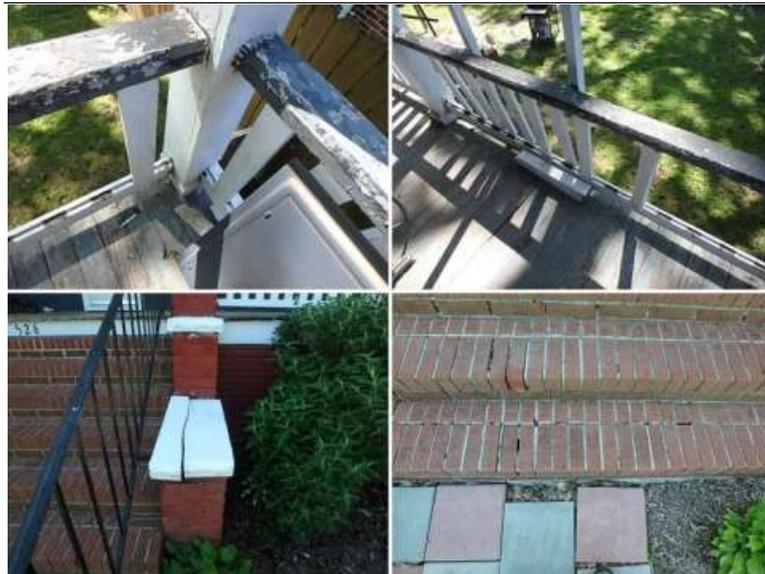
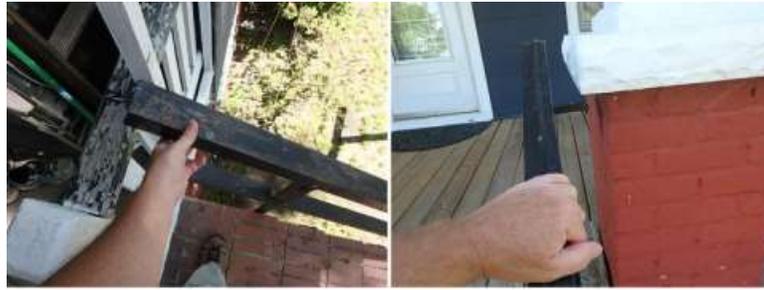
Repair or replace any moisture damaged steps, boards, posts and railings as needed to prevent further damage and safety.

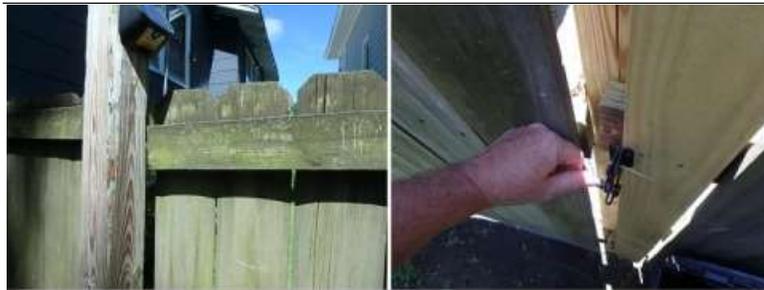
The gate needs repairs and/or adjustments for proper function and latching.
