Appendix A

Photographs

Figure A.1. Oak Grove Watershed - Photo Locations

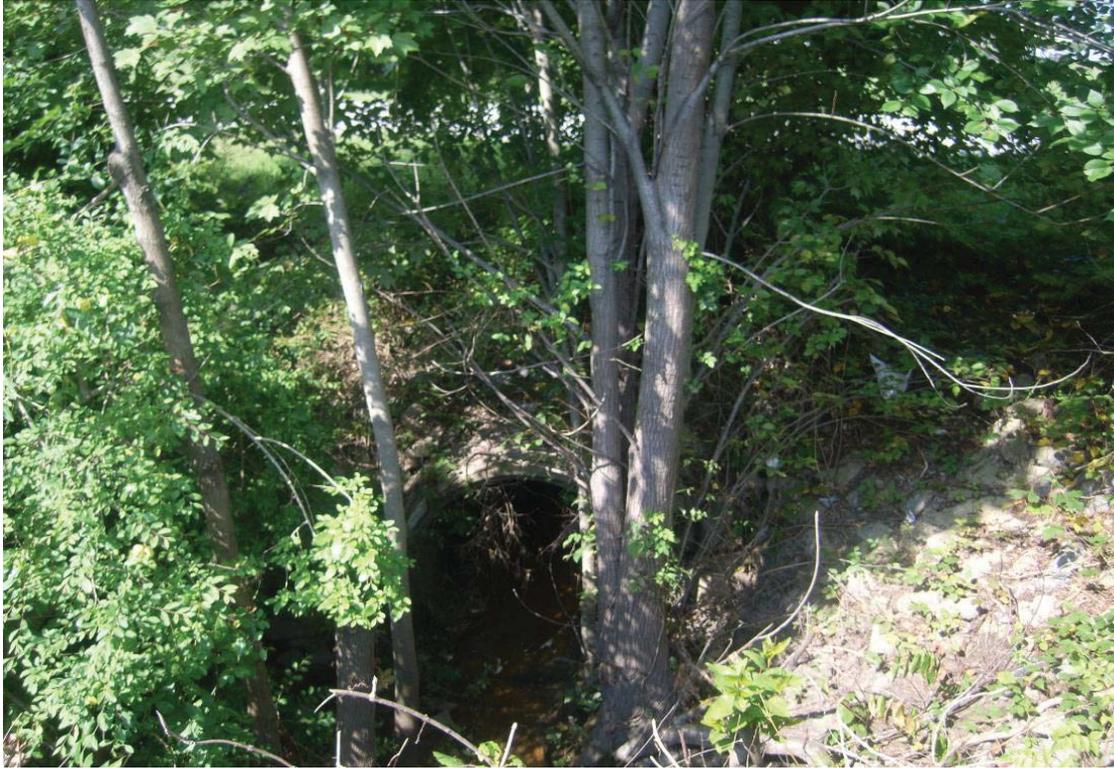
Photo 1. Node 118 - looking at culvert inlet

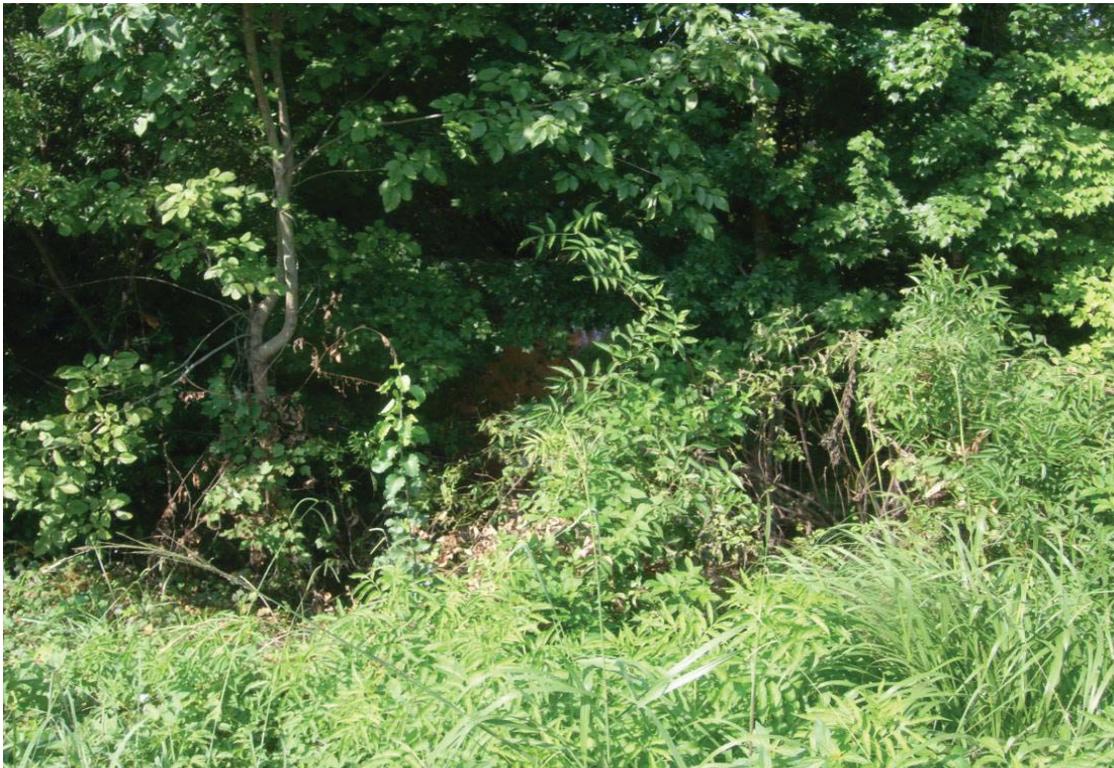
Photo 2. Node 120 - looking downstream

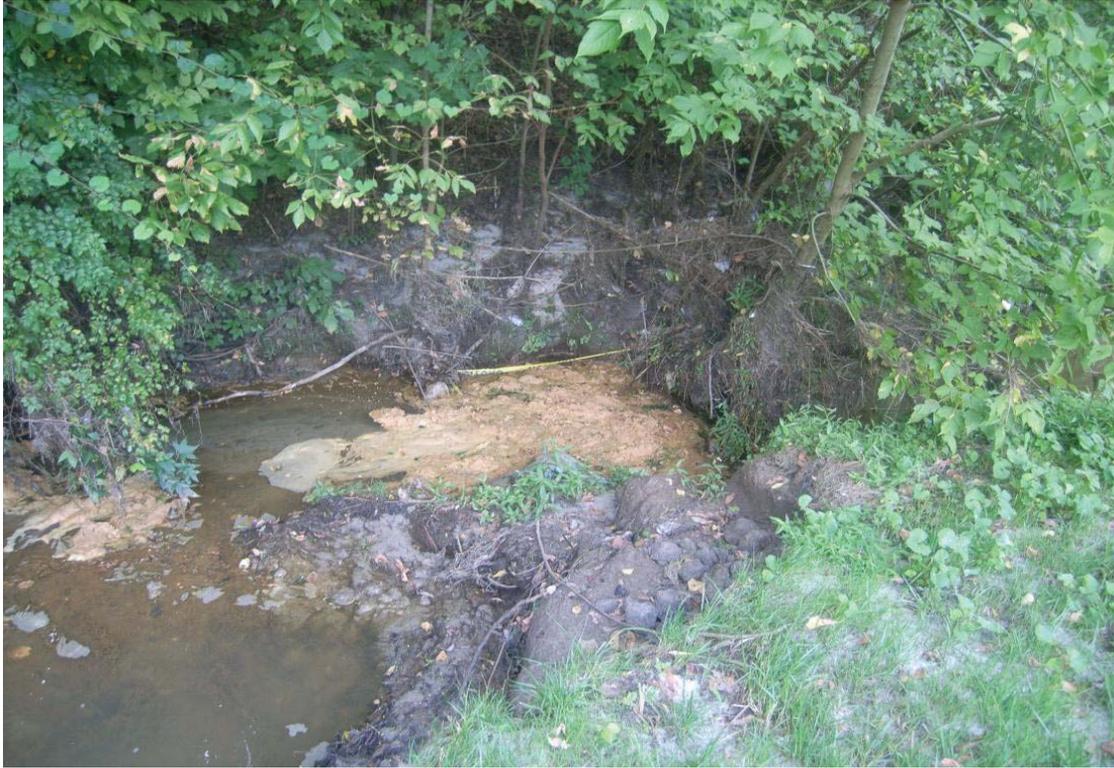
Photo 5. Node 151 - looking at sediment built up before culvert (1)

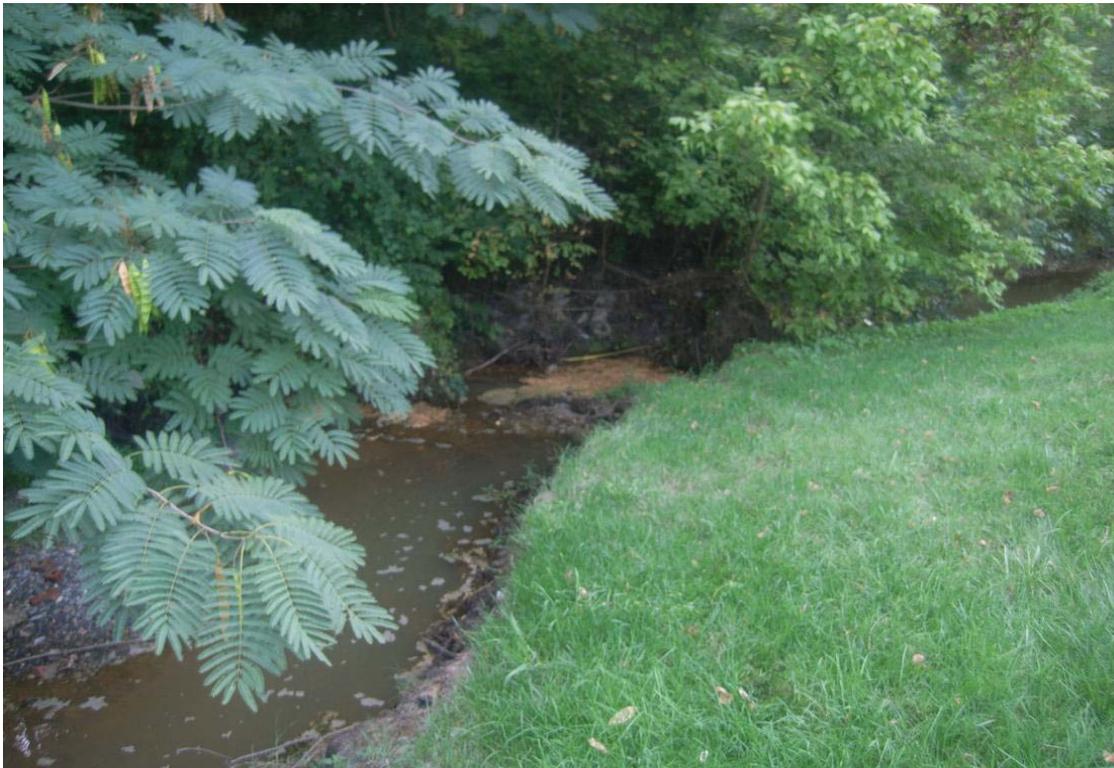
Photo 6. Node 151 - looking at sediment built up before culvert (2)

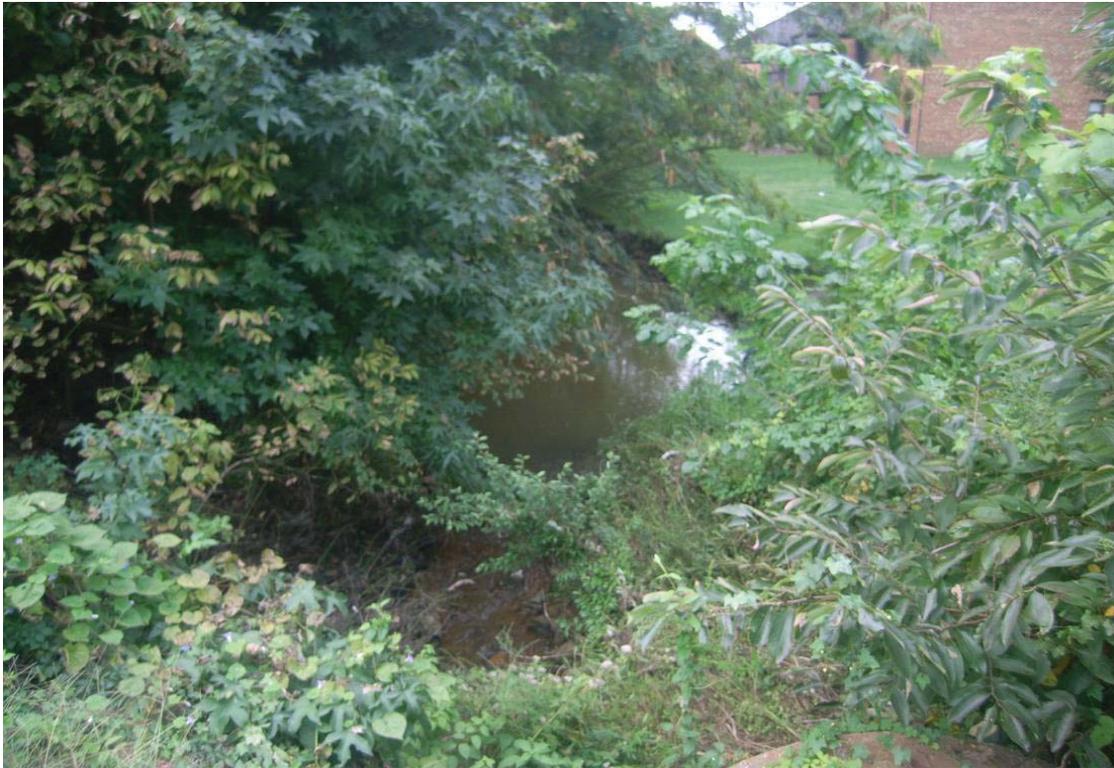
Photo 7. Node 151 - looking upstream

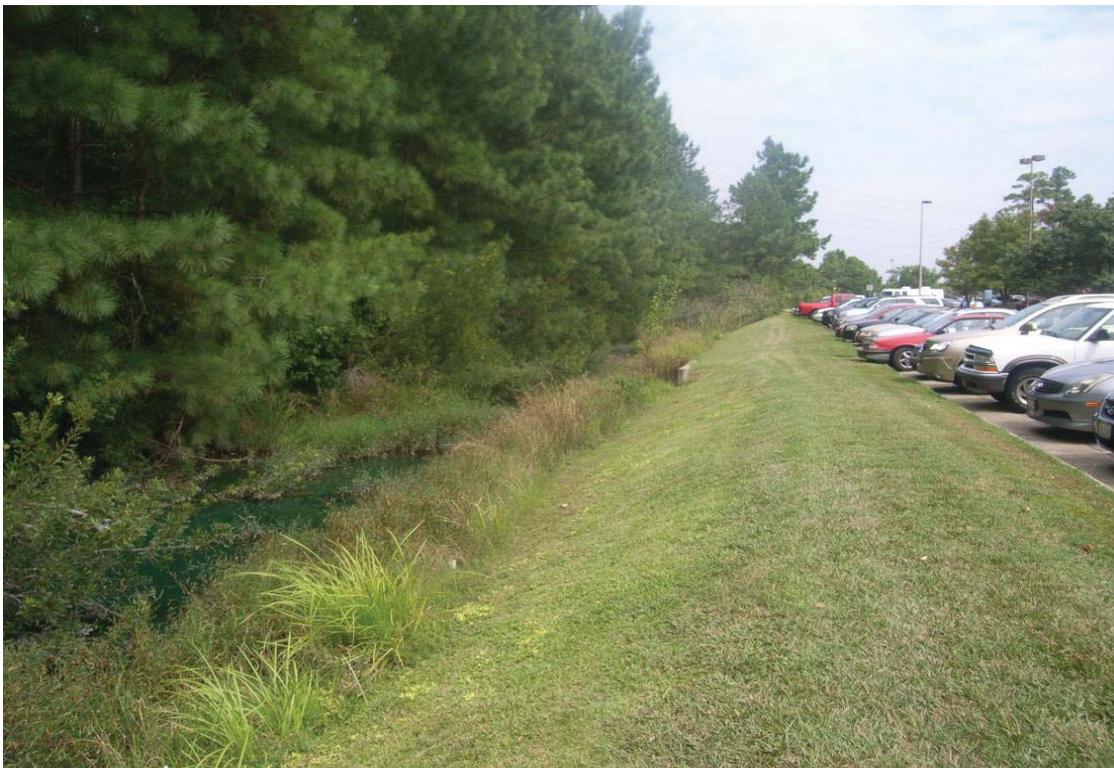
Photo 8. Node 207 - looking downstream

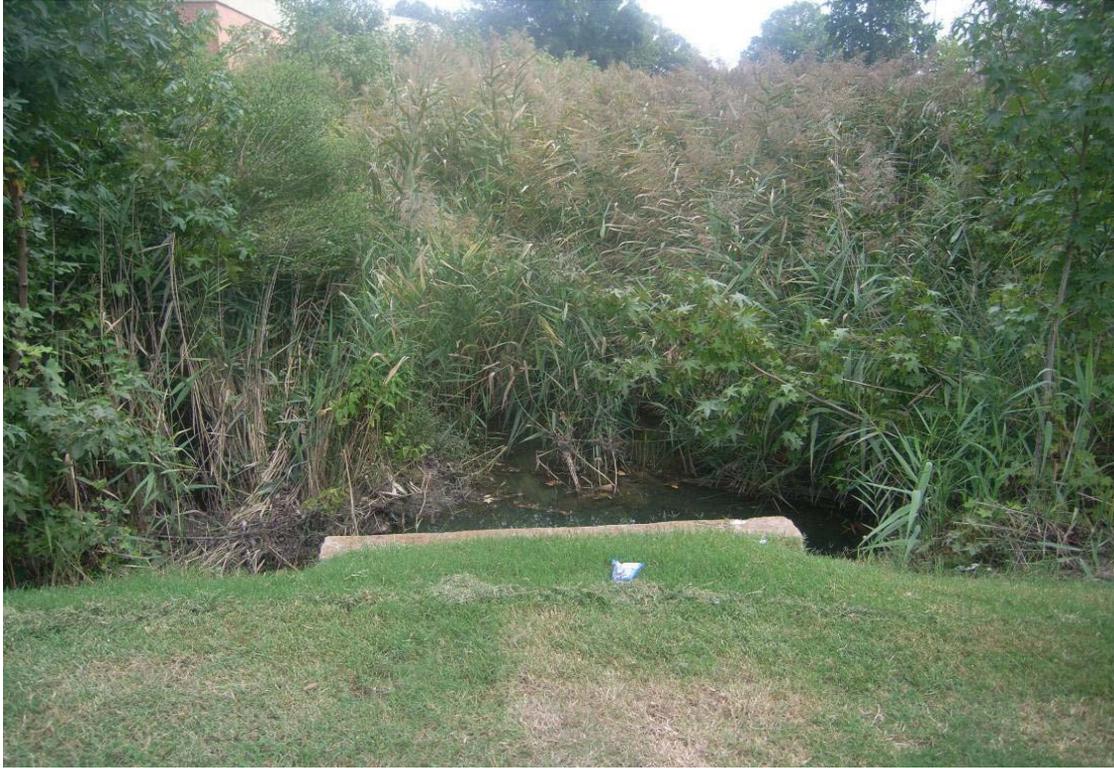
Photo 11. Node 213 - looking downstream

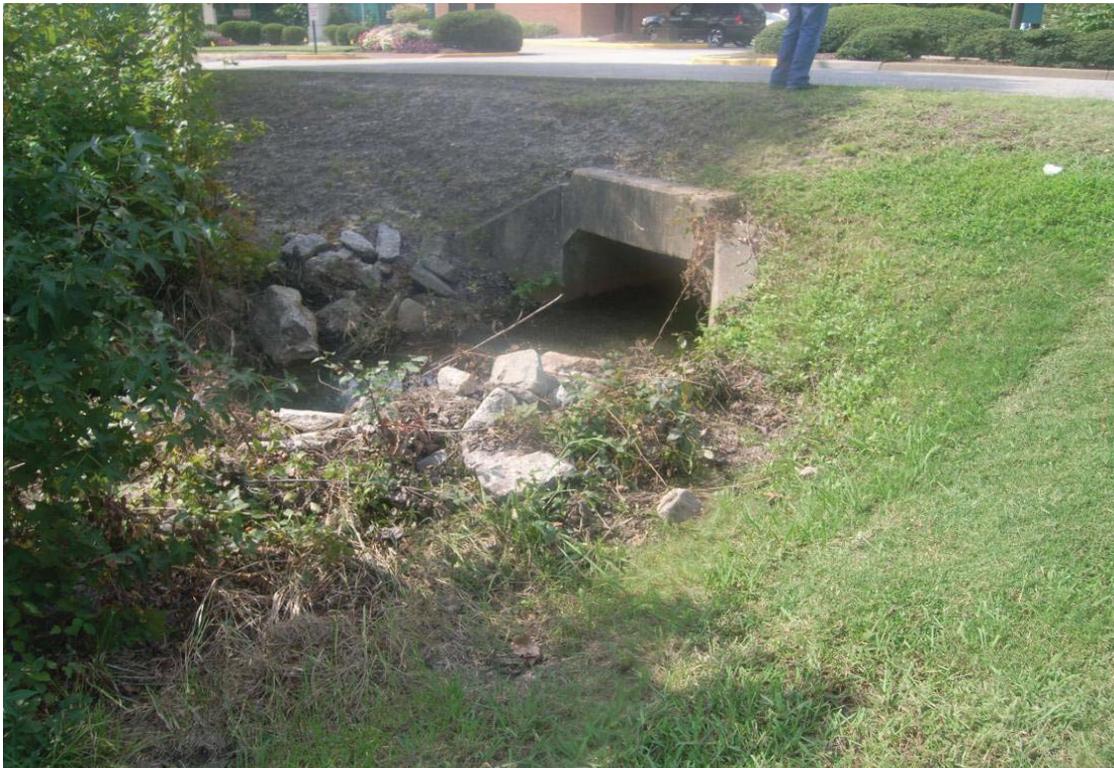
Photo 12. Node 216 - looking at downstream culvert outlet

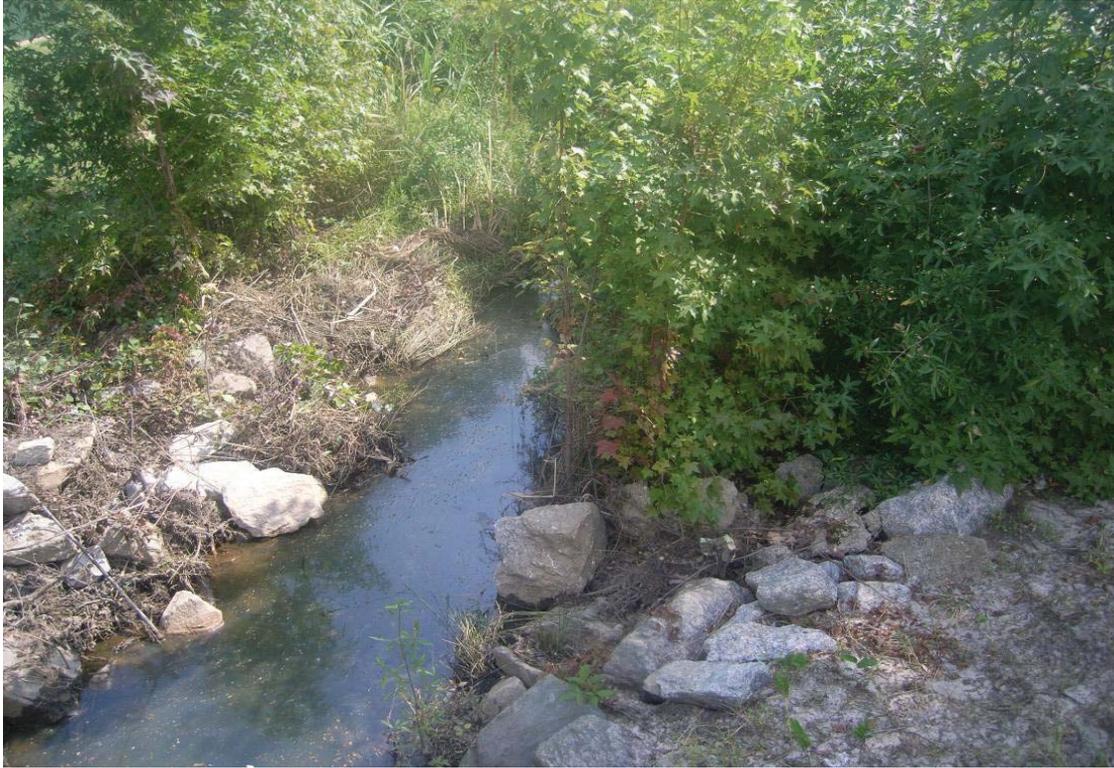
Photo 13. Node 216 - looking at downstream

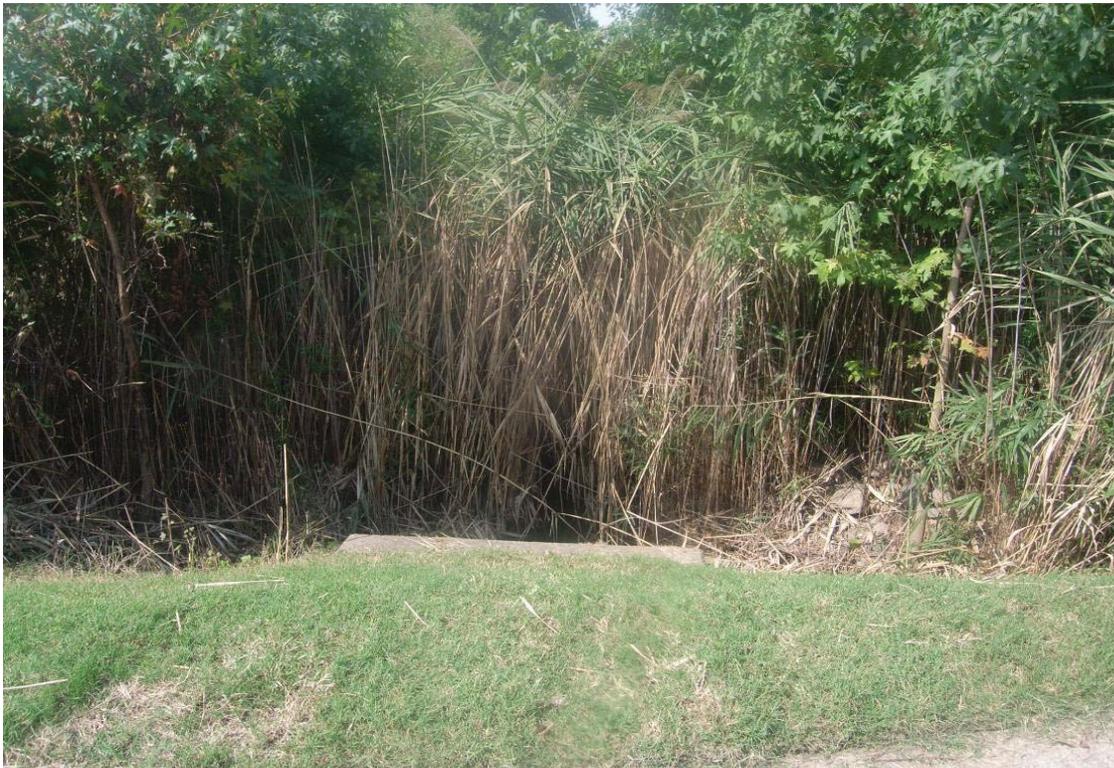
Photo 14. Node 216 - looking at upstream

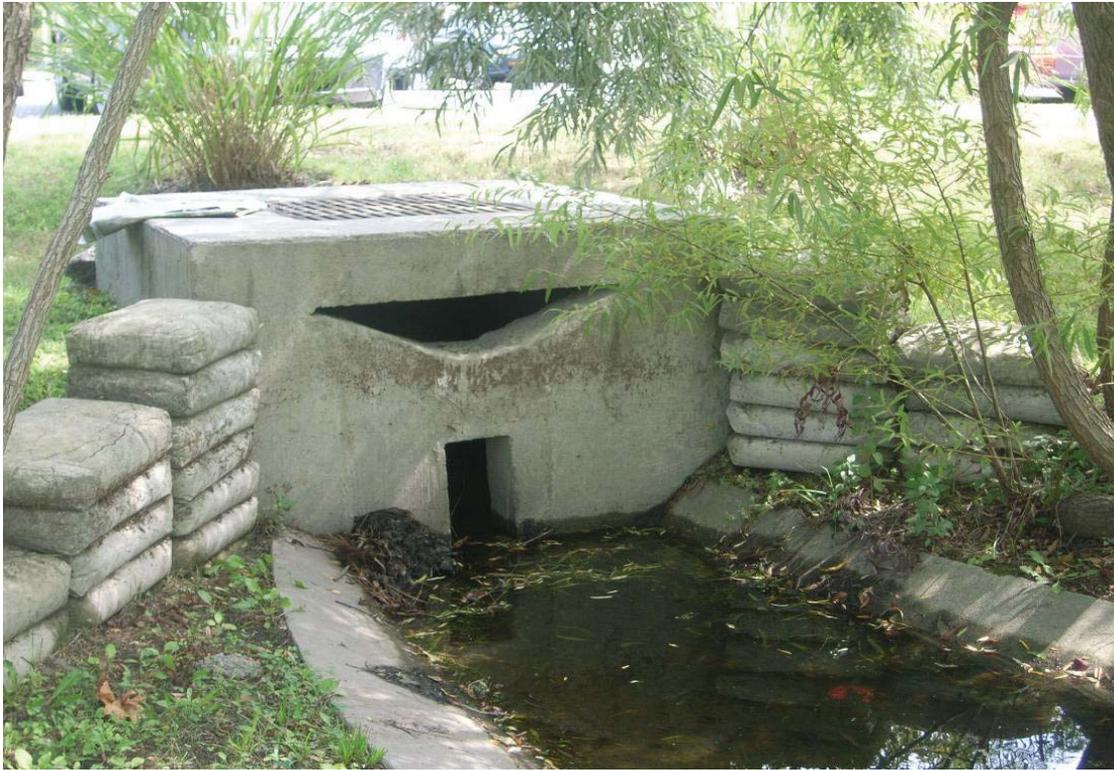
Photo 15. Node 225 - looking at outfall structure (1)

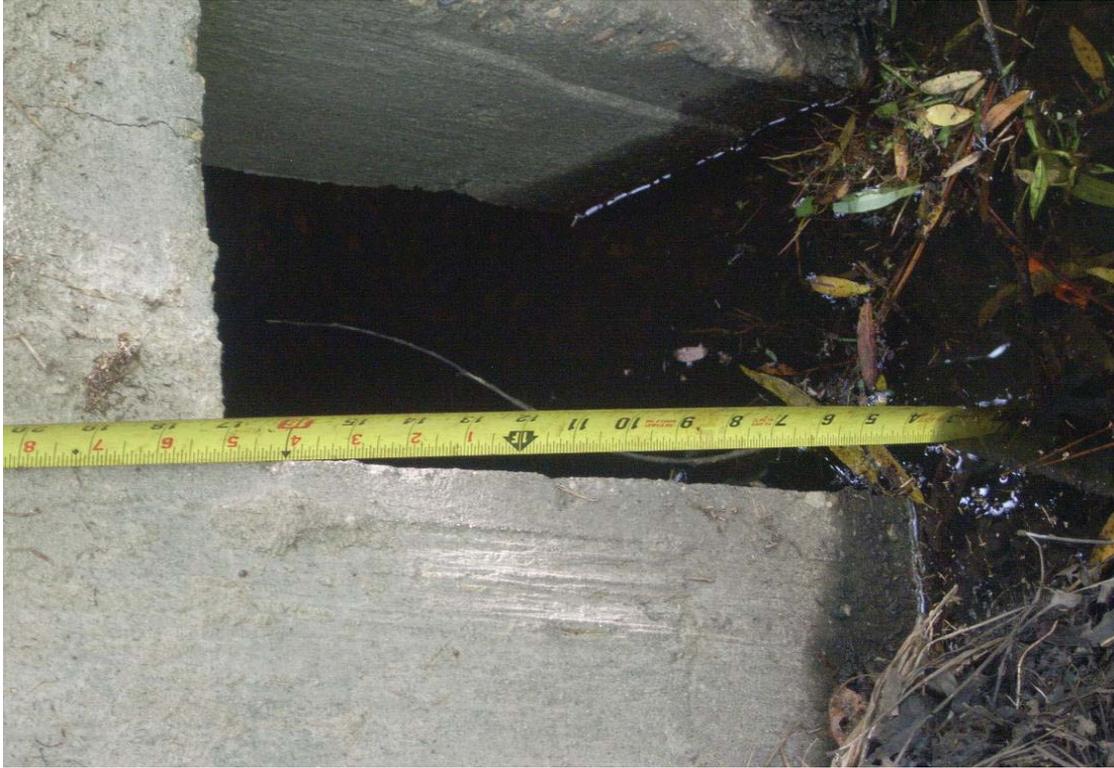
Photo 17. Node 225 - looking at outfall structure (3)

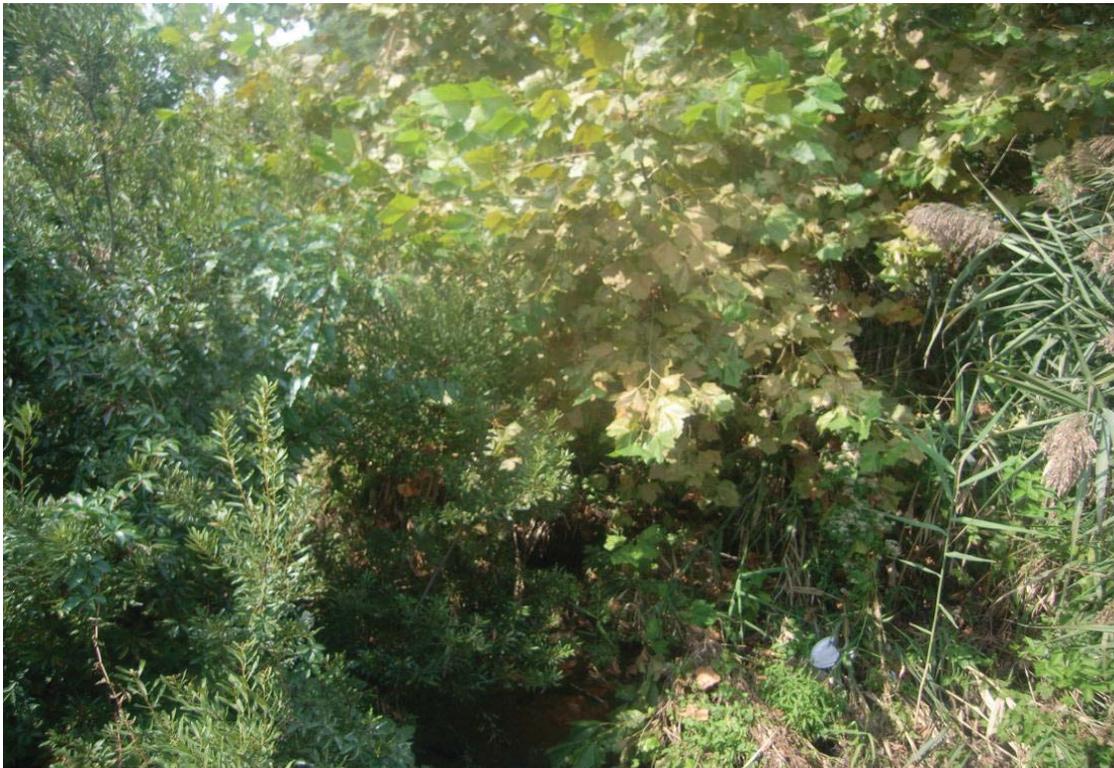
Photo 18. Node 237 - looking at upstream

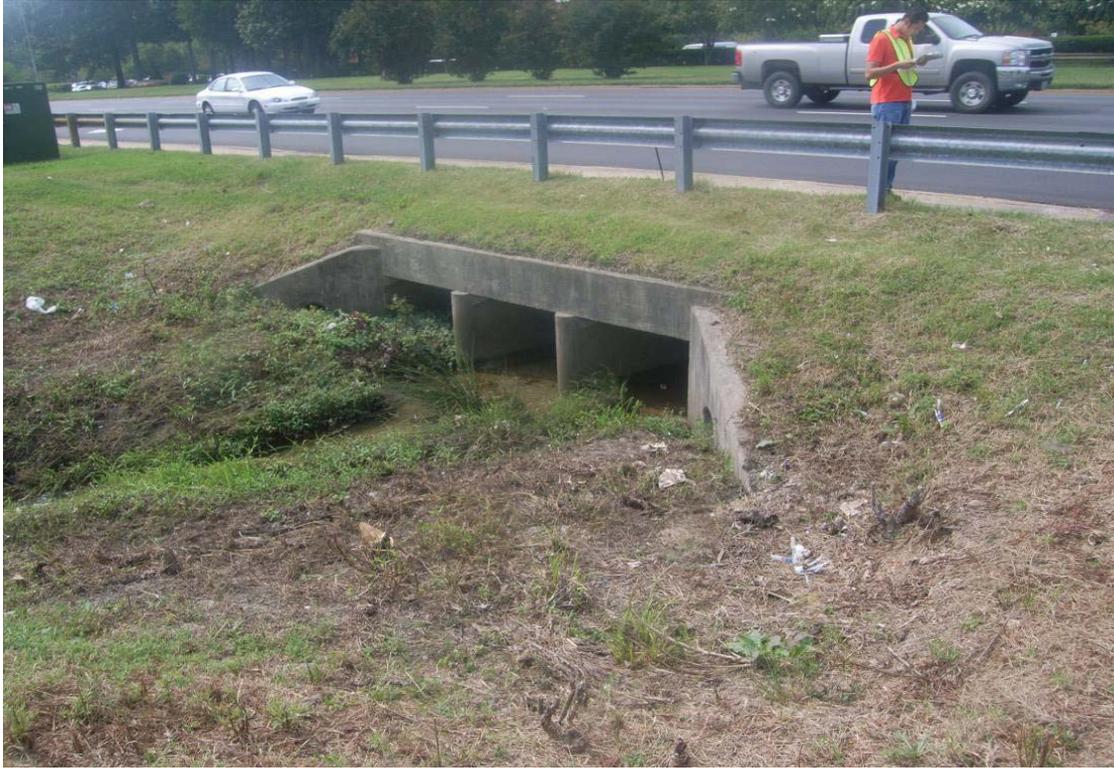
Photo 19. Node 239 - looking at culvert outlet

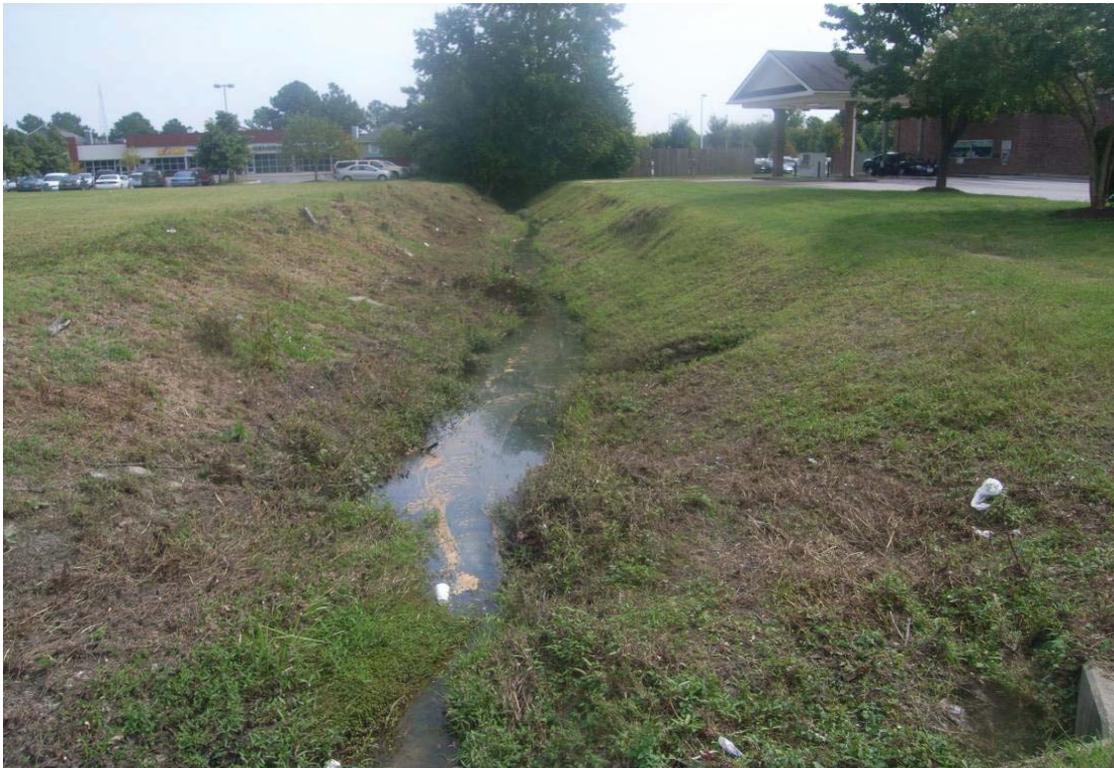
Photo 20. Node 239 - looking downstream

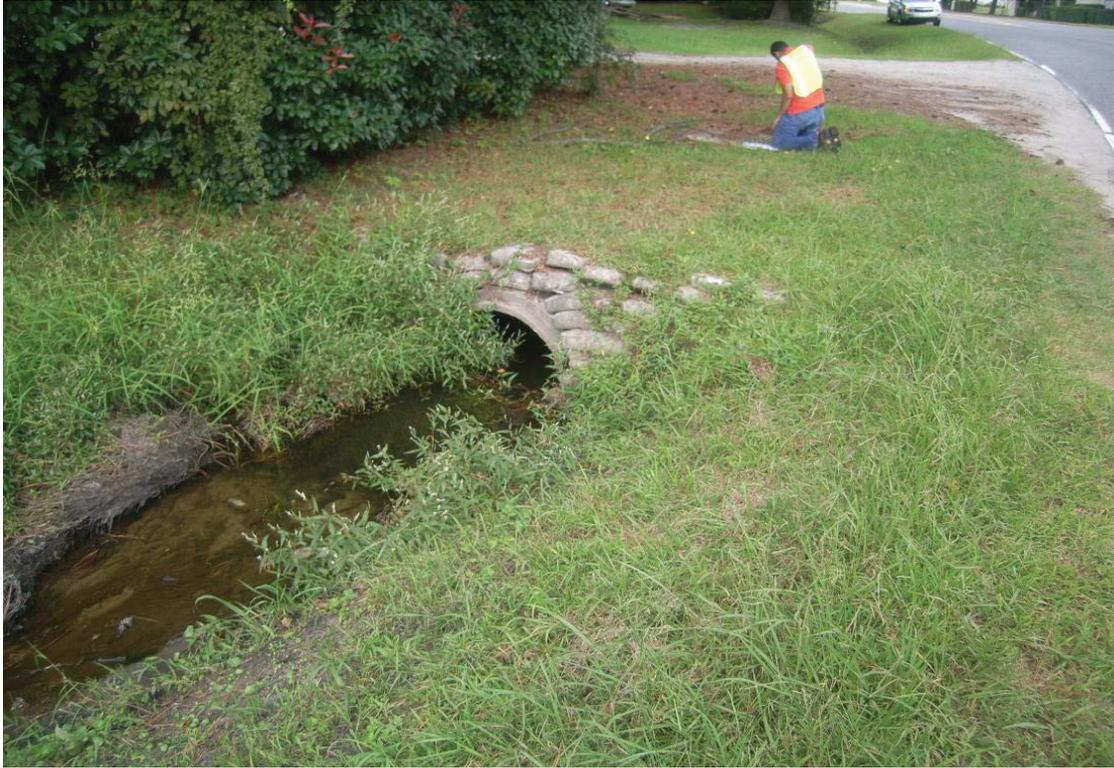
Photo 21. Node 266 - looking at culvert

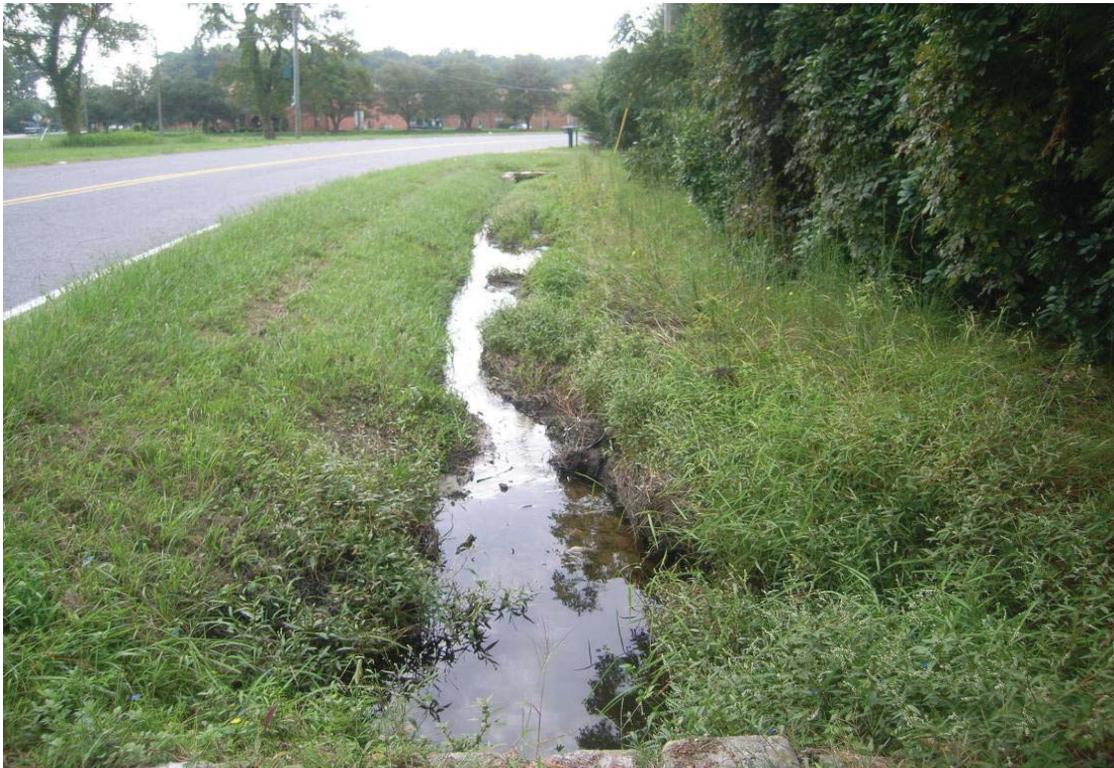
Photo 22. Node 266 - looking downstream

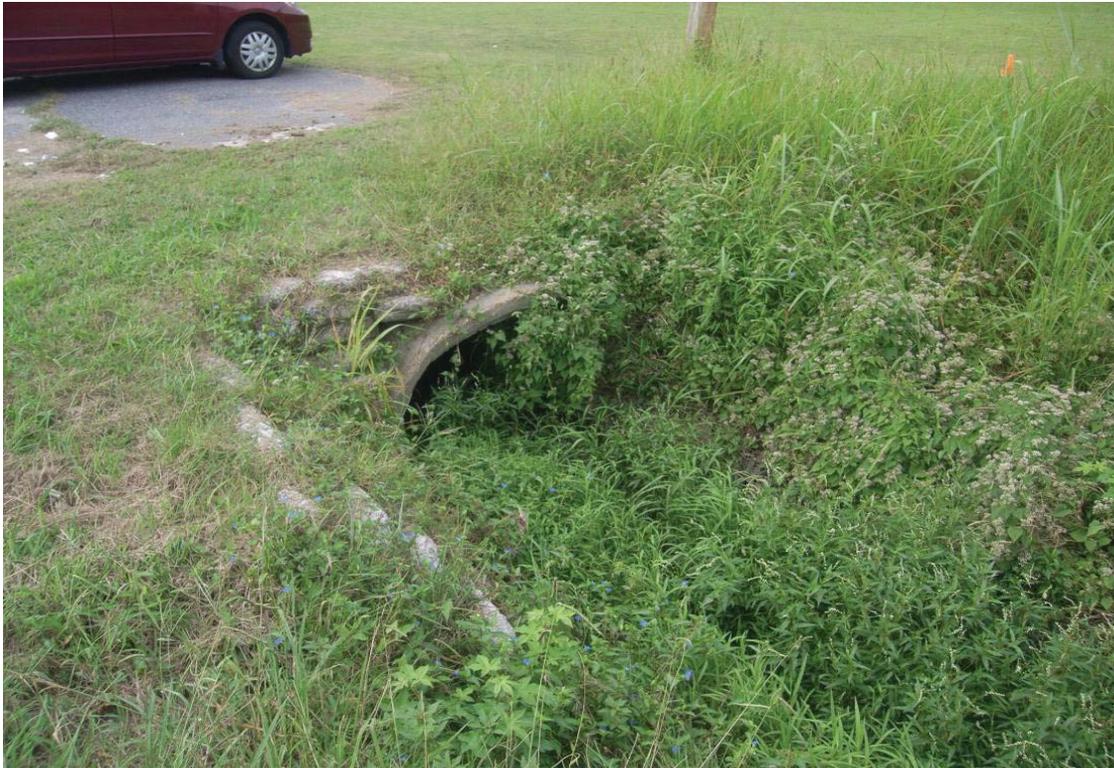
Photo 23. Node 272 - looking at culvert inlet

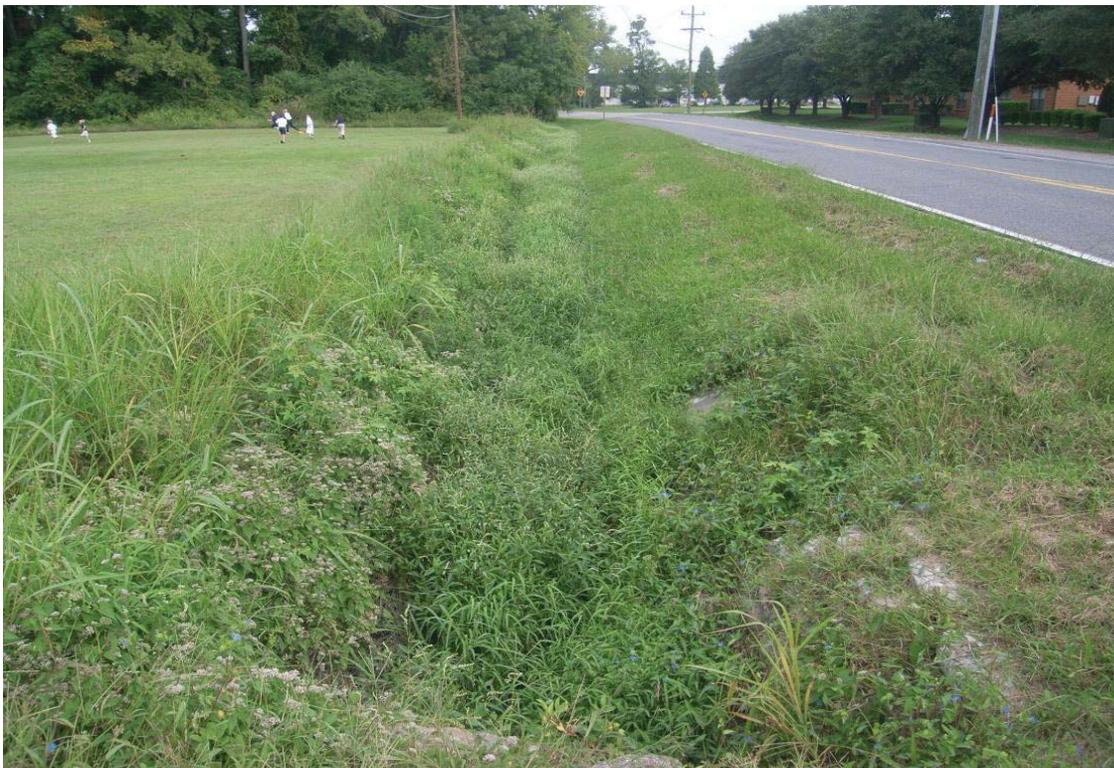
Photo 24. Node 272 - looking upstream

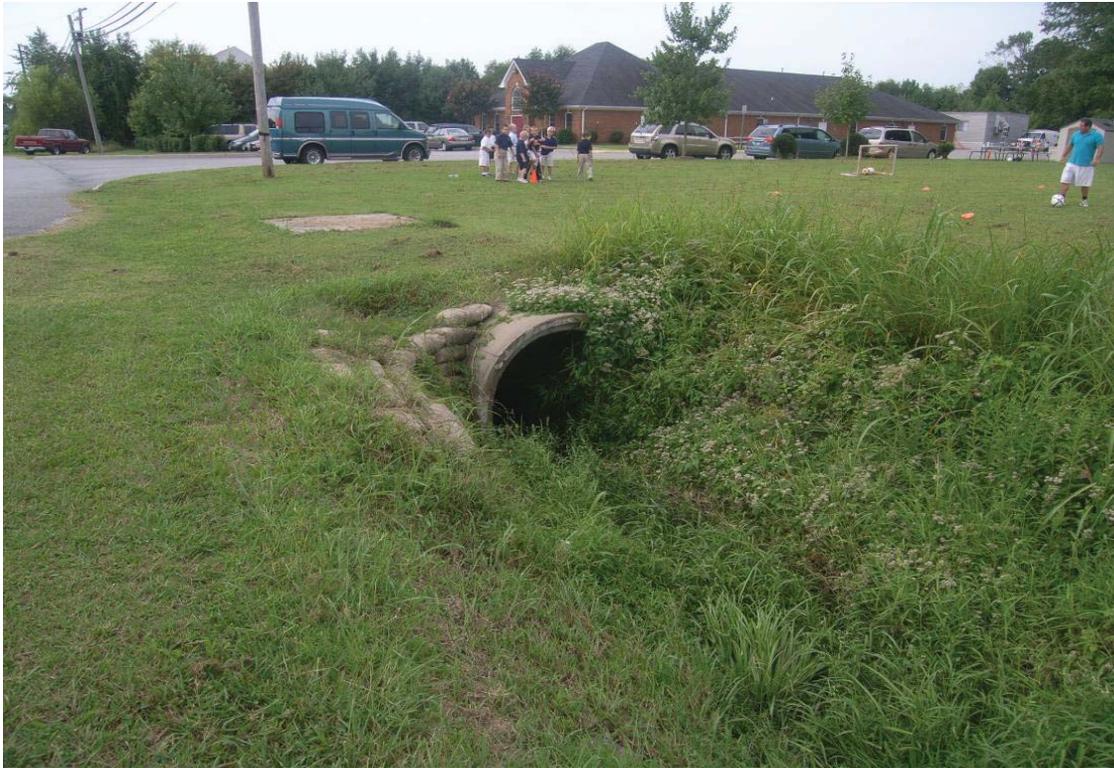
Photo 25. Node 274 - looking at pipe inlet

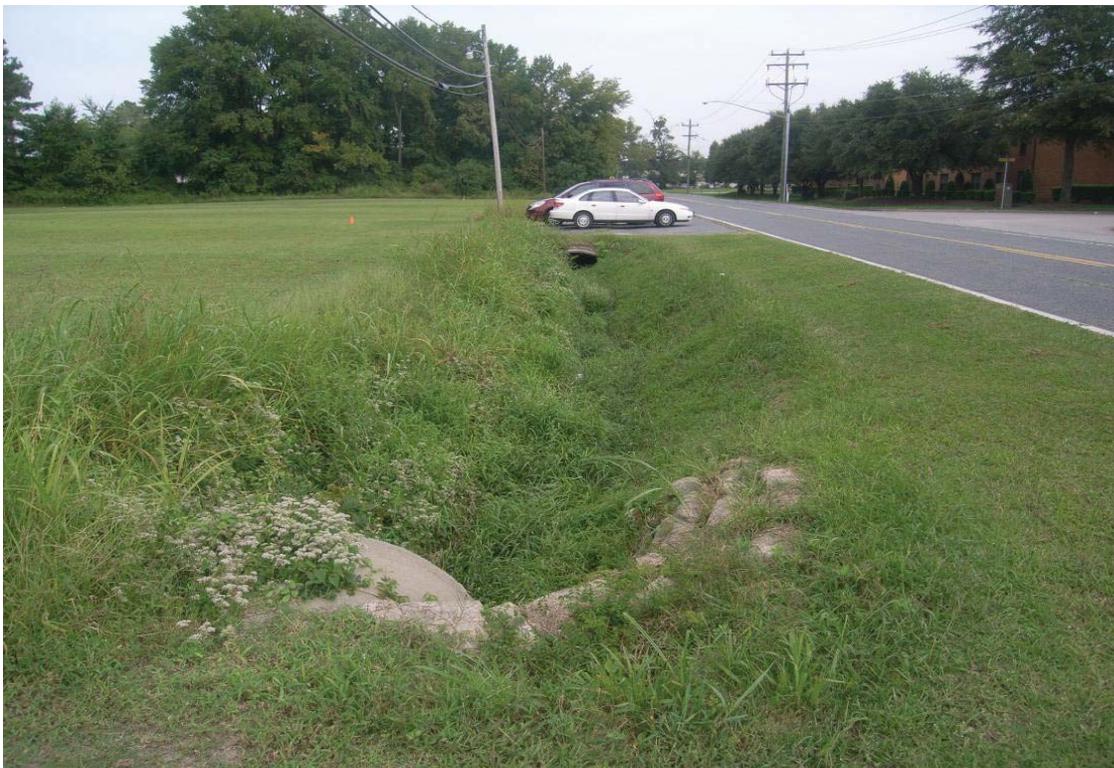
Photo 26. Node 274 - looking upstream

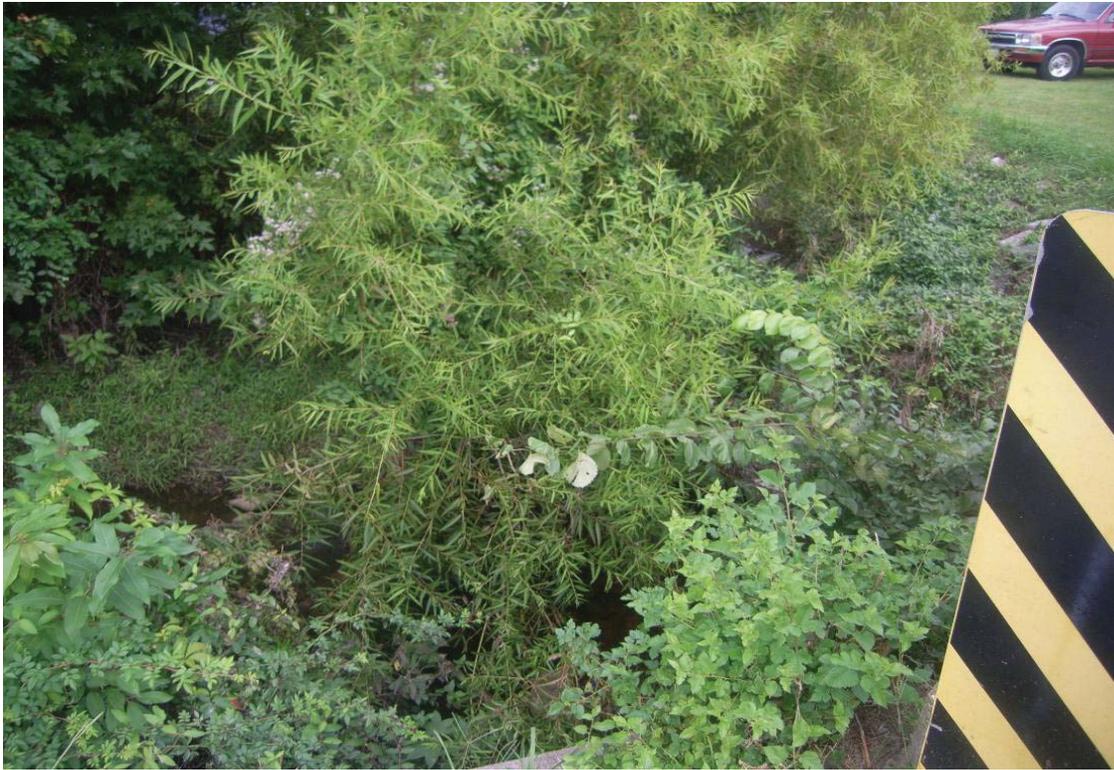
Photo 27. Node 276 - looking at ditch

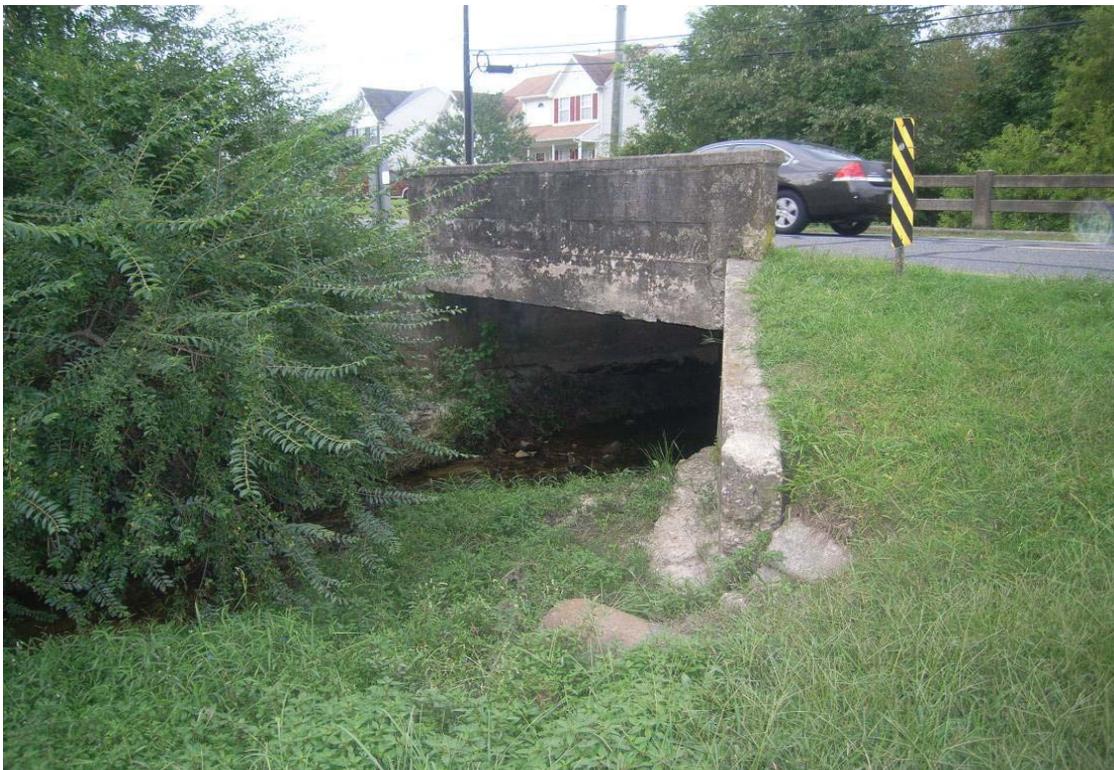
Photo 28. Node 278 - looking at bridge

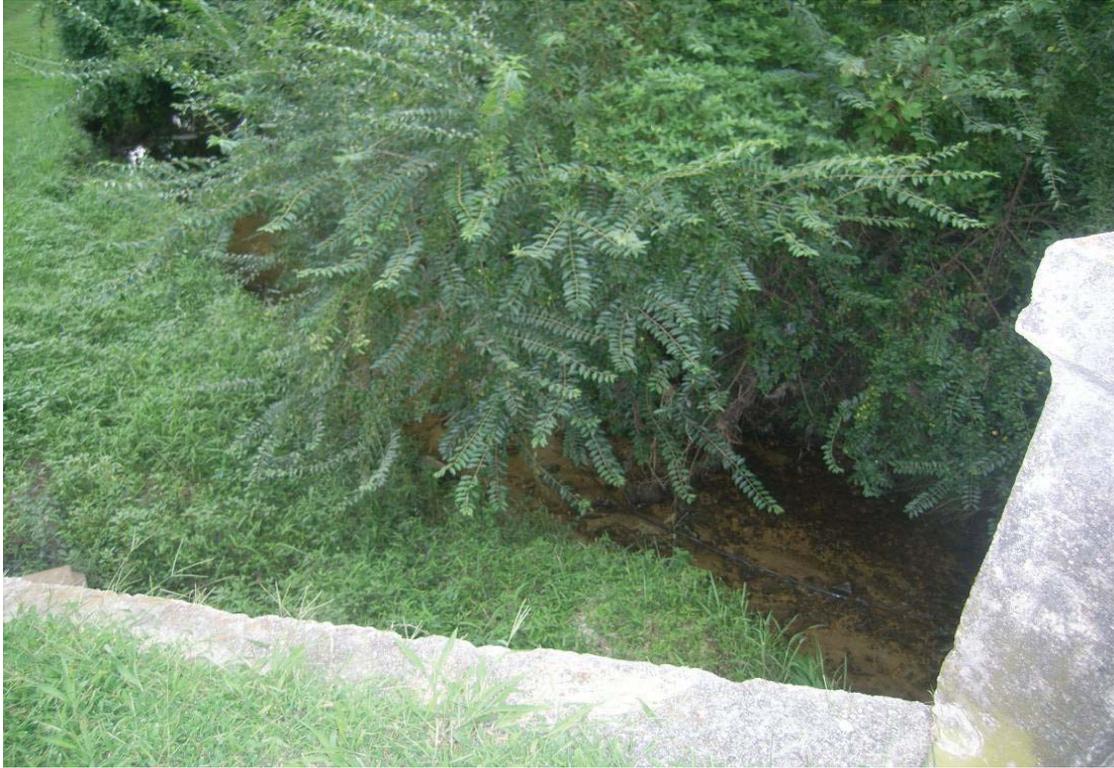
Photo 29. Node 278 - looking downstream

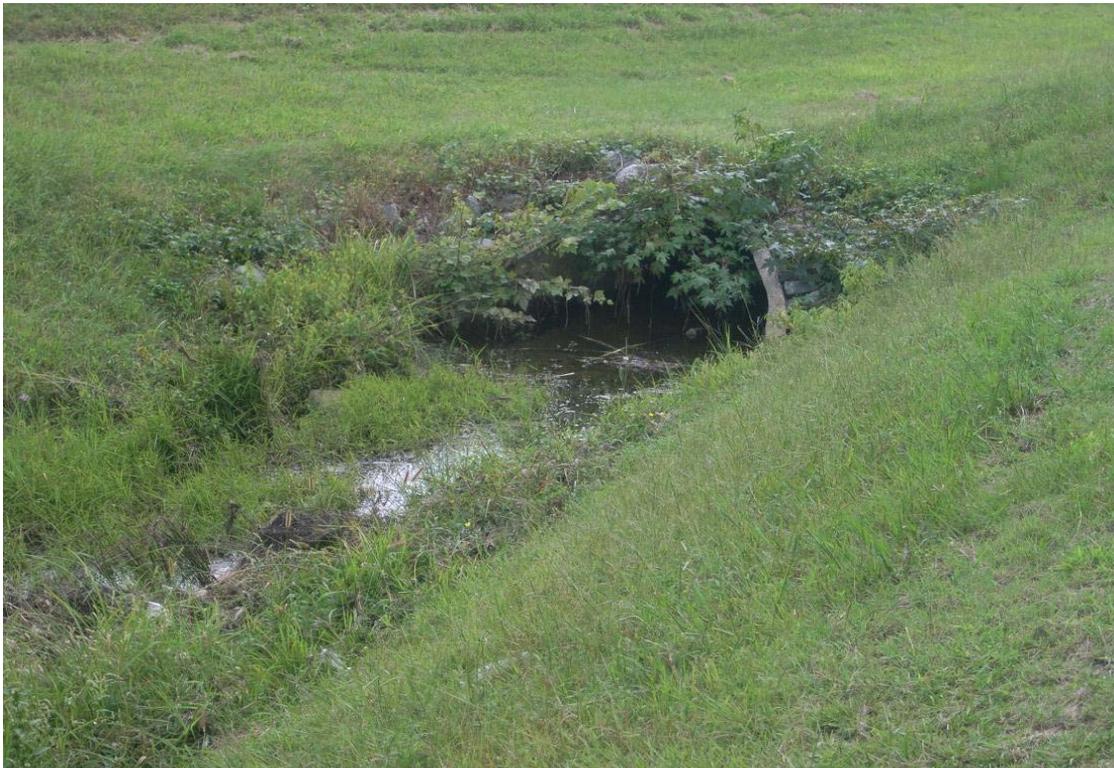
Photo 30. Node 335 - looking at culvert outlet

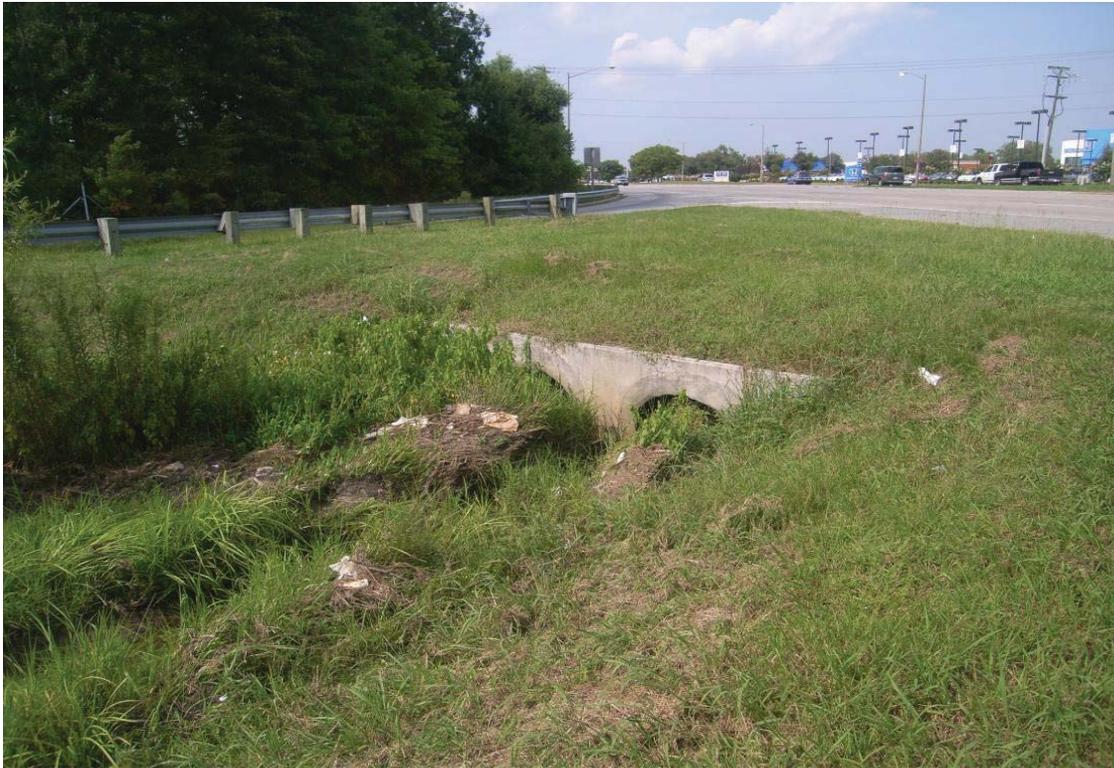
Photo 31. Node 336 - looking at culvert inlet
