Appendix A

Photographs

Figure A.1. Oak Grove Watershed - Photo Locations

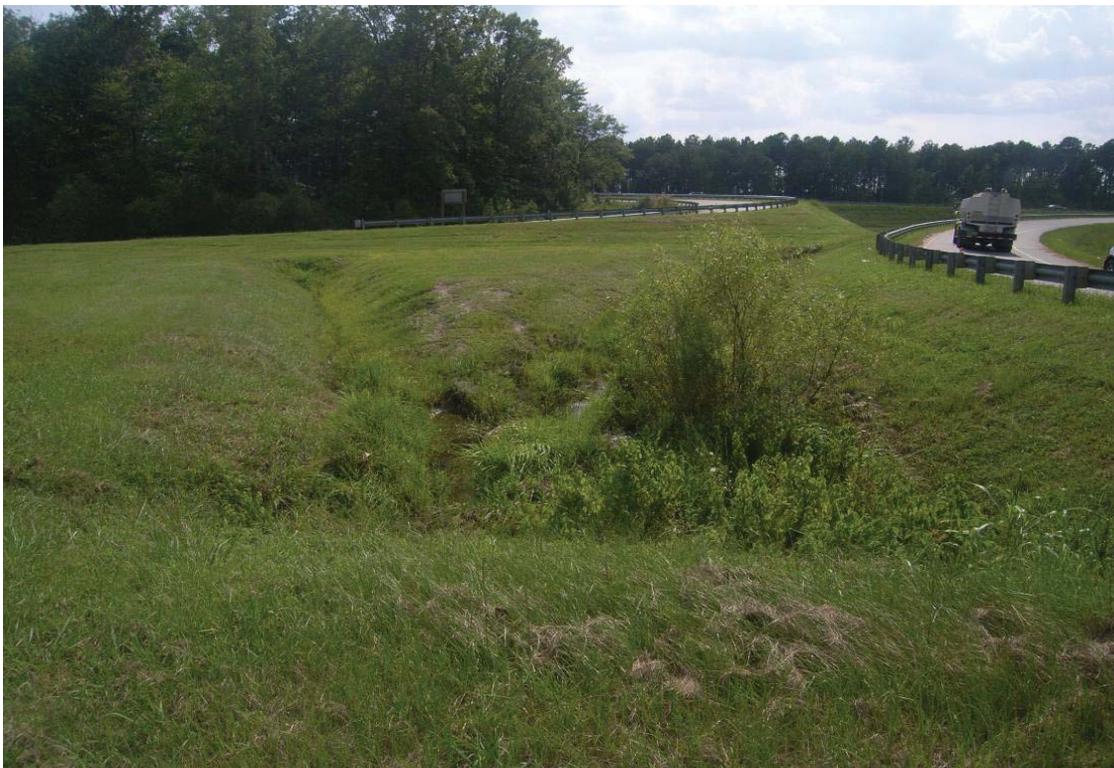
Photo 32. Node 336 - looking upstream (1)

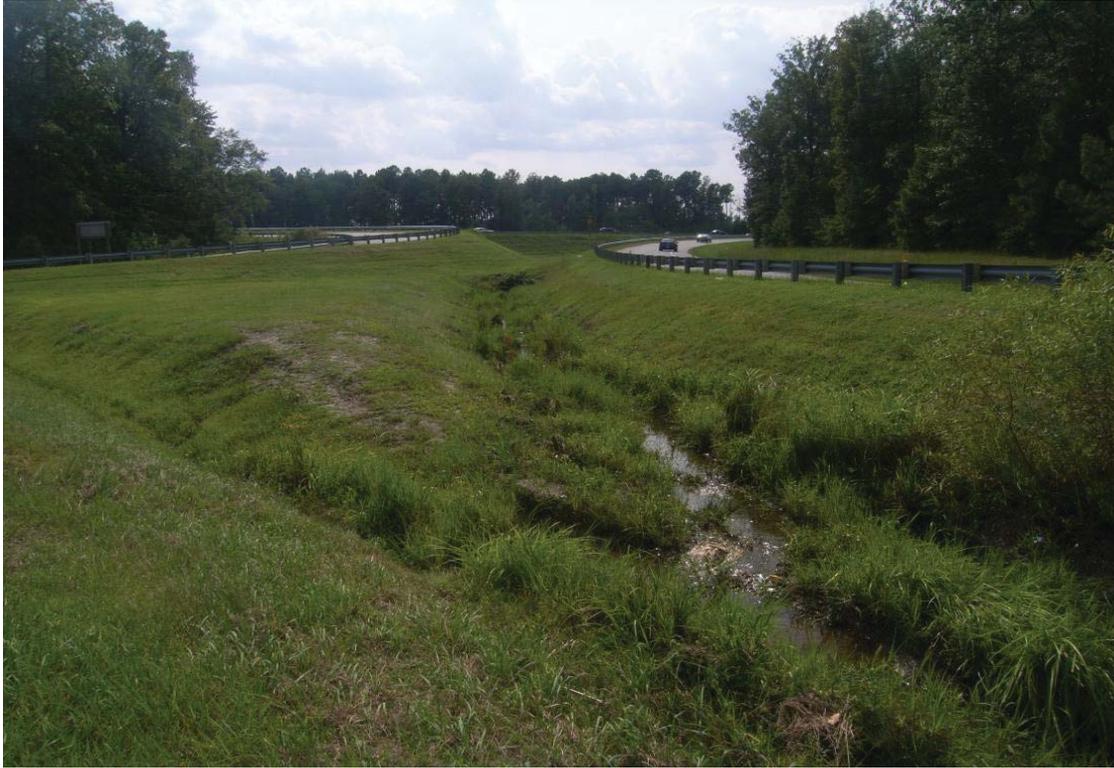
Photo 33. Node 336 - looking upstream (2)

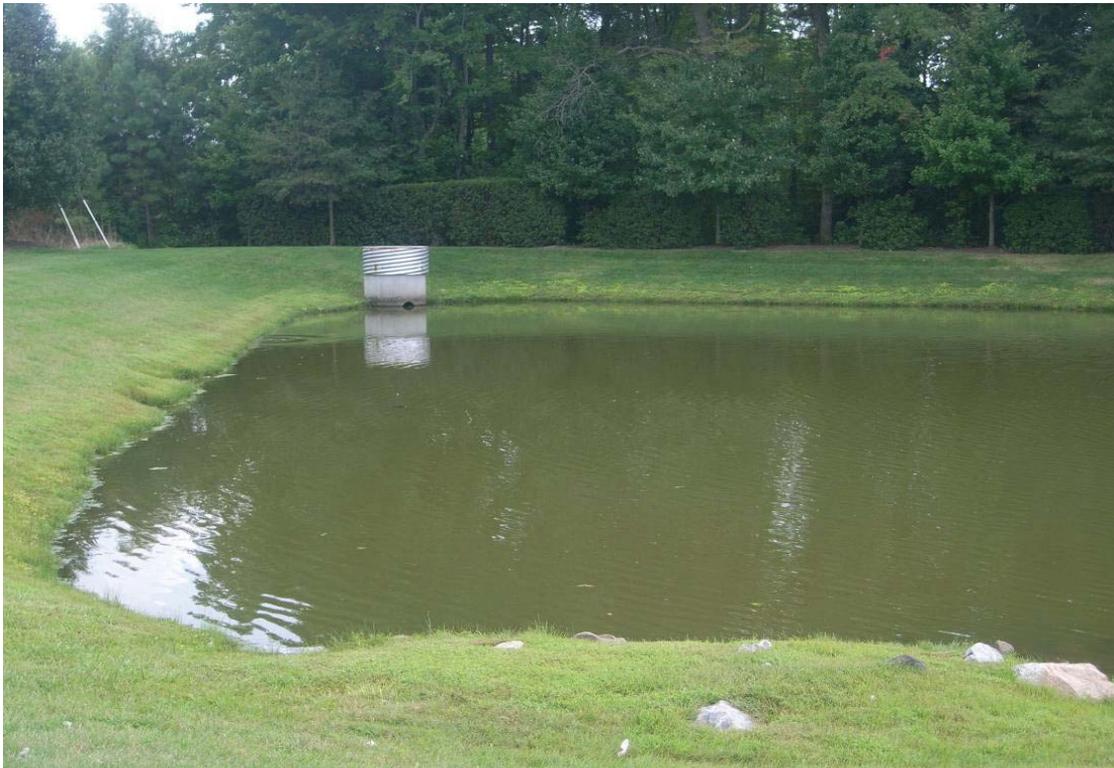
Photo 34. Node 338 - looking at BMP and outfall structure

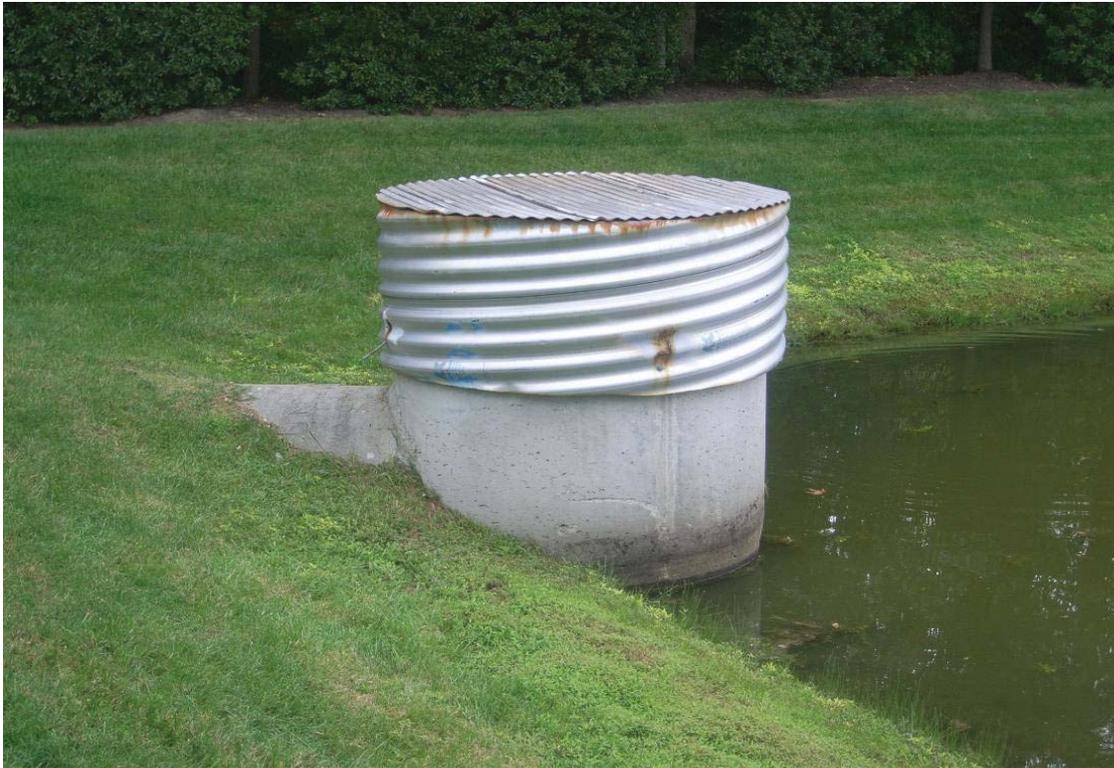
Photo 35. Node 338 - looking at outfall structure

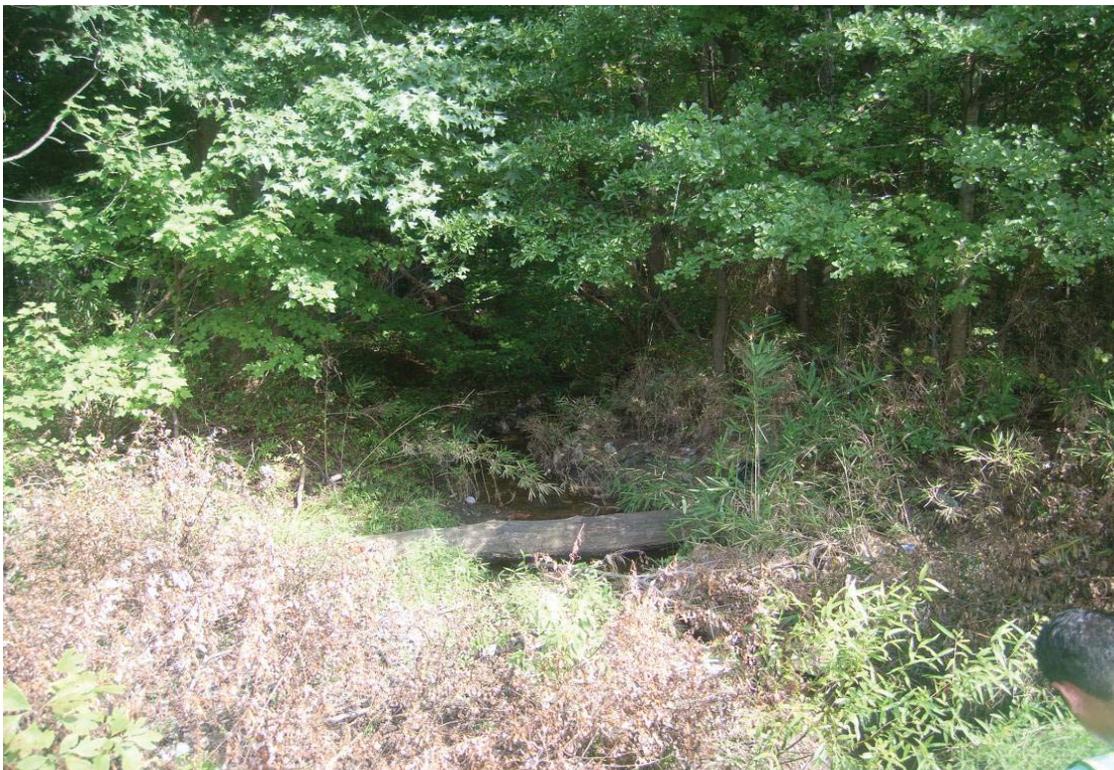
Photo 36. Node 345 - looking downstream

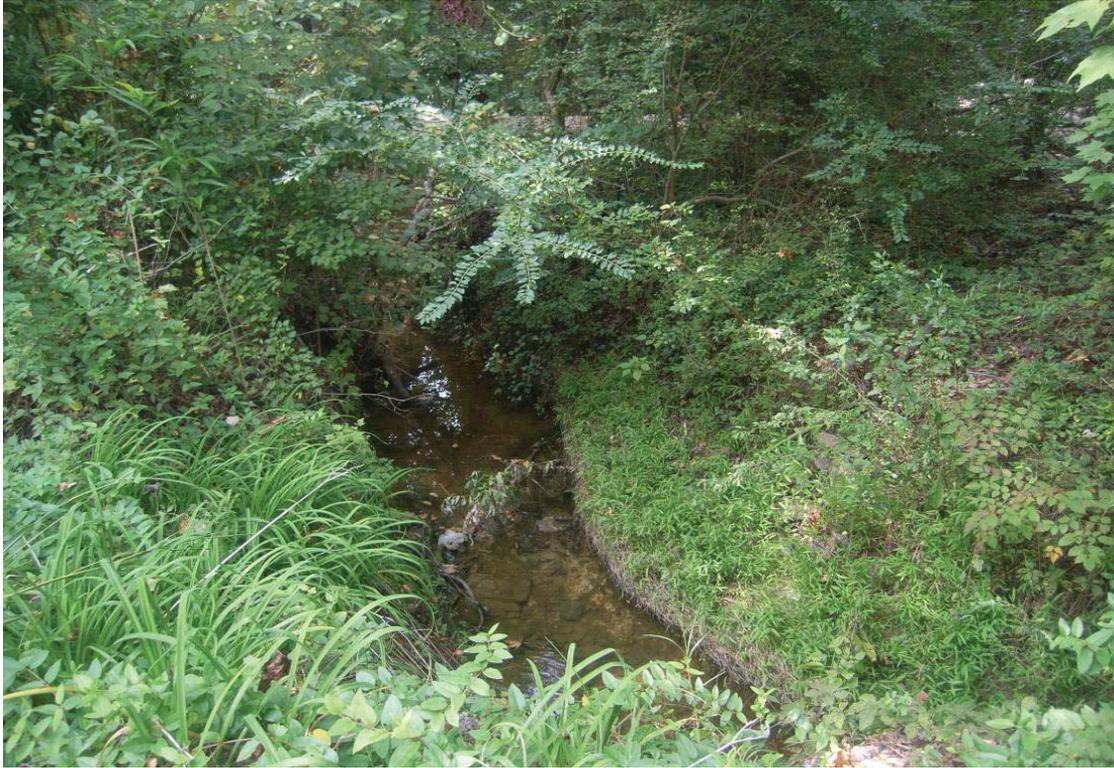
Photo 37. Node 356 - looking upstream

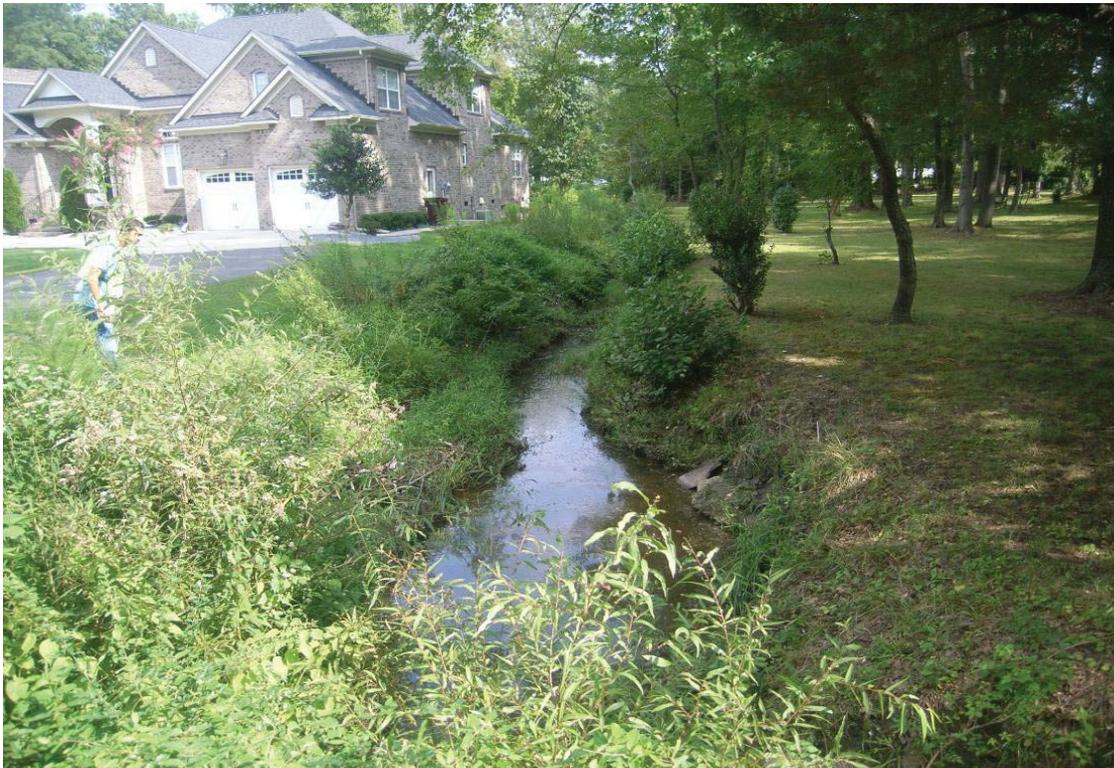
Photo 38. Node 357 - looking downstream

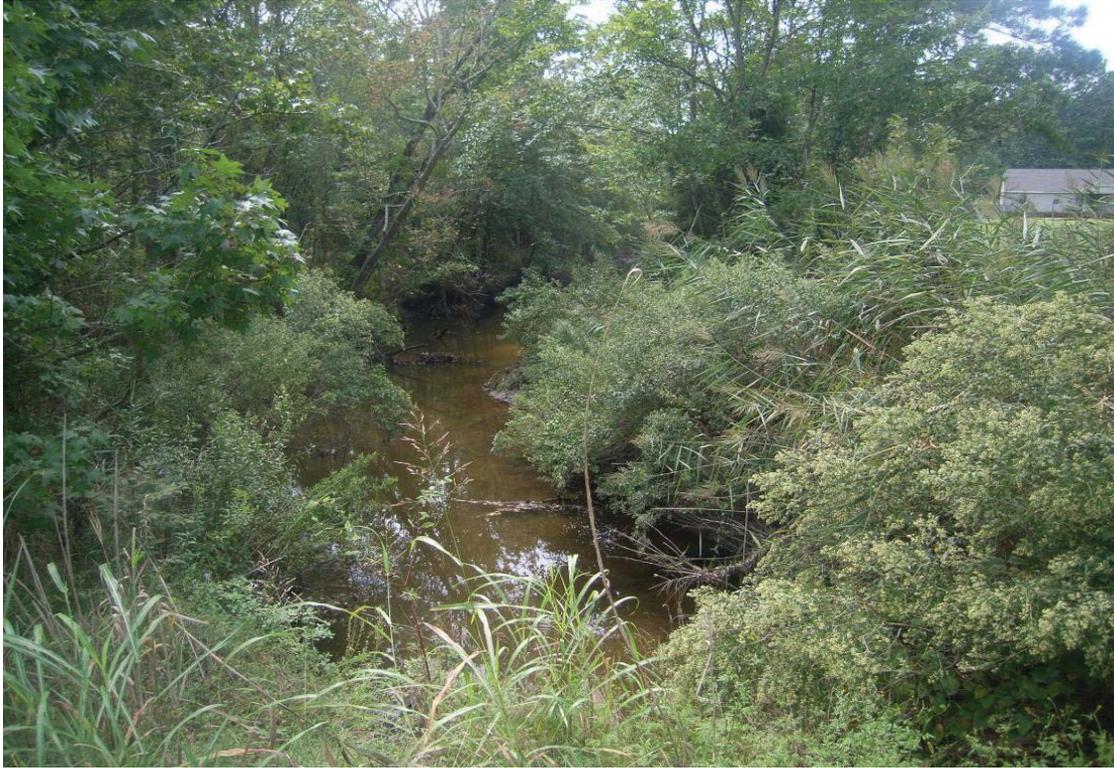
Photo 39. Node 400 - looking downstream

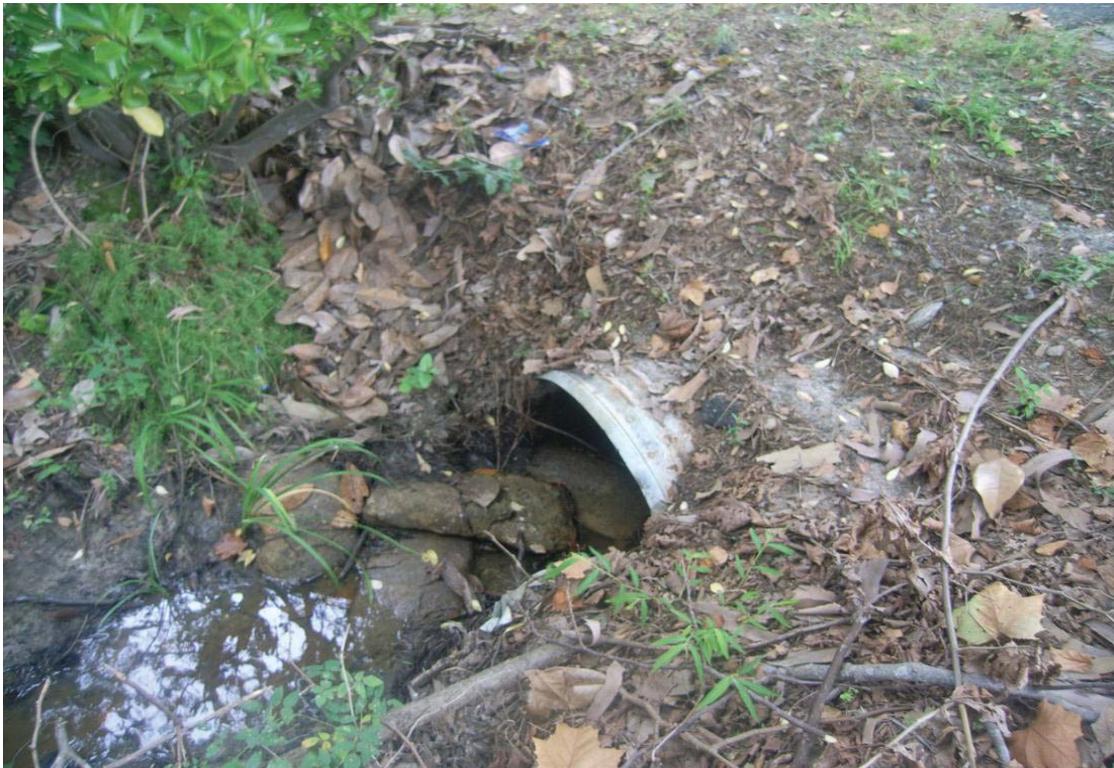
Photo 40. Node 406 - looking at culvert inlet

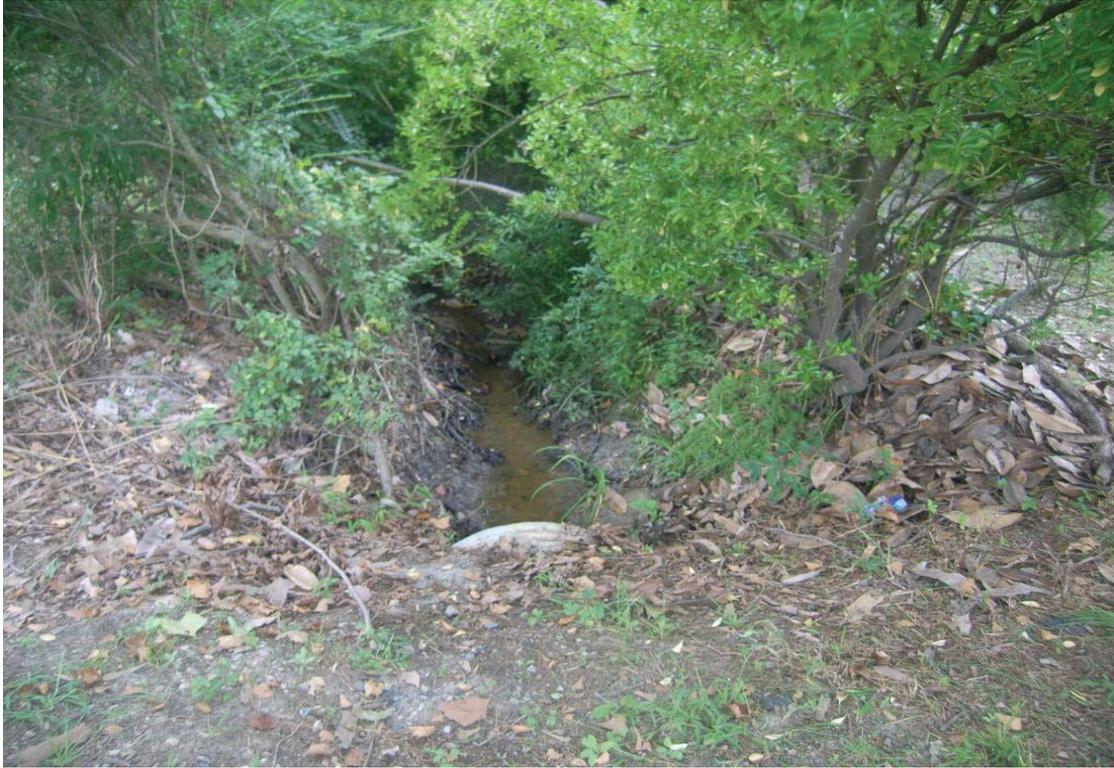
Photo 41. Node 406 - looking upstream

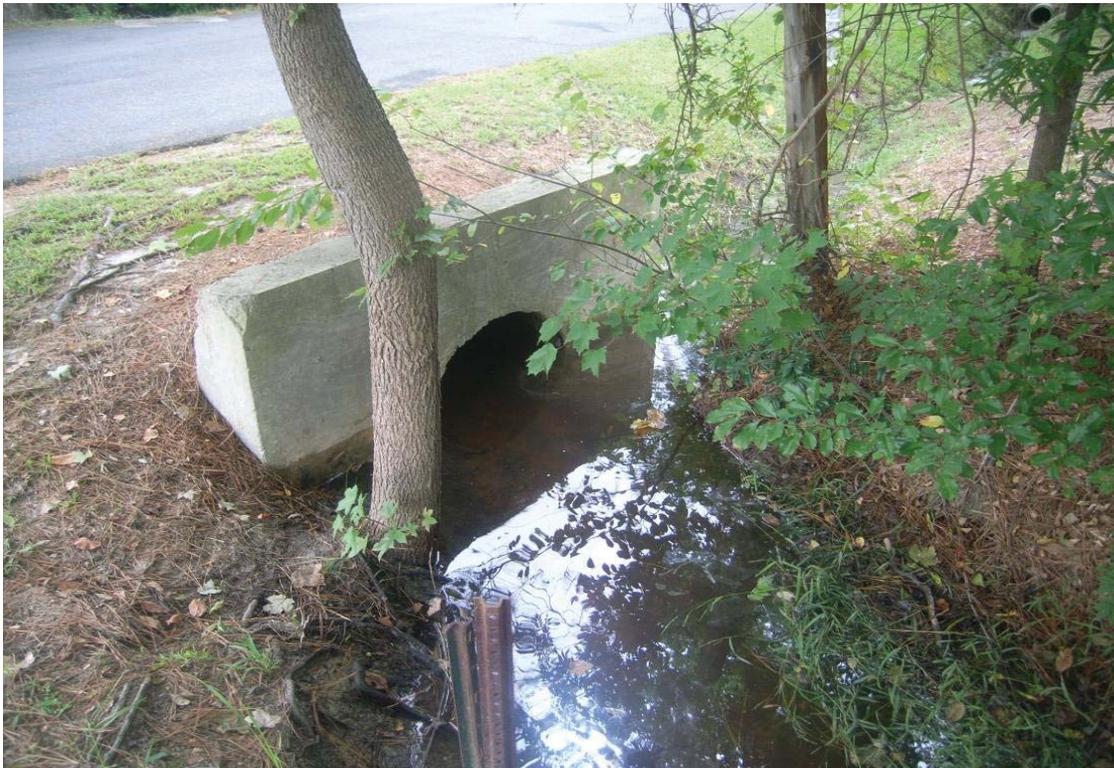
Photo 42. Node 409 - looking at culvert outlet

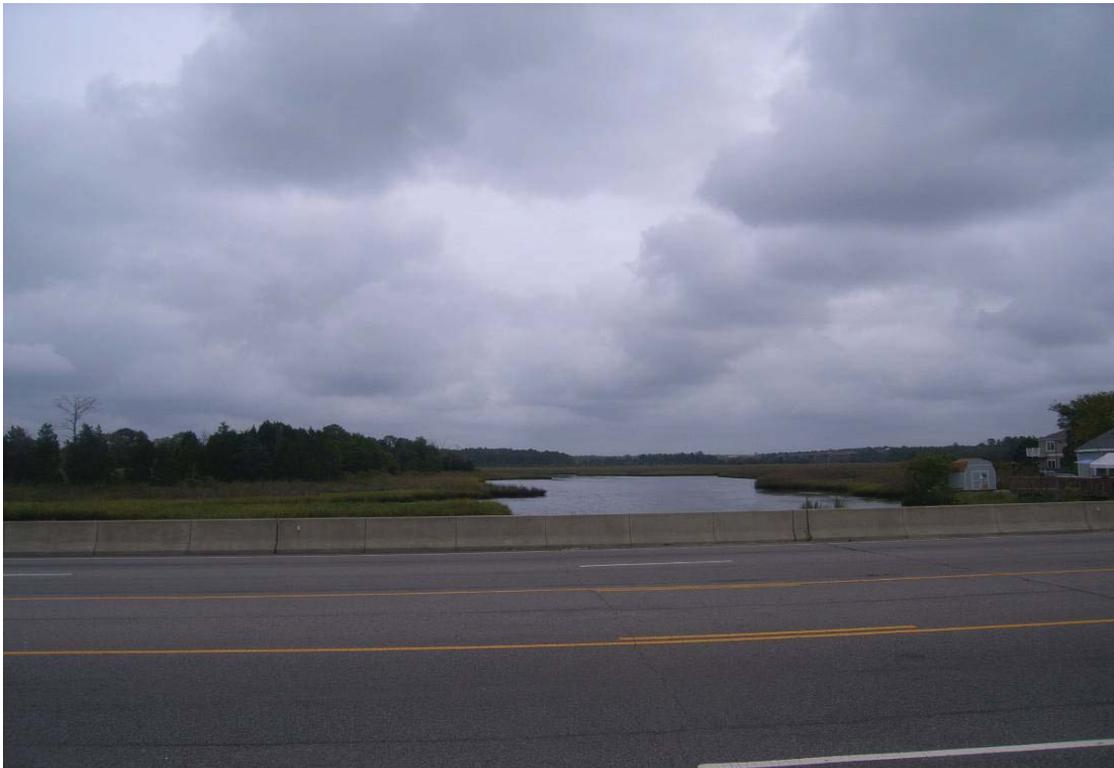
Photo 44. Node 423 - looking upstream

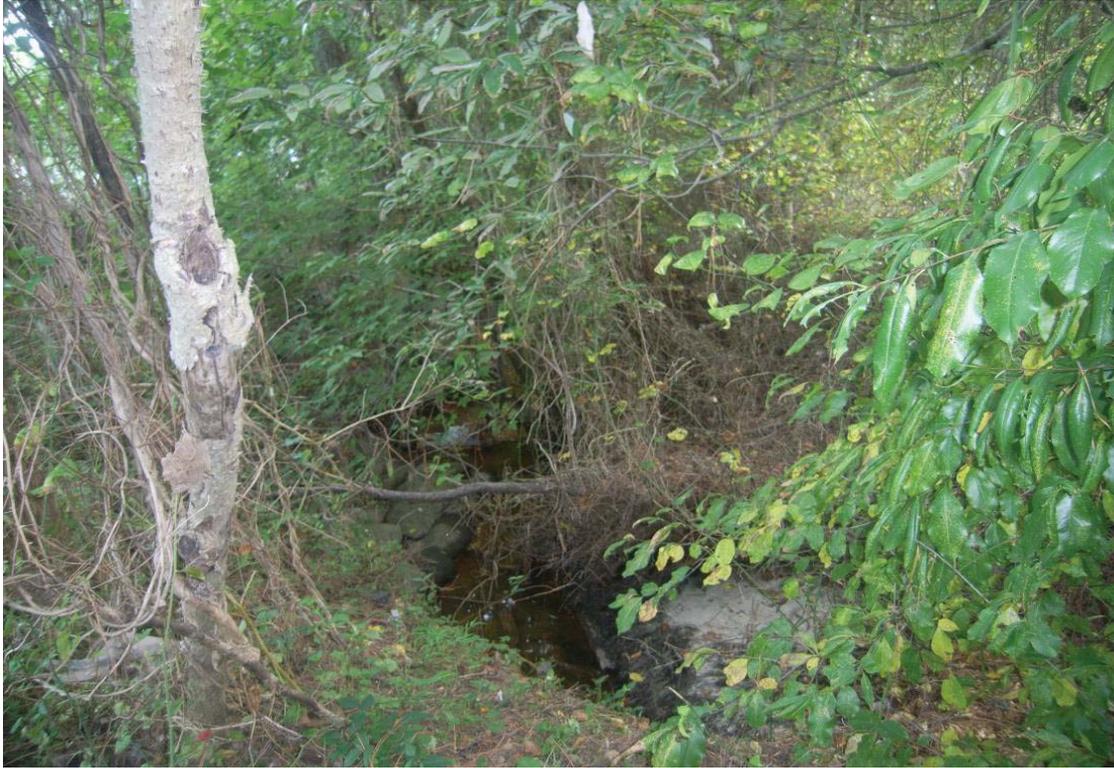
Photo 47. Node 452 - looking at ditch (1)

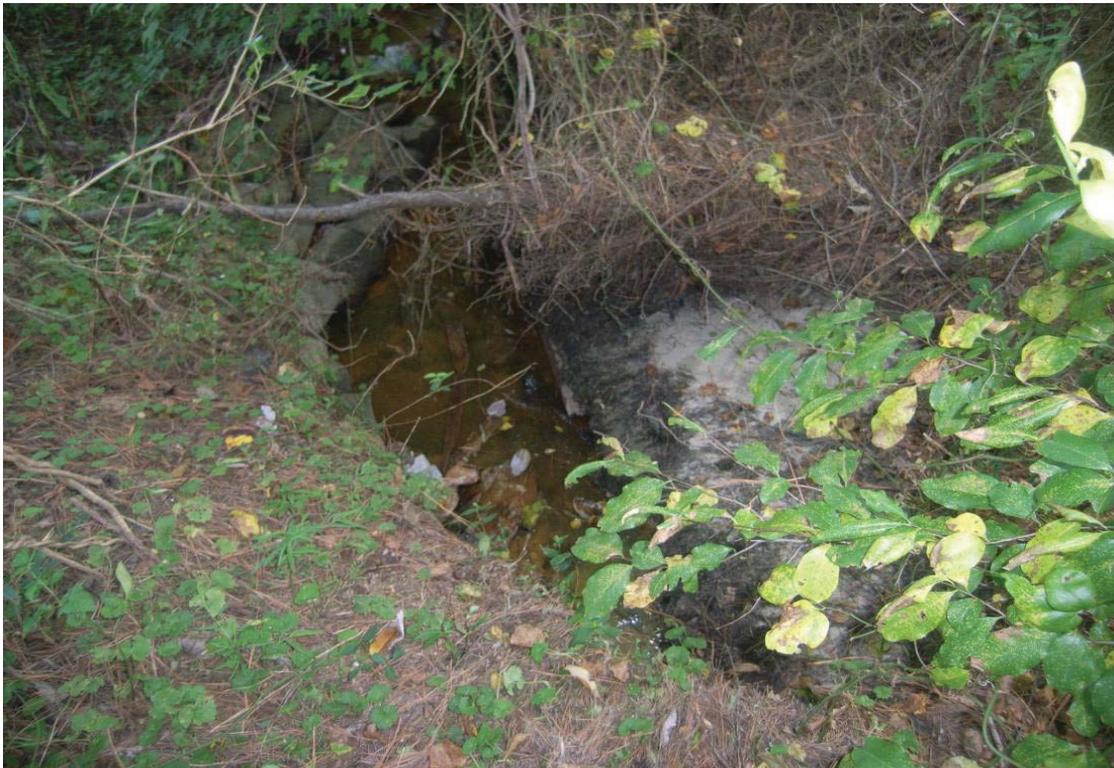
Photo 48. Node 452 - looking at ditch (2)

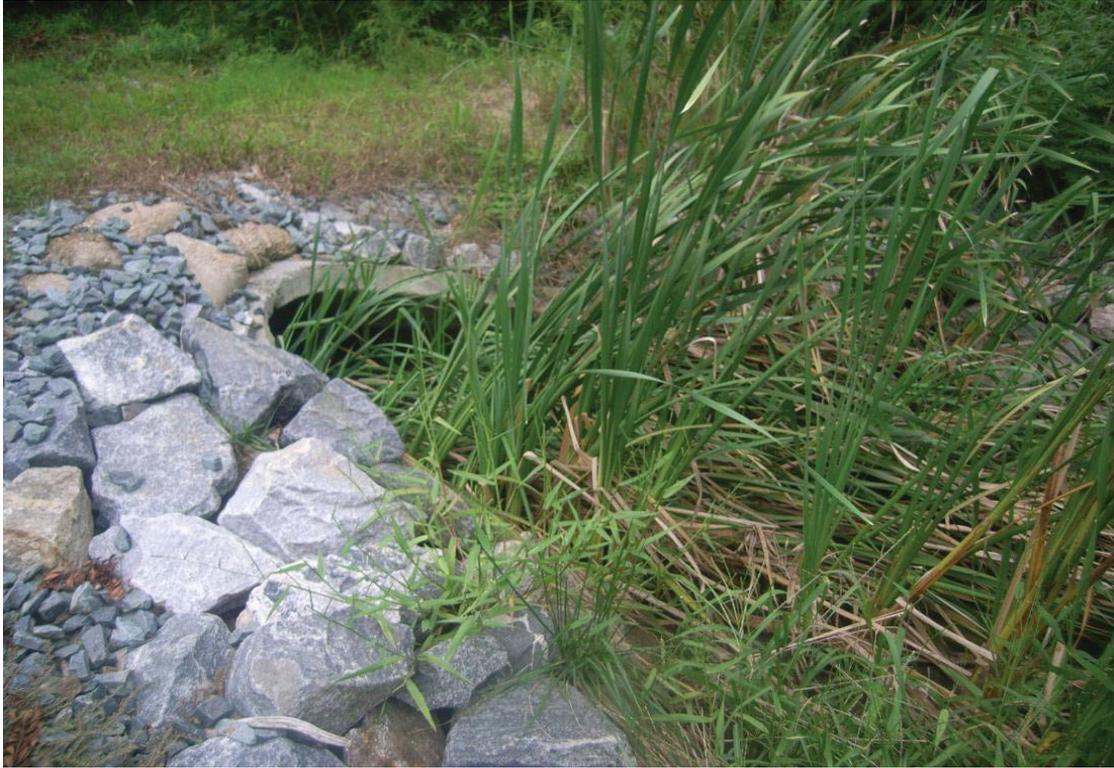
Photo 51. Node 493 - looking at pipe outlet

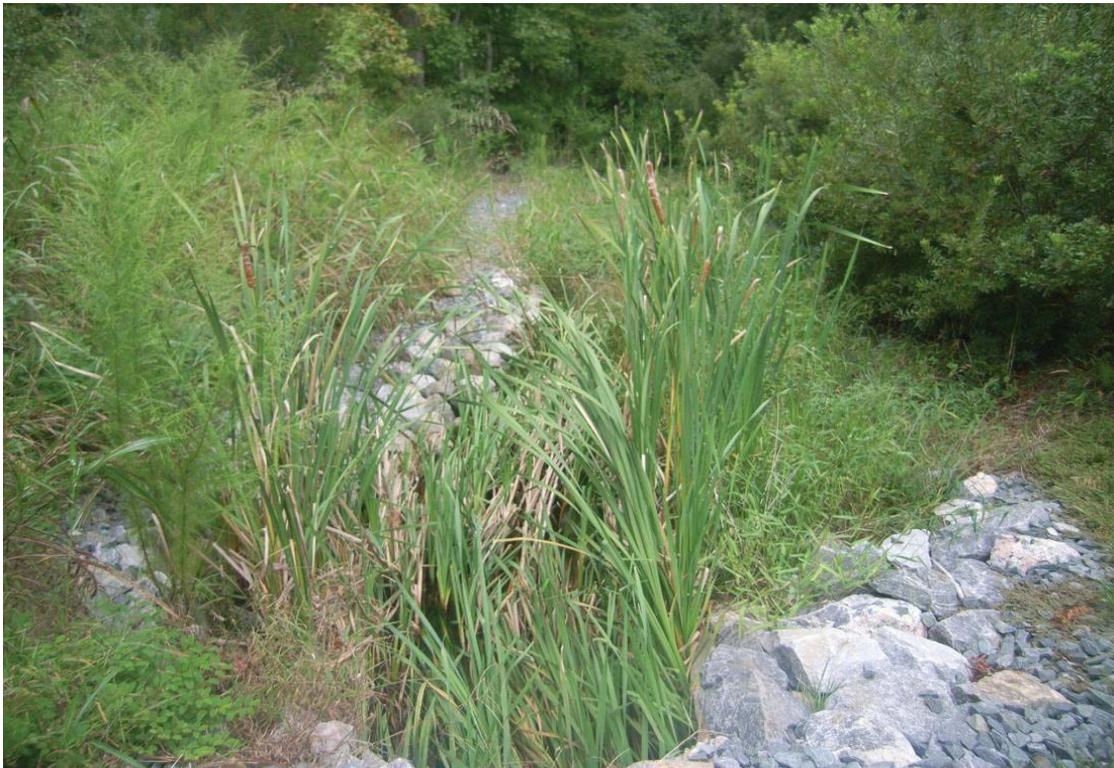
Photo 52. Node 493 - looking downstream

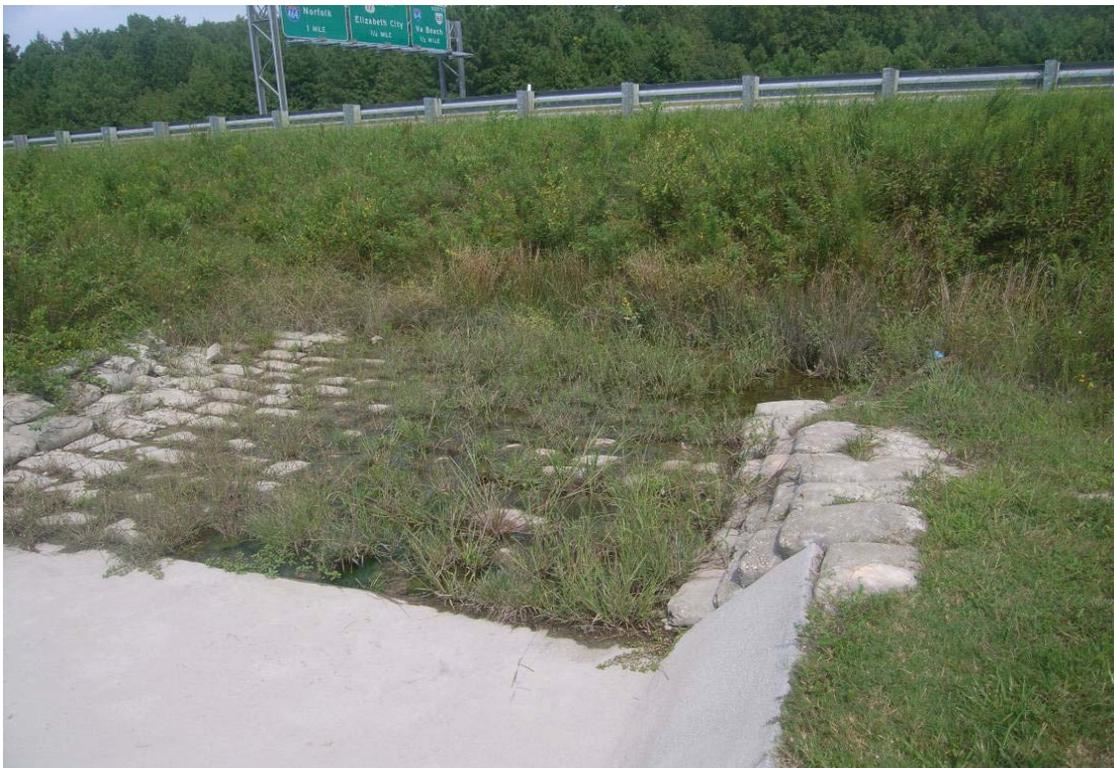
Photo 54. Node 519 - looking at ditch

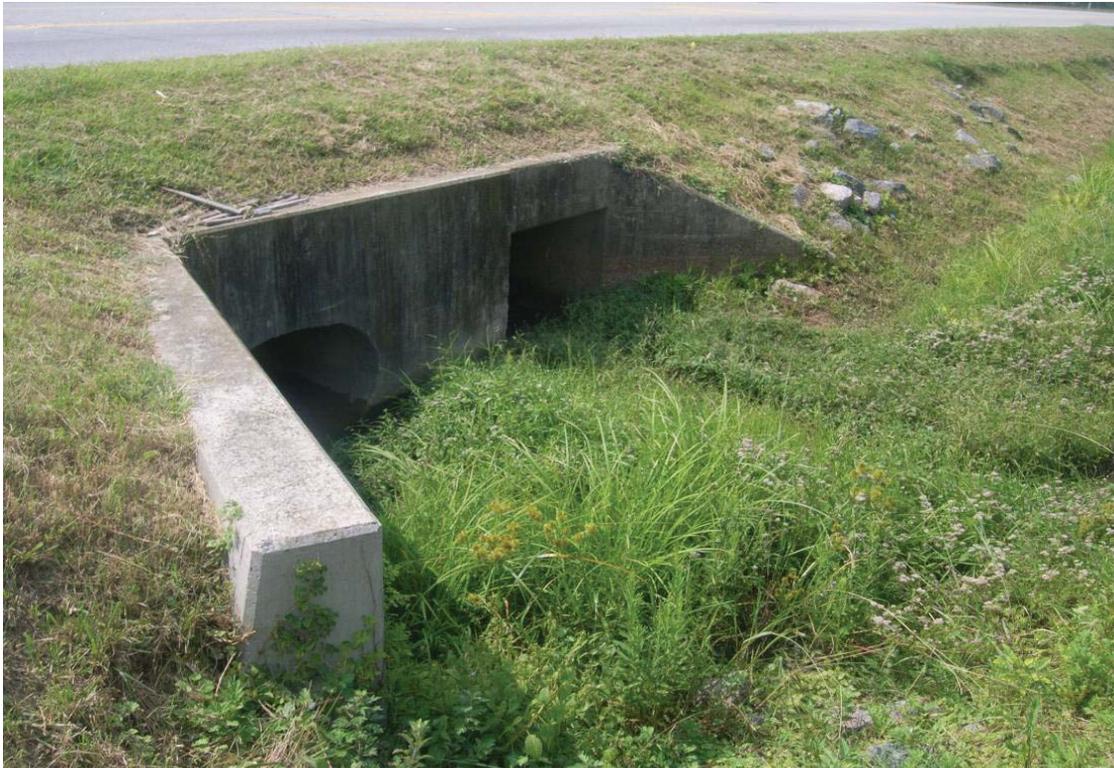
Photo 57. Node 537 - looking at culvert inlet

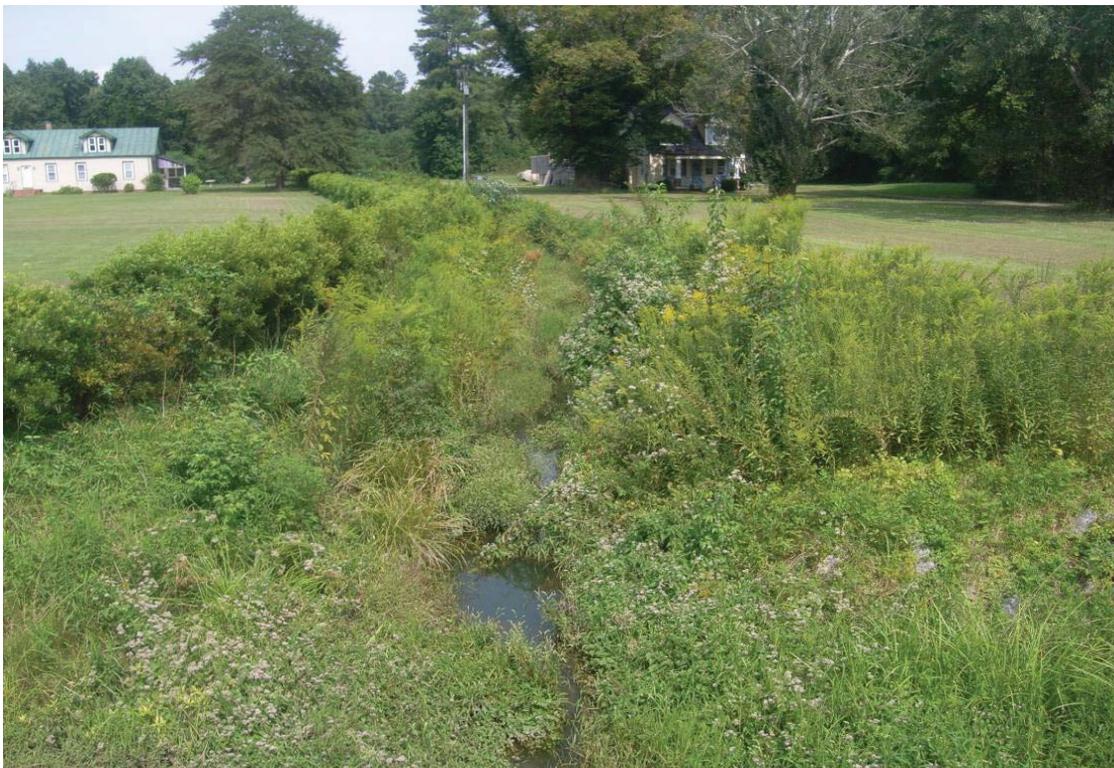
Photo 58. Node 537 - looking upstream toward Photo 1. Node 529

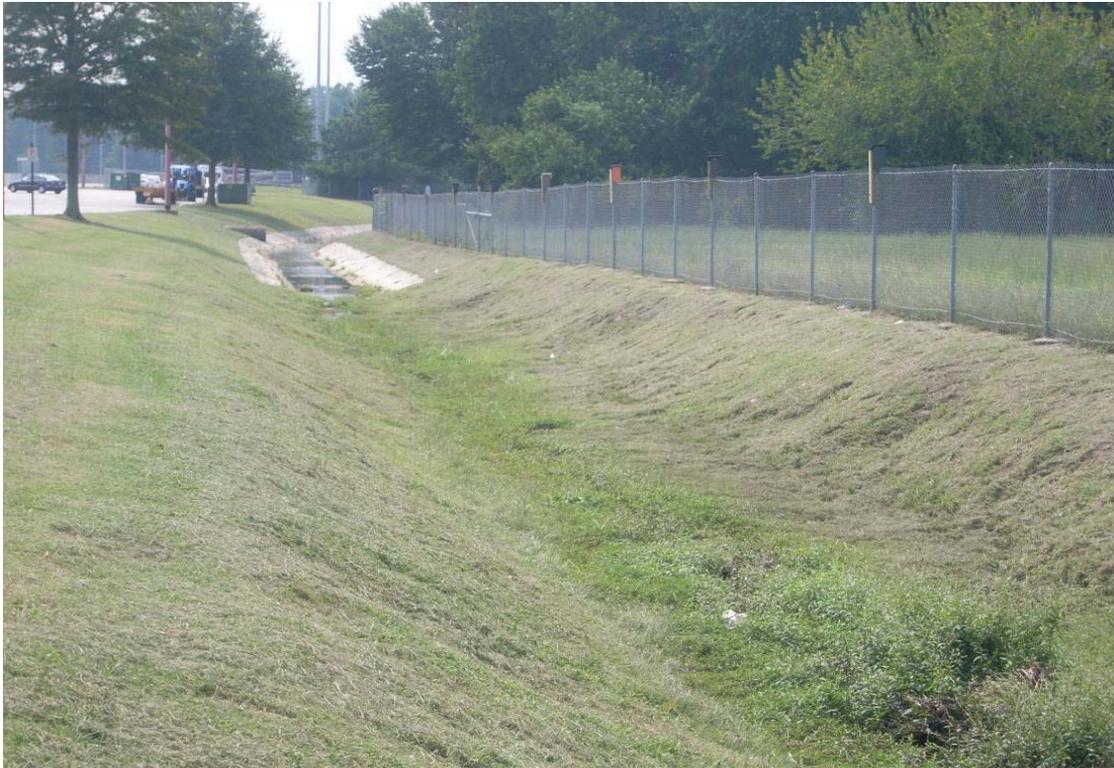
Photo 61. Node 545 - looking downstream

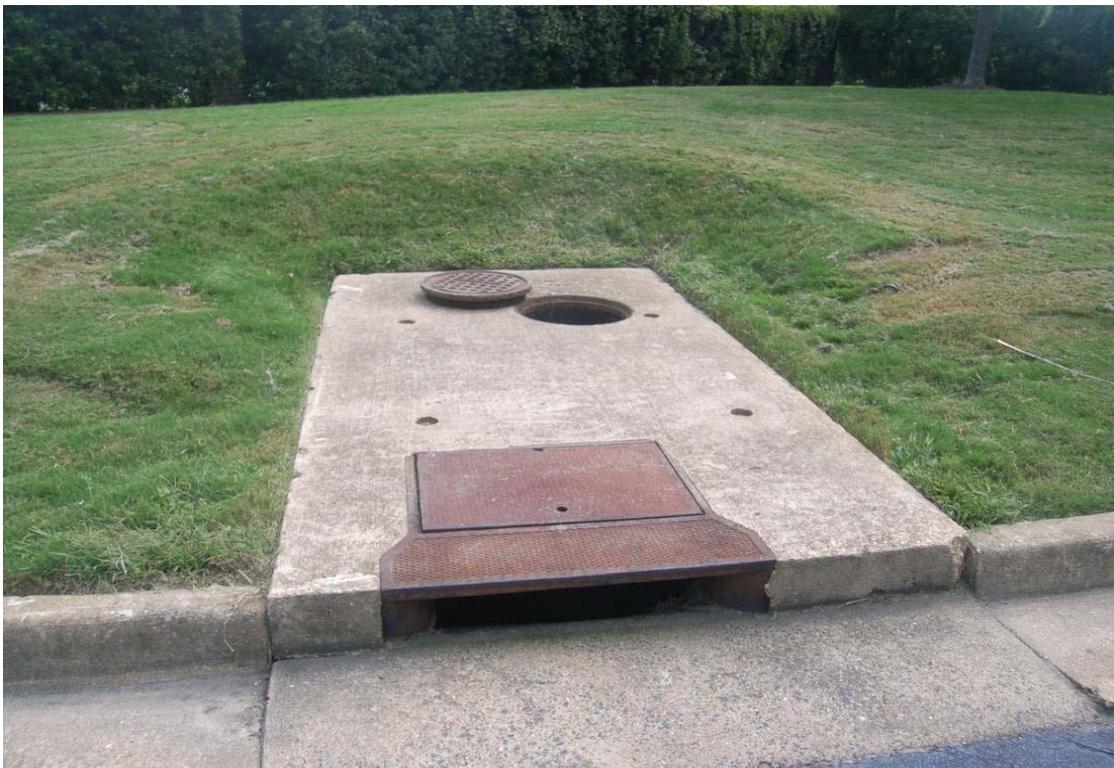
Photo 62. Node 561 - looking at junction

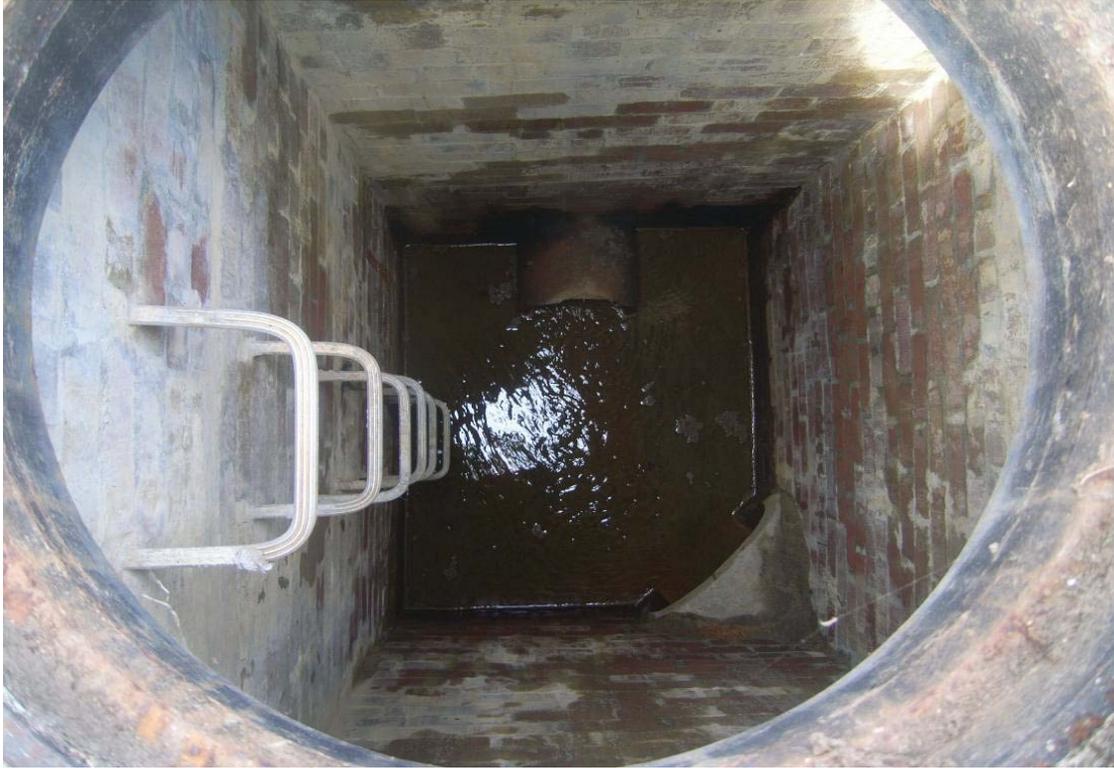
Photo 63. Node 562 - looking inside junction

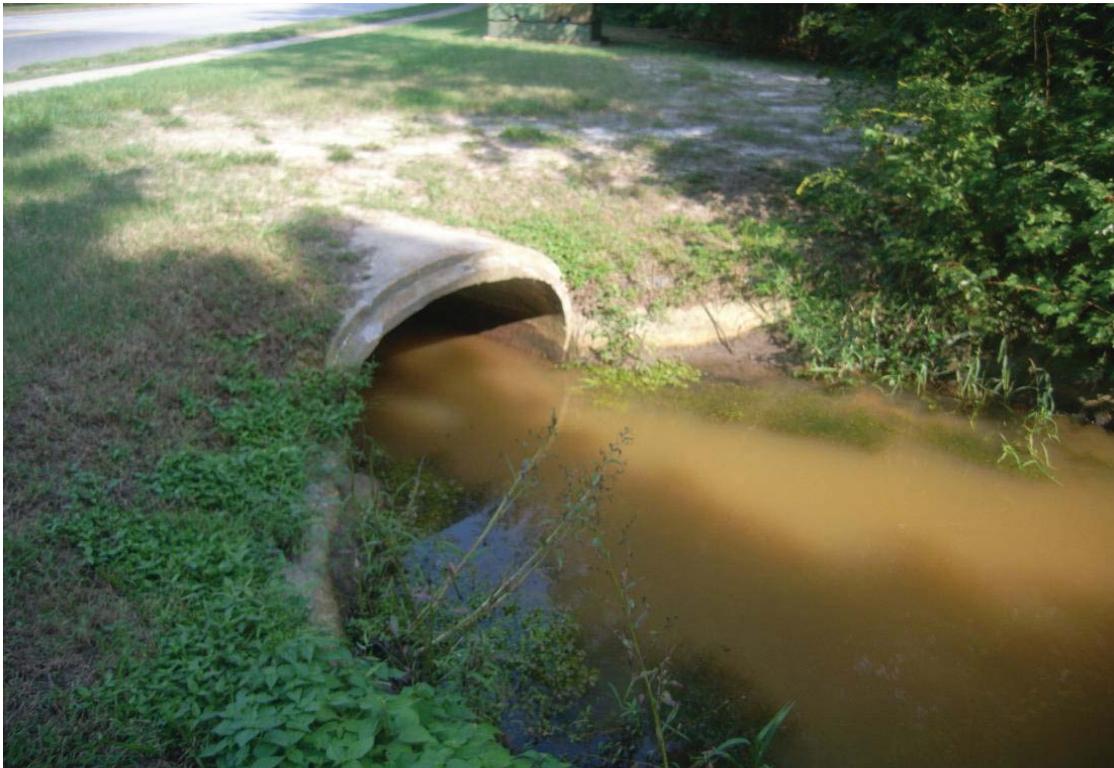
Photo 64. Node 618 - looking at culvert outlet

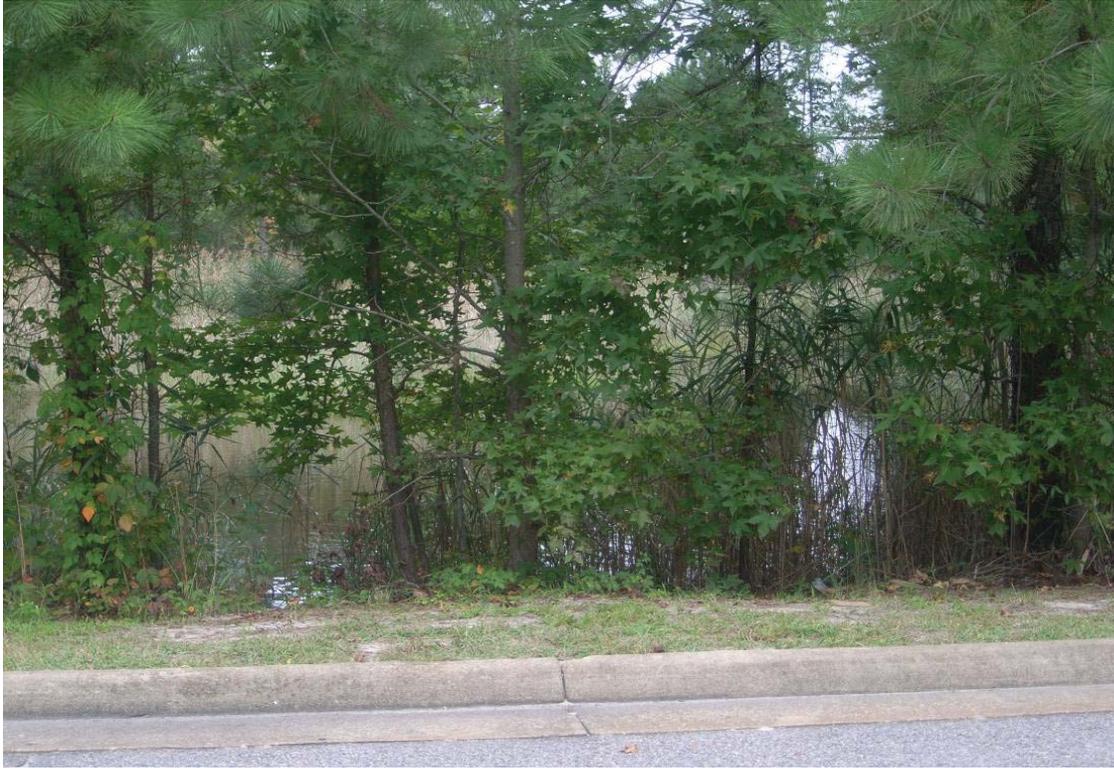
Photo 67. Node 688 - looking downstream (2)

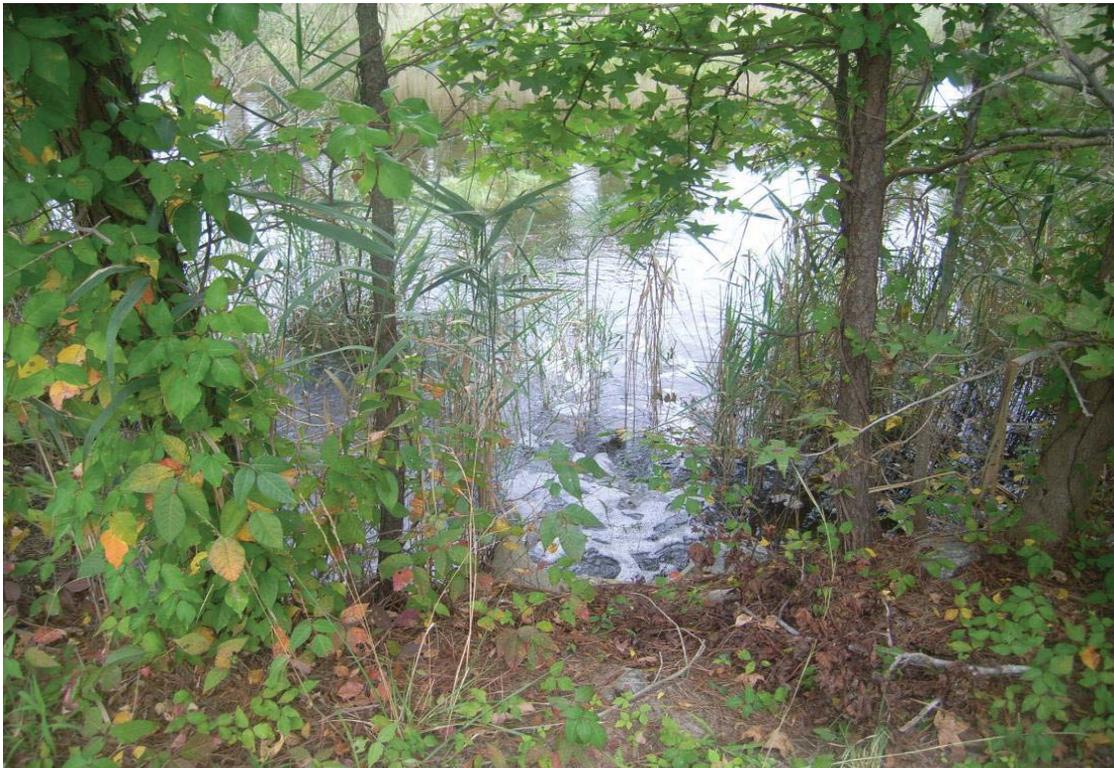
Photo 68. Node 688 - looking upstream at retention area (Photo 1. Node 685) (1)

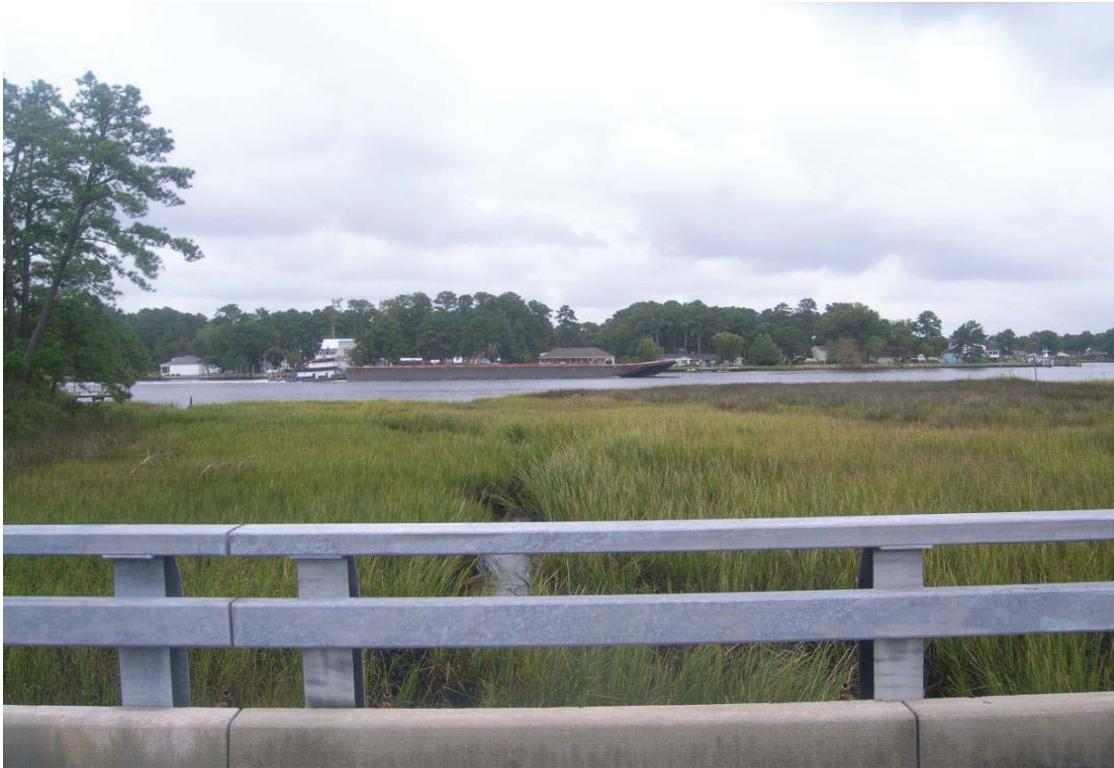
Photo 71. Node 709 - looking downstream
