Appendix A

Photographs

Figure A.1. Oak Grove Watershed - Photo Locations

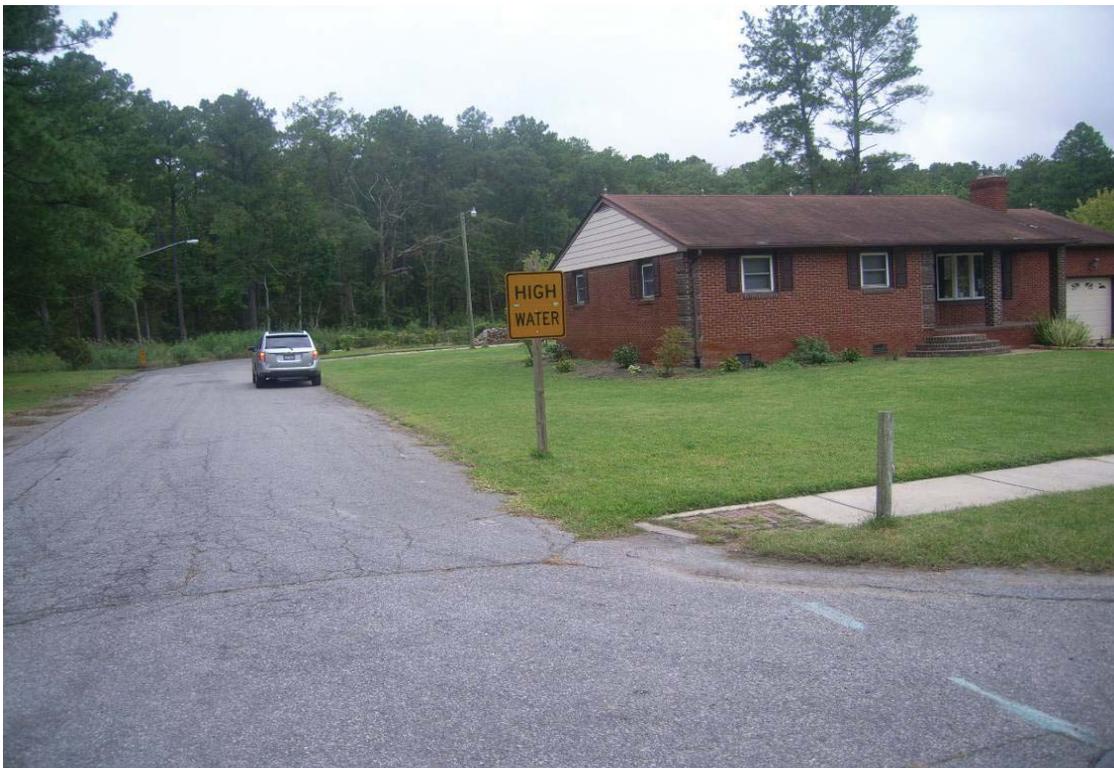
Photo 72. Node 725 - looking at road toward Photo 1. Node 728

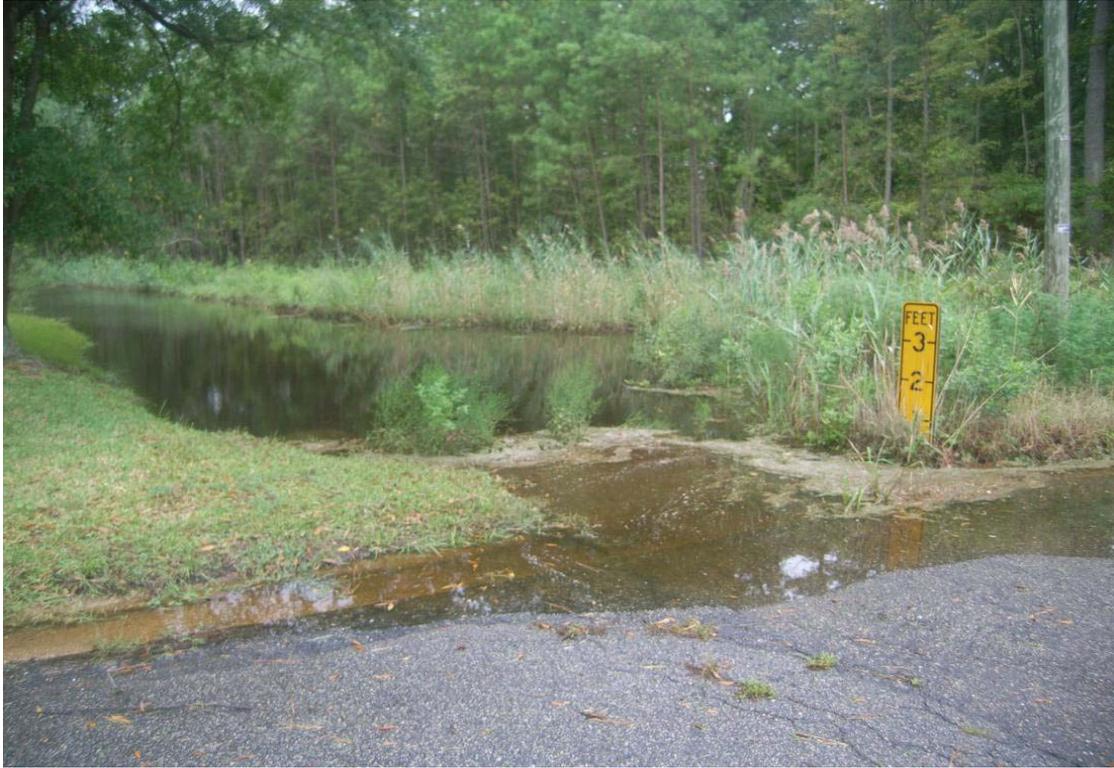
Photo 75. Node 728 - looking downstream

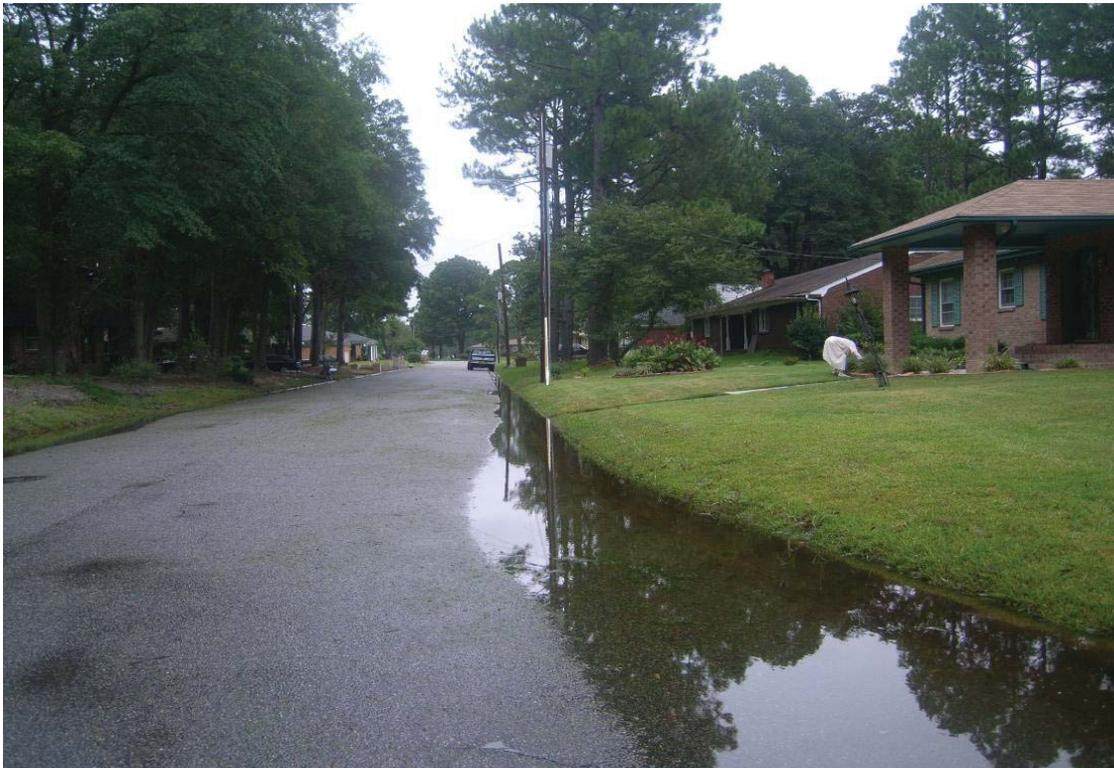
Photo 76. Node 734 - looking at road toward Cherrytree Ln.

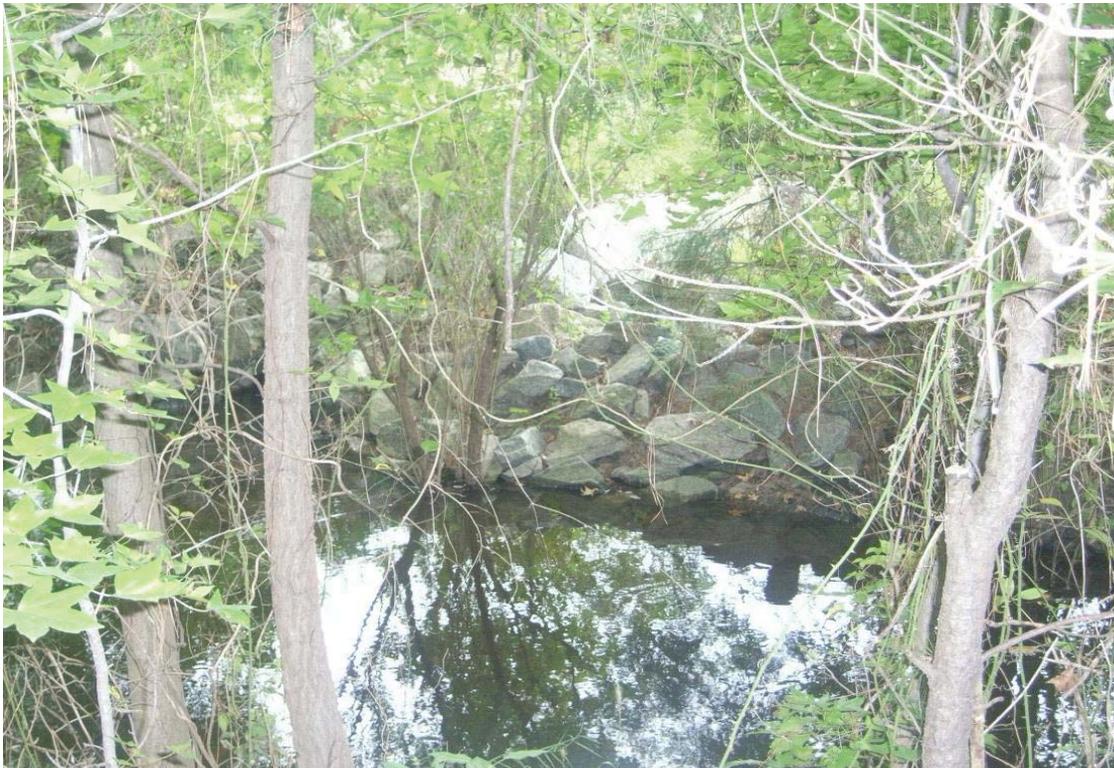
Photo 78. Node 751 - looking at ditch

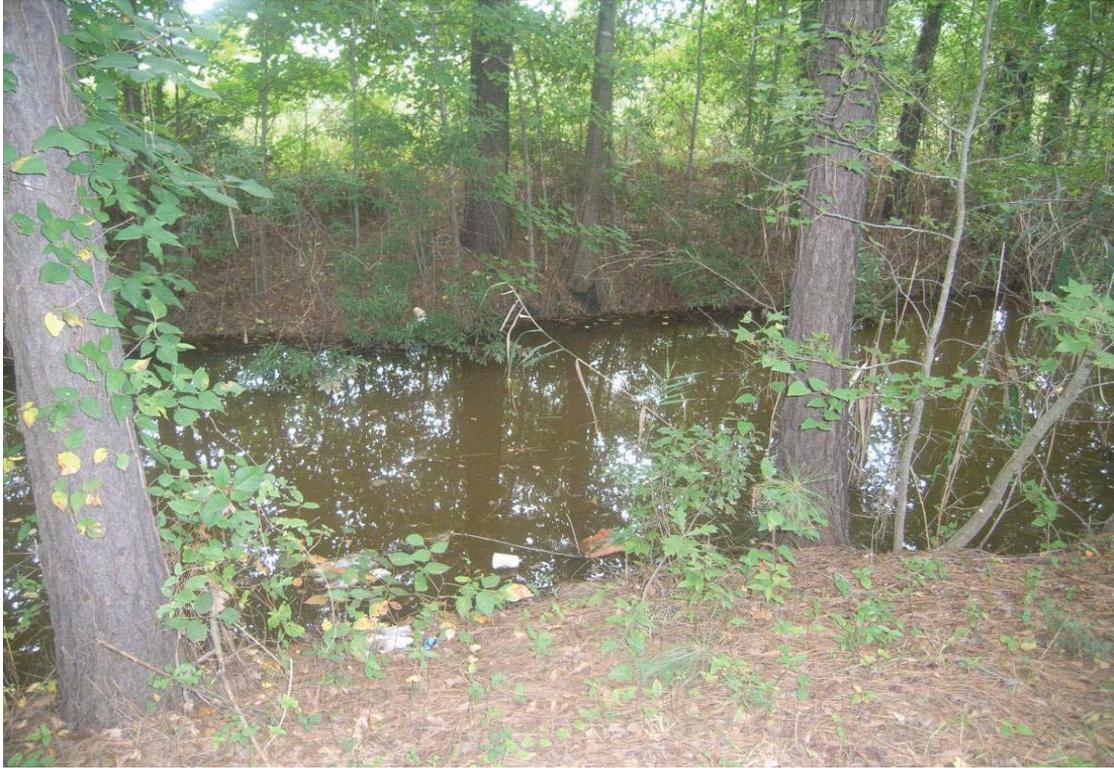
Photo 79. Node 754 - looking at ditch between Photo 1. Nodes 751 and 754

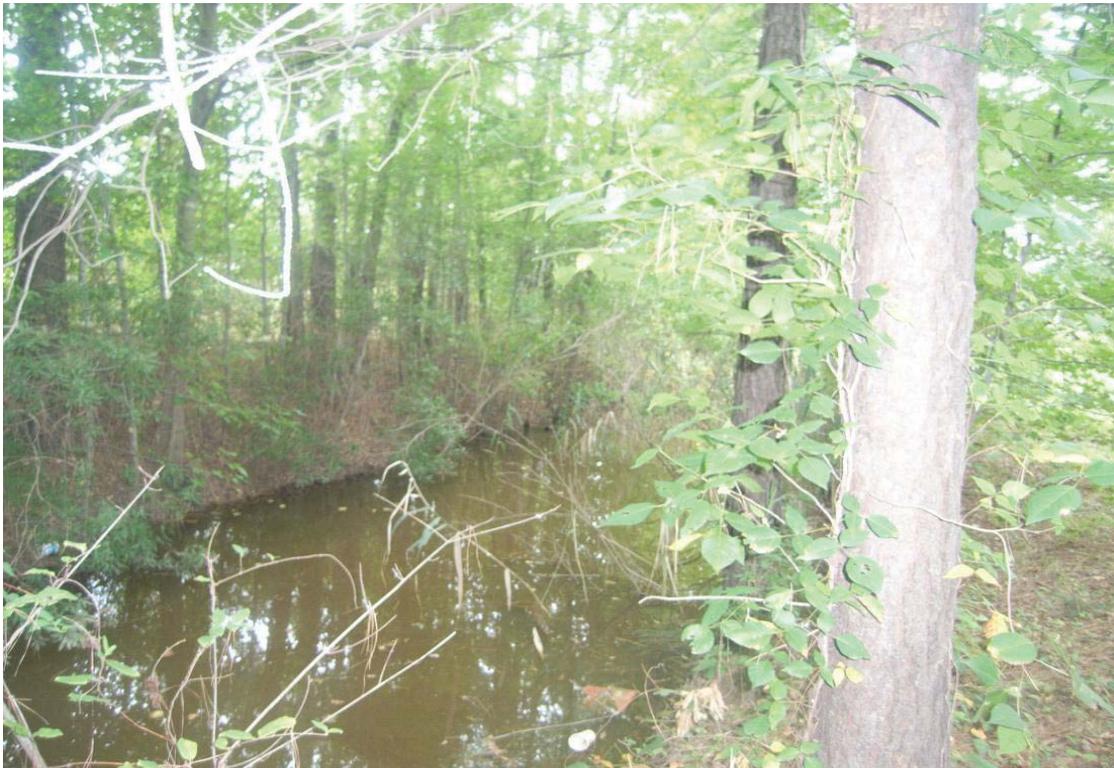
Photo 80. Node 754 - looking toward Photo 1. Node 754

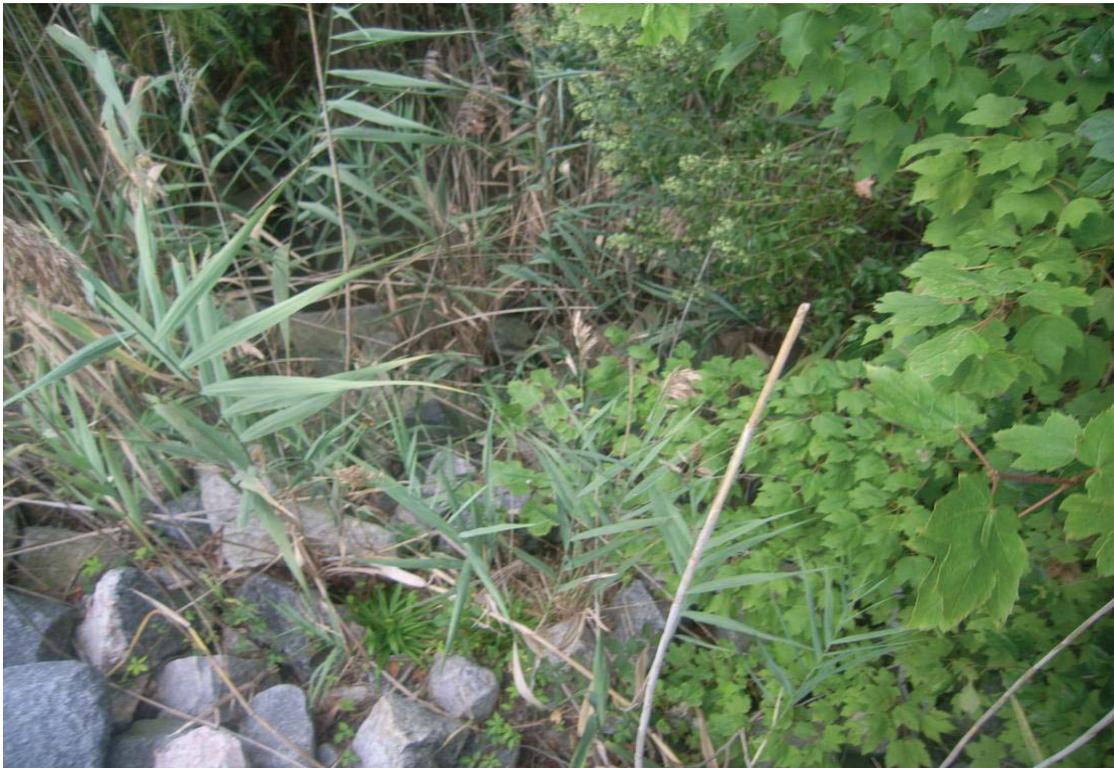
Photo 82. Node 754 - looking upstream (2)

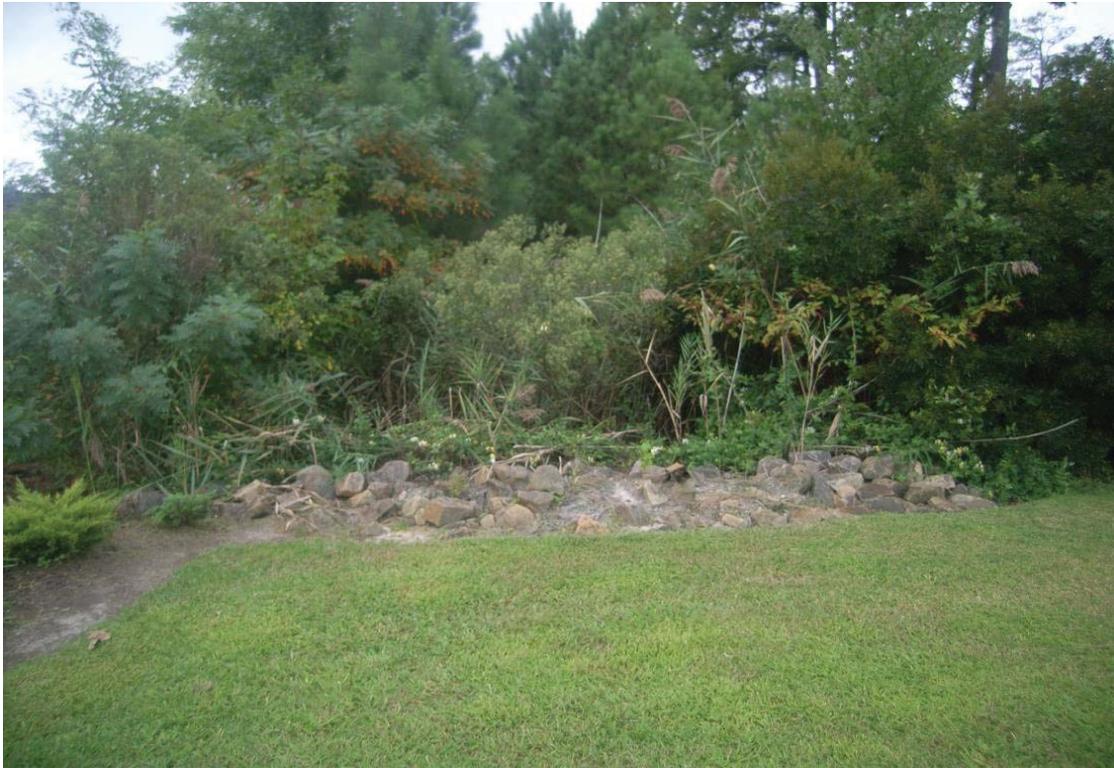
Photo 83. Node 755 - looking downstream (1)

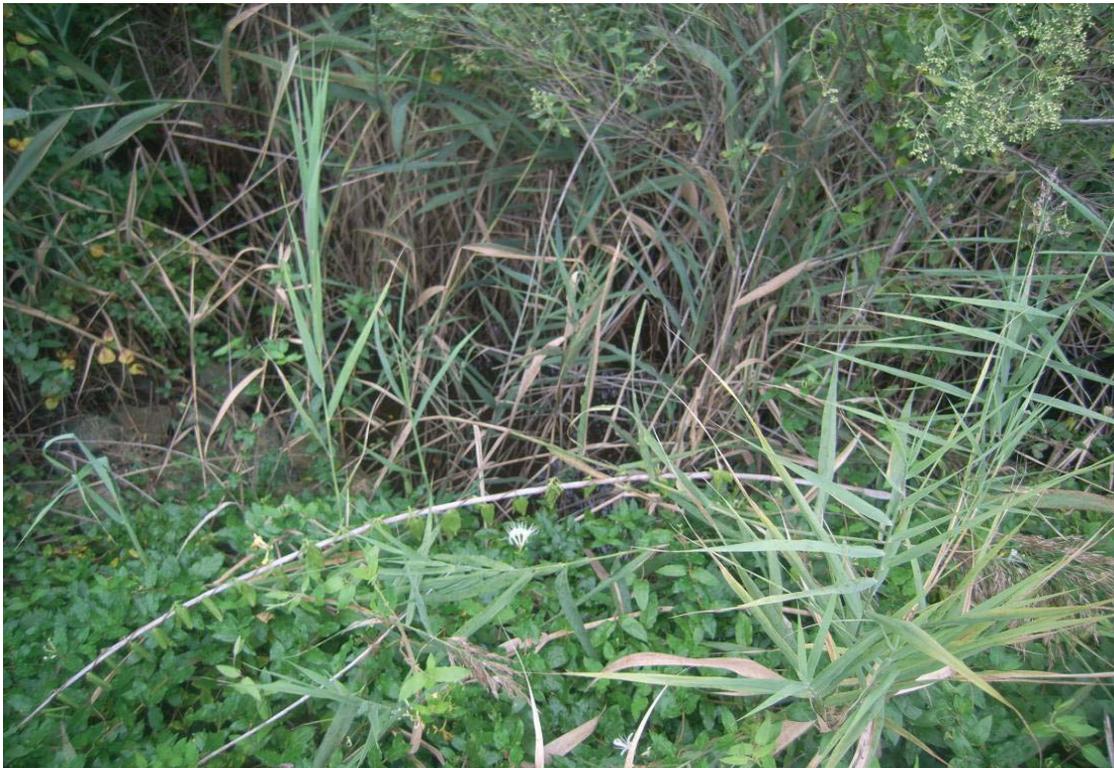
Photo 84. Node 755 - looking downstream (2)

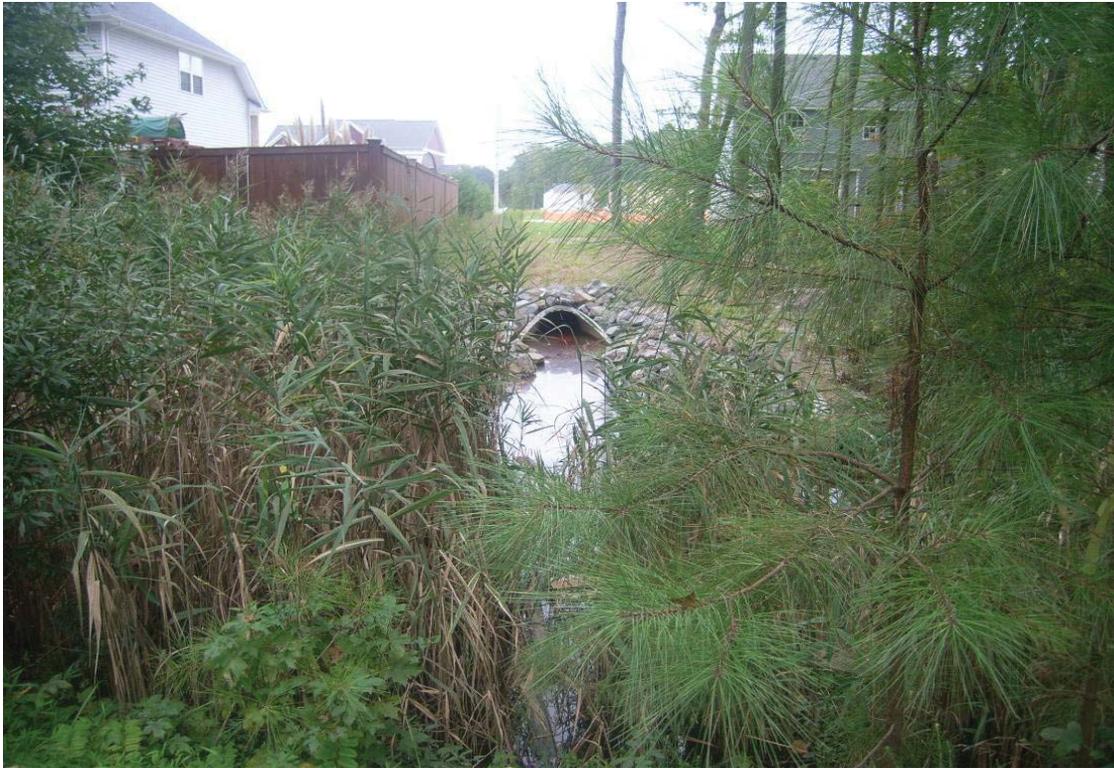
Photo 85. Node 769 - looking at pipe outlet from Photo 1. Node 767

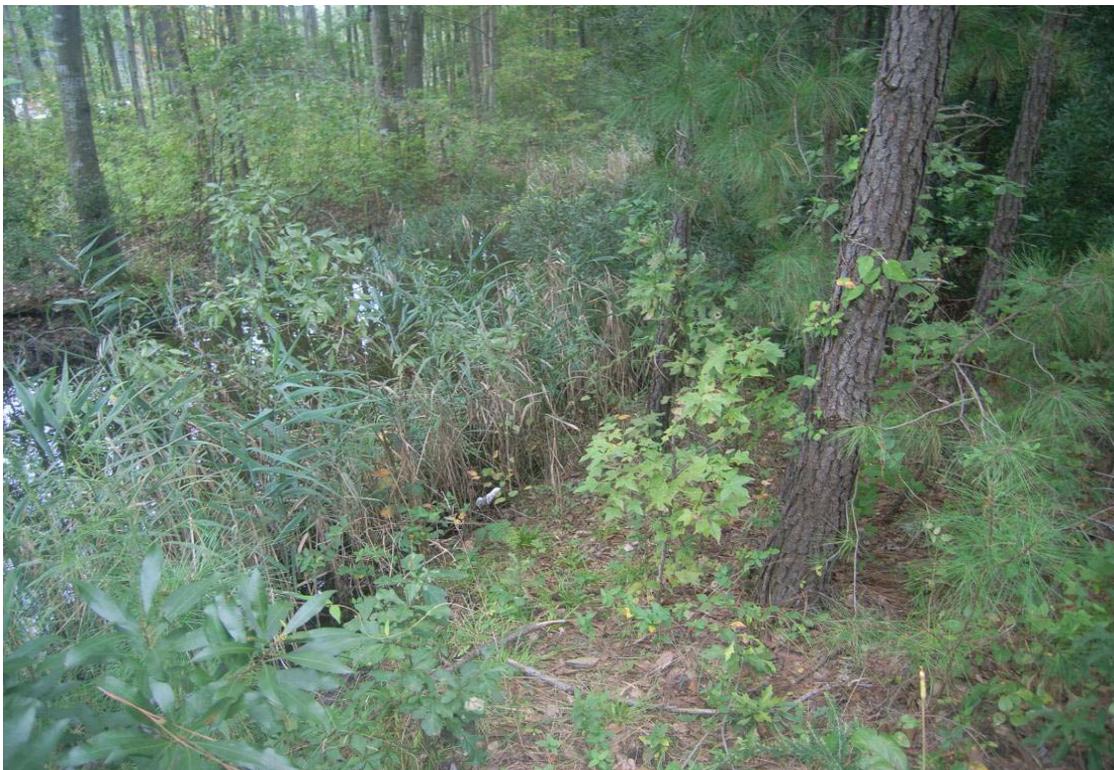
Photo 86. Node 769 - looking downstream

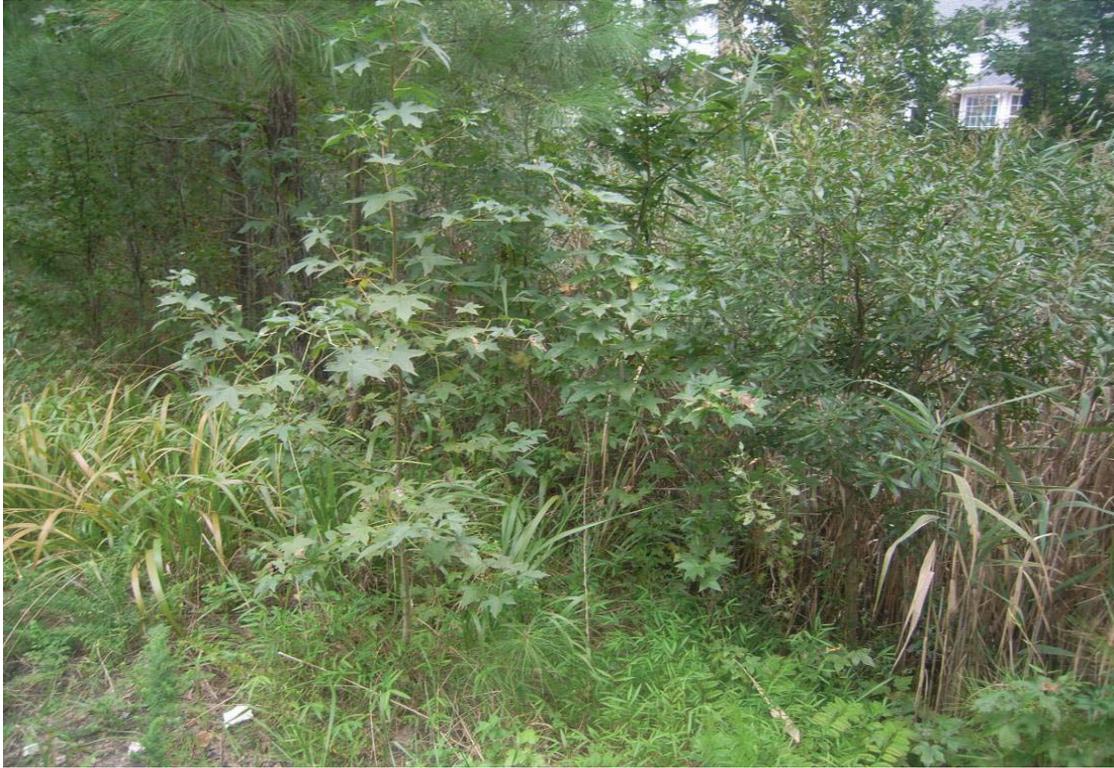
Photo 87. Node 769 - looking upstream

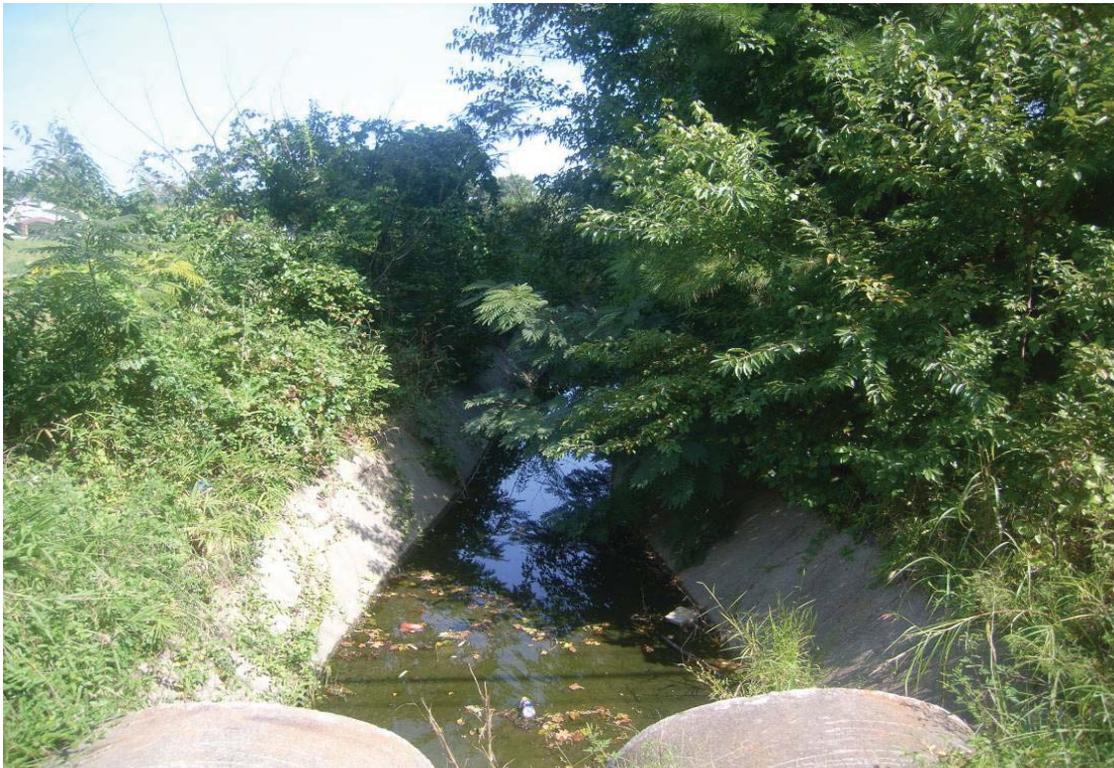
Photo 88. Node 833 - looking upstream

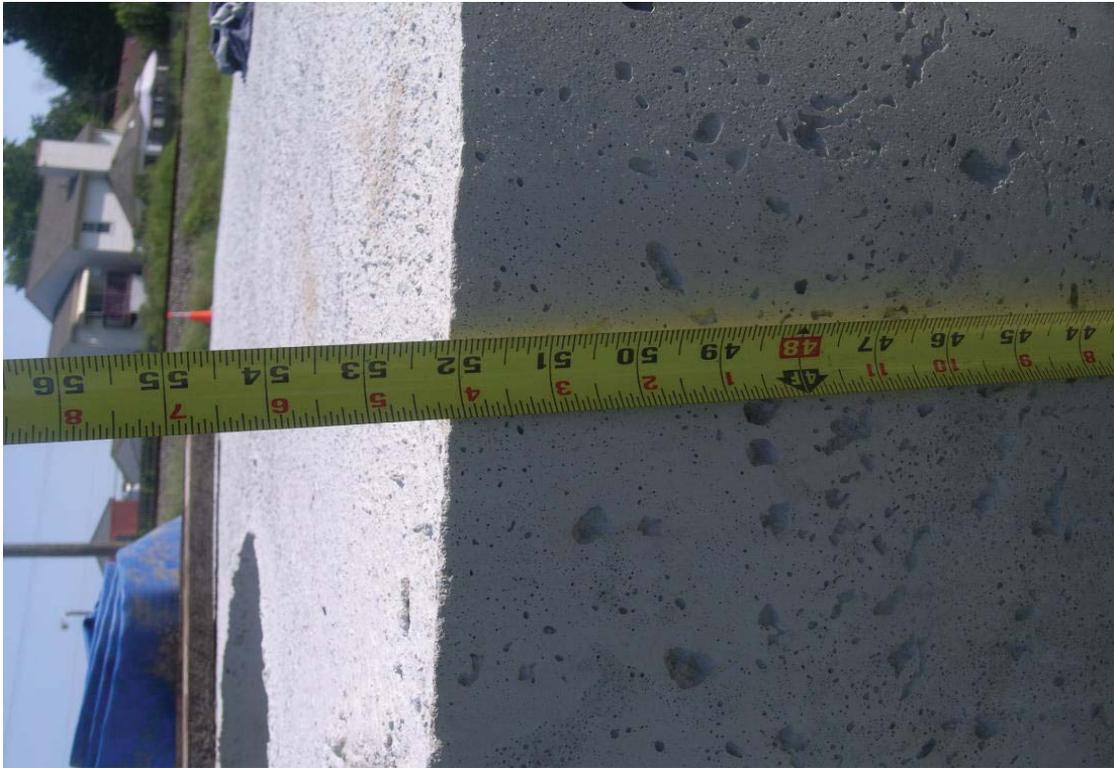
Photo 91. Node 835 - outfall structure (2)

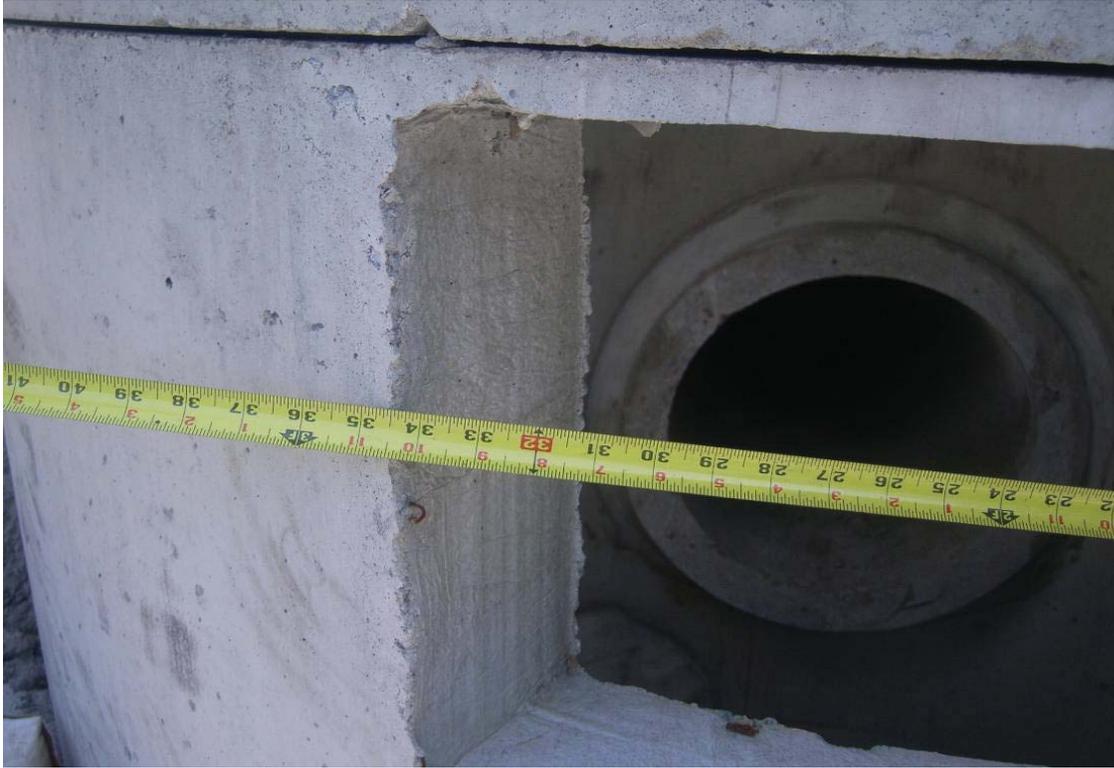
Photo 93. Node 835 - outfall structure (4)

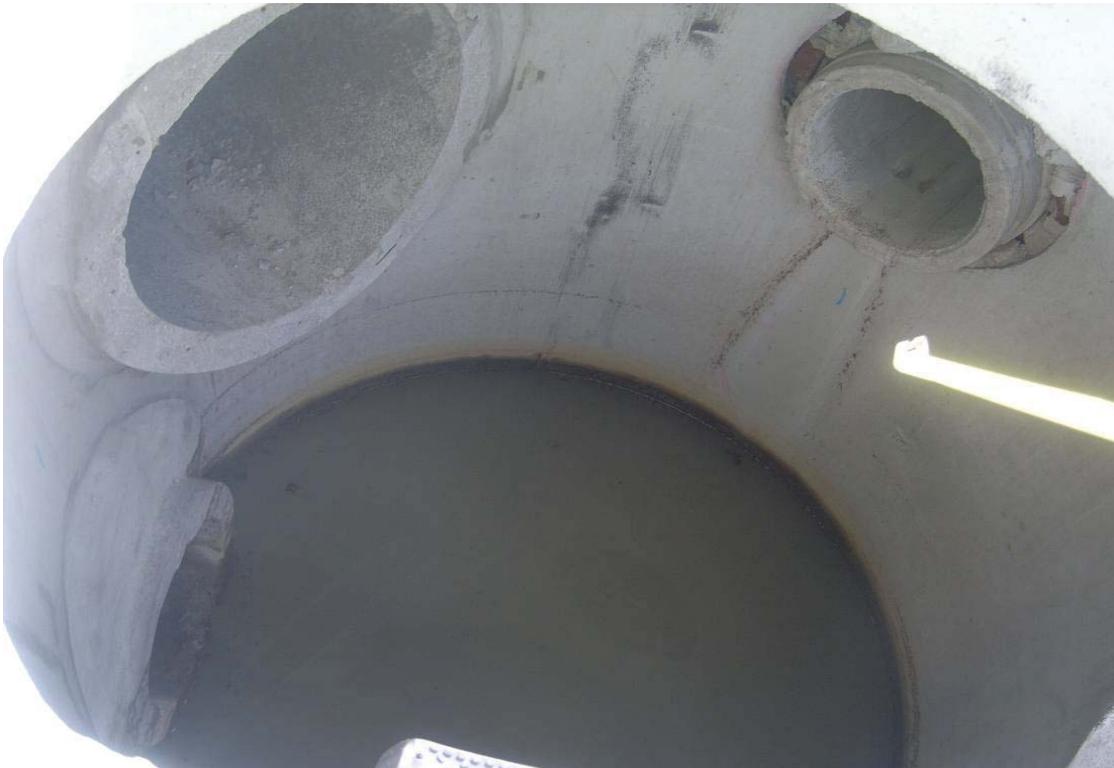
Photo 94. Node 835 - outfall structure (5)

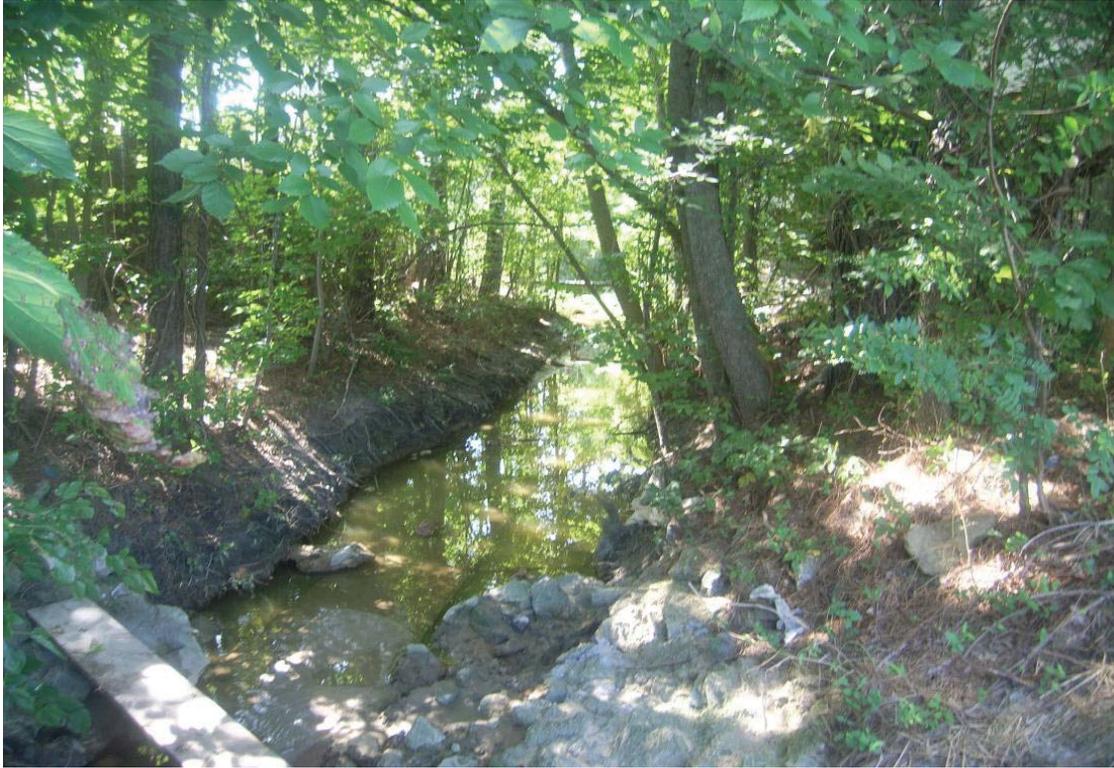
Photo 95. Node 840 - looking downstream
