Jordan Bridge Assessment

City Council Work Session

August 19, 2008

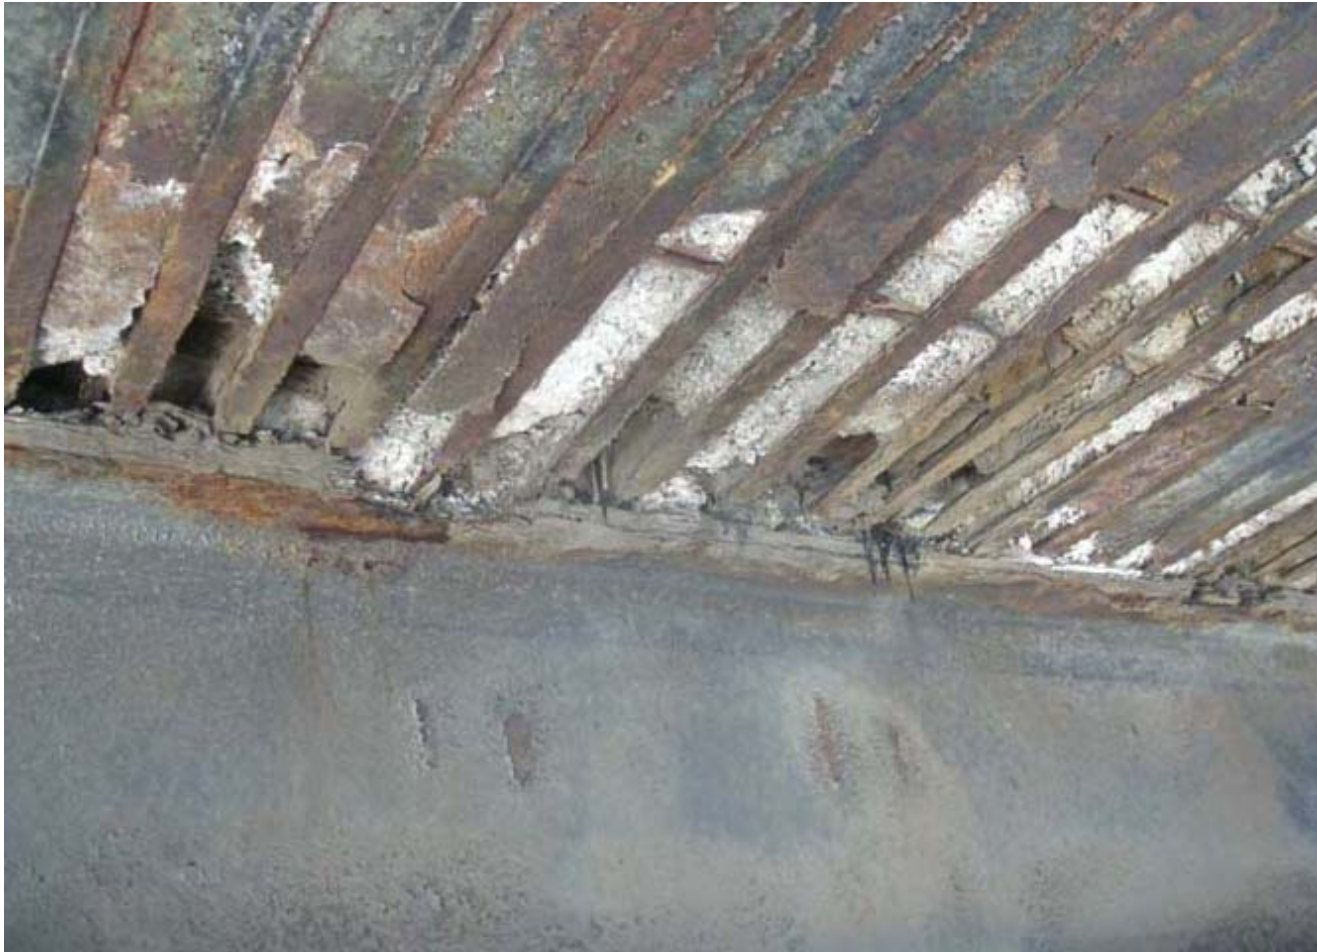
Concrete filled grid deck has heavy corrosion with up to 100% loss of section to steel pans. Primary grid bars are corroded with up to 100% loss of section primarily at the overhang but extending up to 3 LF inside of exterior stringers. 10% - 85% loss of section to the top flanges of primarily the exterior stringers and 10% -80% loss of section to the bottom flanges at some locations. (At this location stringer has 85% loss of section or full length of the top flange).

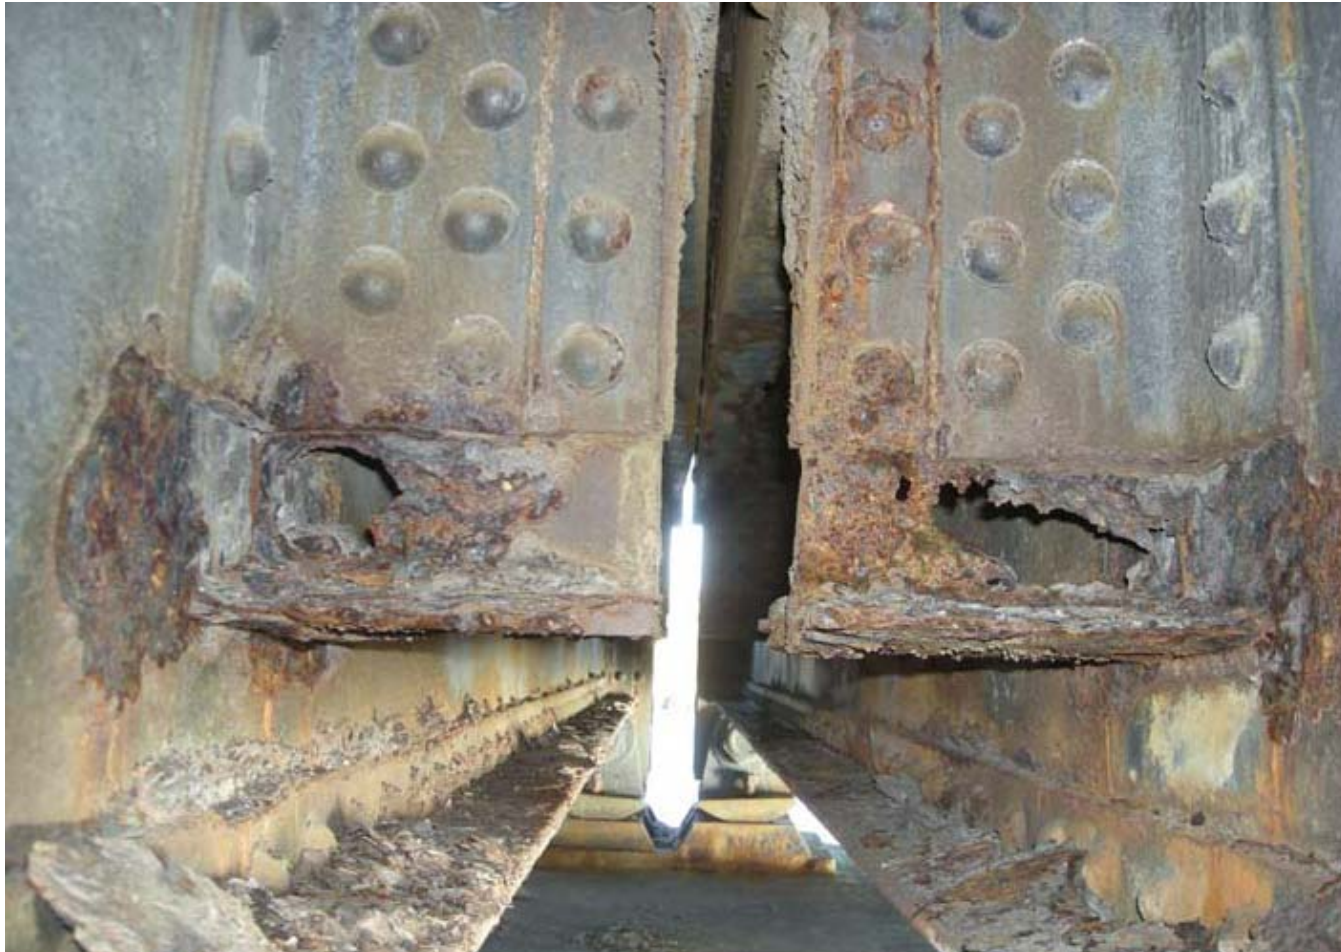
Looking at cantilever stub stringers over Pier 2. Stub cantilever beams supporting the edge of the deck at the joints have up to 50% loss of section to the top flange and up to 100% loss of section to the bottom flange and web.

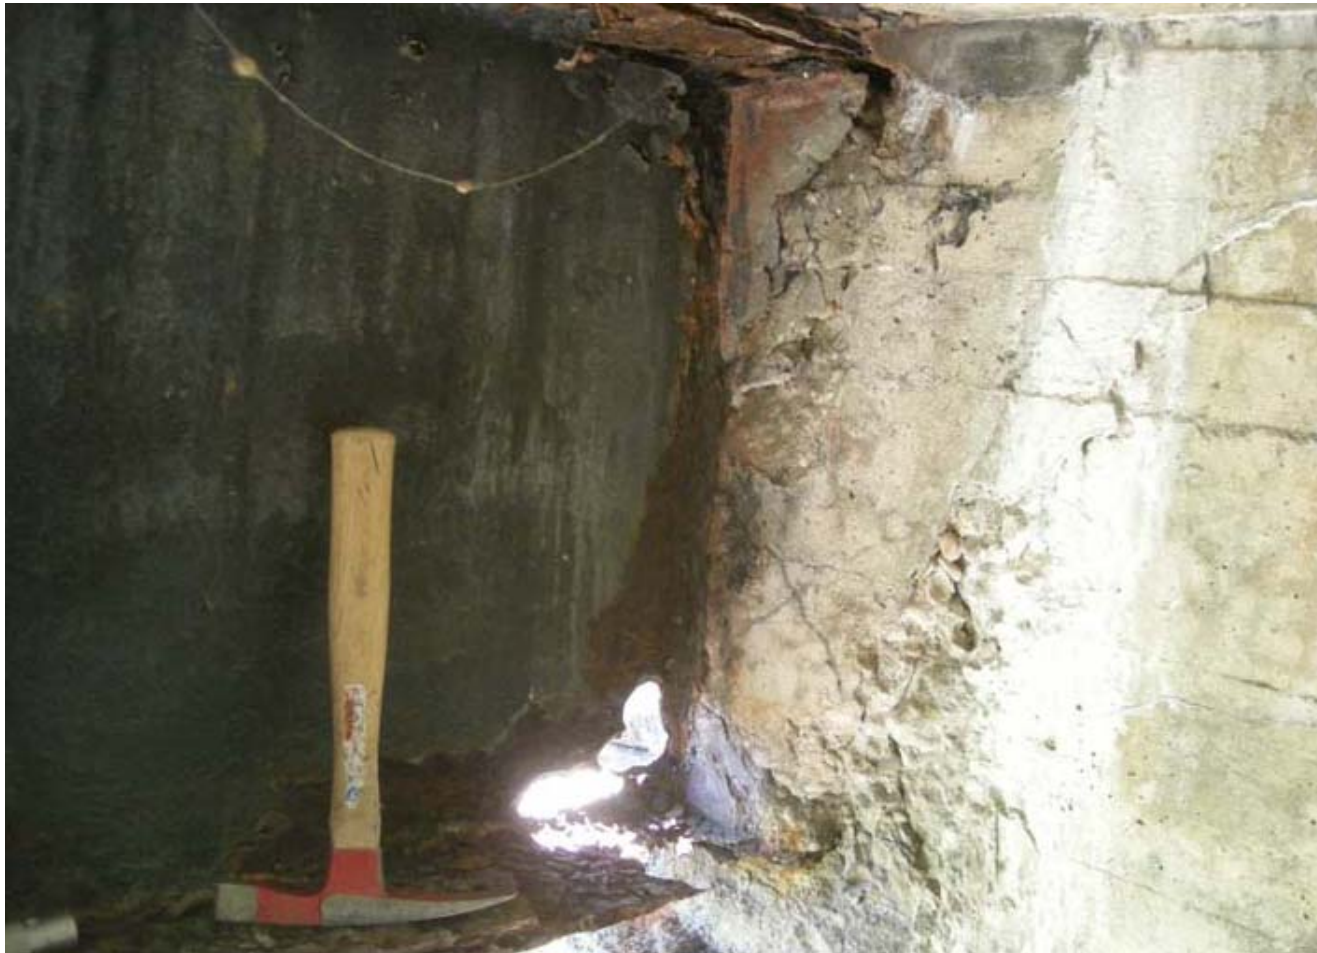
Looking at Beam D in Span GD at Bent 1D. Section loss up to 100% to bottom flanges at bearings of primarily the exterior beams. (At this location bottom flange has 80% loss of section with a 4" wide x 3" long rust perforation.) Webs of beams typically have 1/4" but up to 3/8" loss of section at the bearings with rust perforations typical in the exterior beams. (At this location web has 1/4" loss of section full height with a 6" long x 3" high rust perforation.)

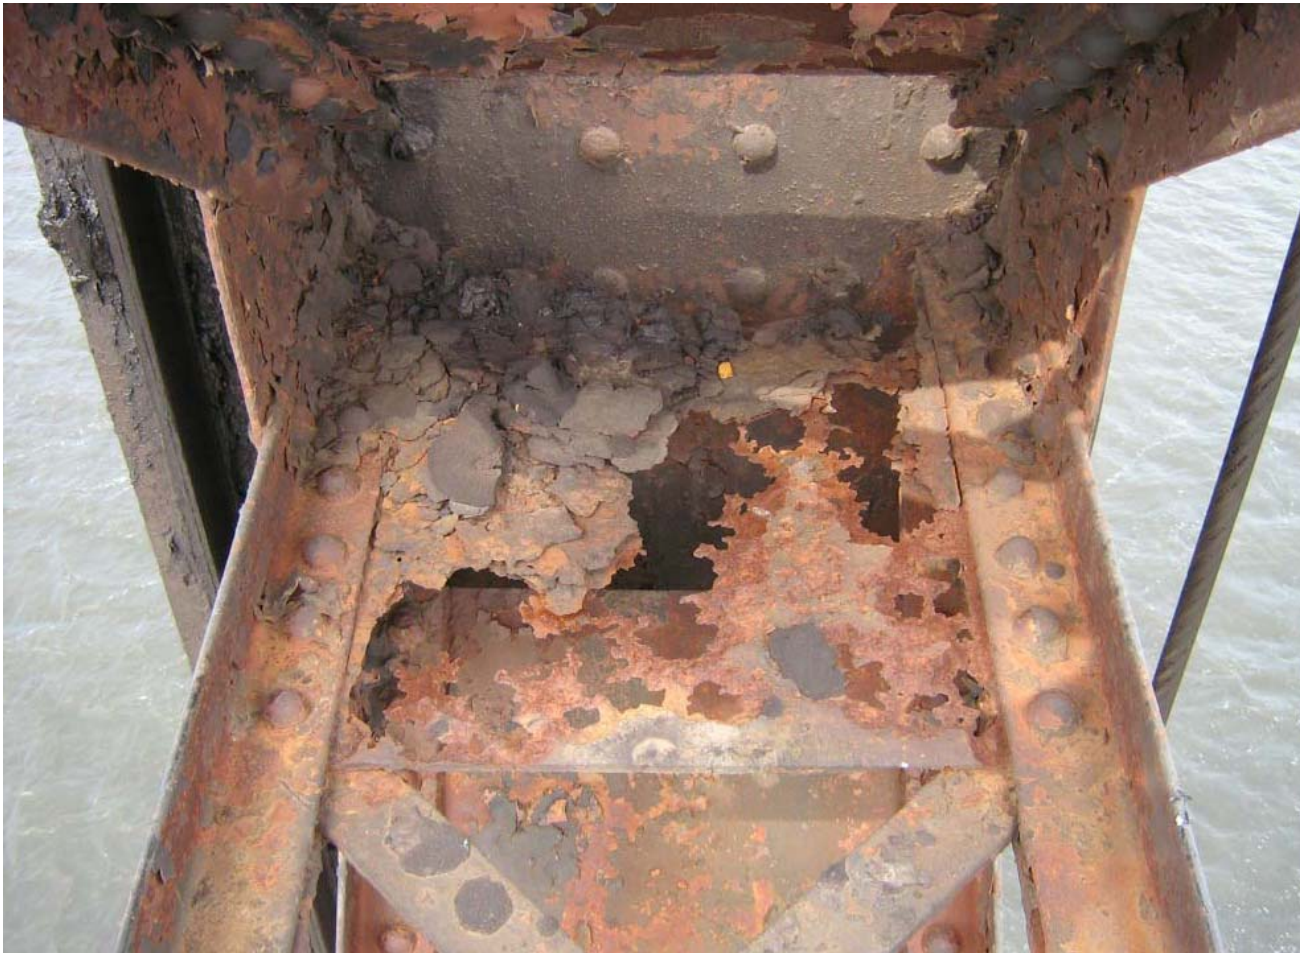
Looking at batten plate in sway member of the west tower. Typically up to 50% but up to 100% loss of section to batten plates in tower sway frame members at intersection gussets and at connections to tower legs. (At this location 99% loss of section with several rust perforations up to 10" long x 6" wide.)

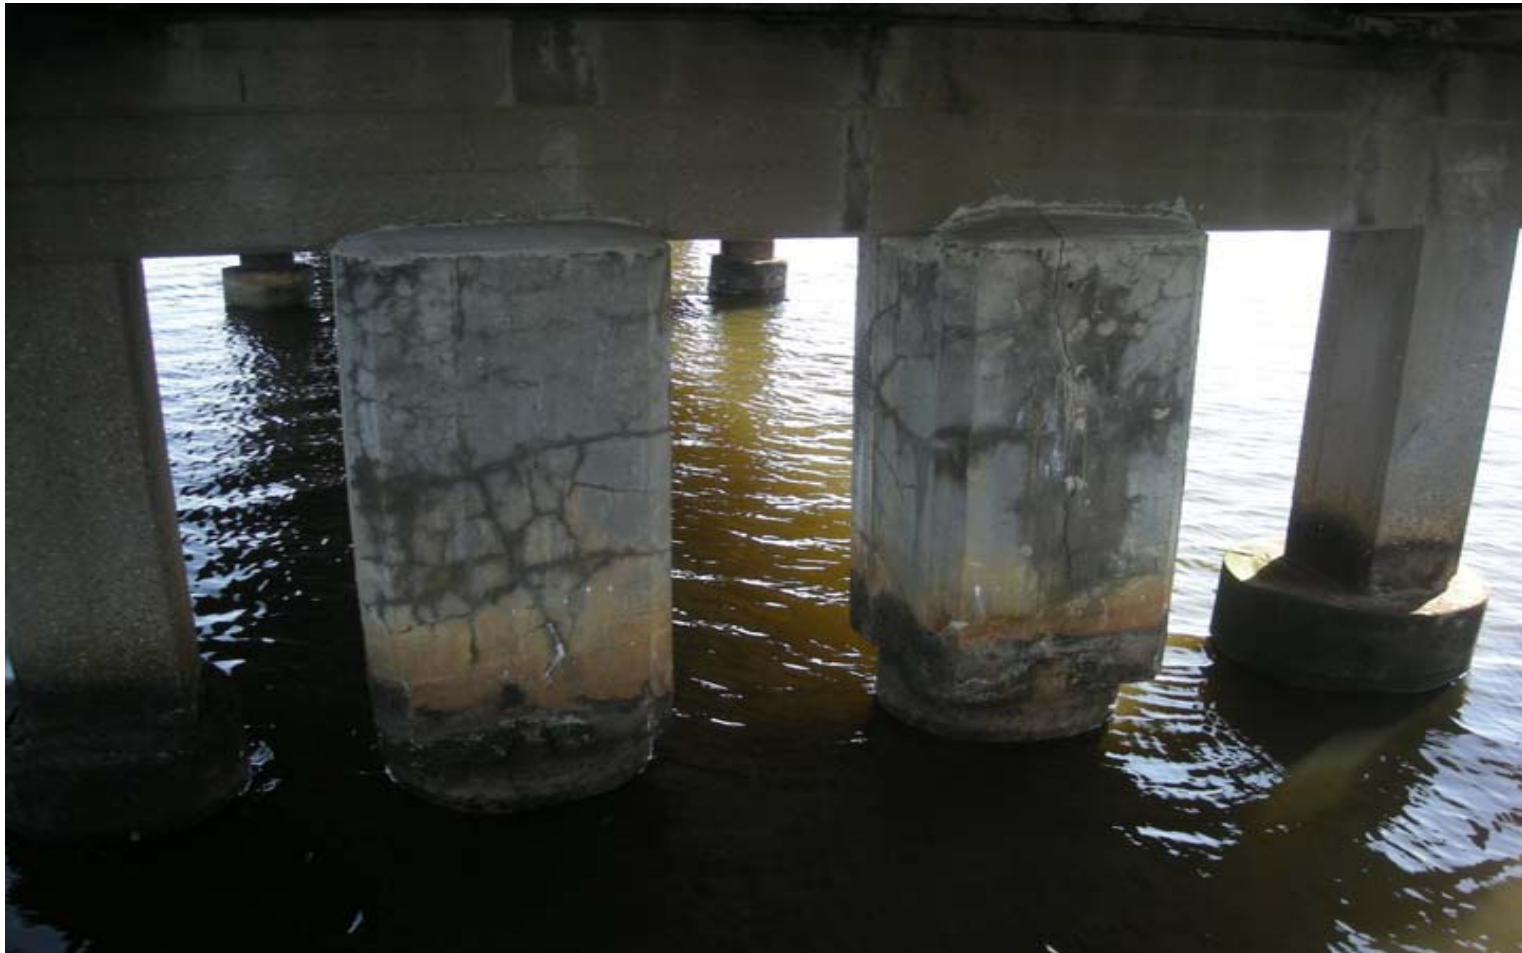
Looking at the west side of Piles 2 and 3 at Bent B3. A majority of the piles have been repaired with concrete jackets. Typically hairline to 1/16" wide but up to 1/8" wide map cracking with efflorescence with some cracks up to 3/8" wide and isolated areas of delamination in jackets.
