AGENDA

Board of Historic and Architectural Review

January 14, 2019

2. 1136 Seaboard Avenue

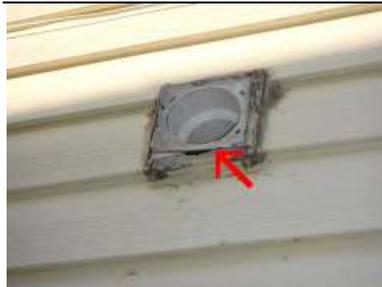
Missing exterior vents are noted around the home.

Many repairs/replacements needed at the siding.

Repairs are needed at the kitchen window, signs of rodents entering the insulation.

Repair the siding at the right side of the house and replace the moisture damaged framing.

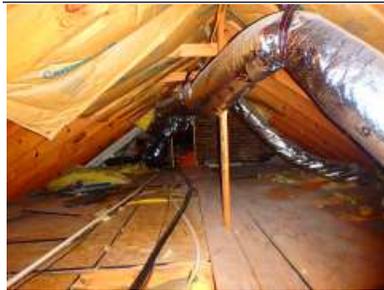
3.1 Structure:

The attic/roof structure utilizes, conventional framing for the structure of the roof. The attic is, full, this means that it spans the entire area of the house.

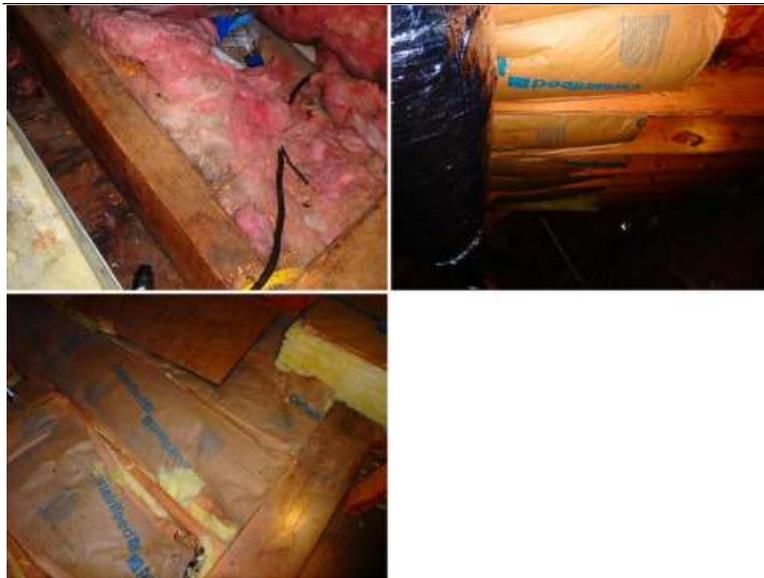
3.5 Condition:

The insulation installed appears to be inadequate. It is recommend to add additional insulation in all areas for proper thermal coverage.

Insulation is installed upside down, correction is needed.

Remove the insulation from the roof rafters.

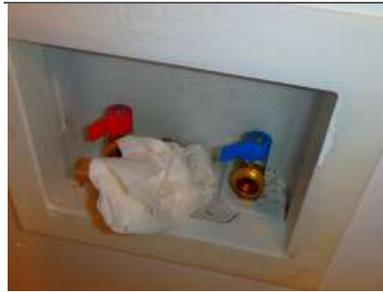
4.3 Maintenance Condition:

Knock arrestors are required at the laundry, ice maker and shut off valves for all new and rehabilitated homes. Inquire to the seller to see if knock arrestors are installed.

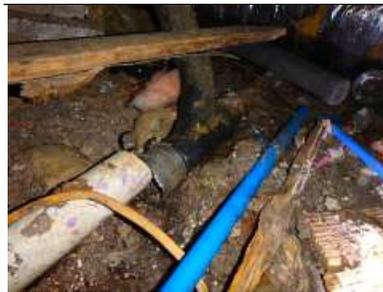
Inspect the disconnected drain line in the middle of the crawl space and repair/remove as needed.

Have a licensed and insured plumbing contractor evaluate and make any further recommendations or repairs as needed to the plumbing system.

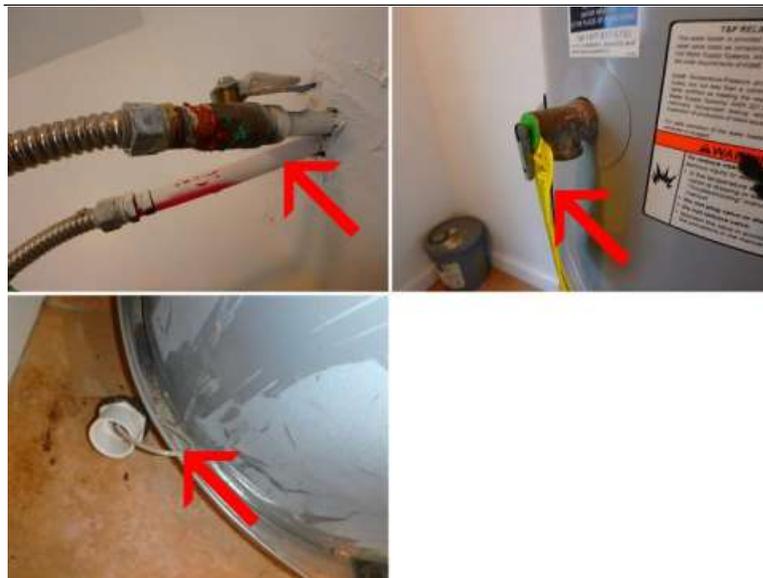
Repair the leaking supply line as needed.

Have a licensed and insured plumbing contractor evaluate and make any further recommendations or repairs as needed to the plumbing system.

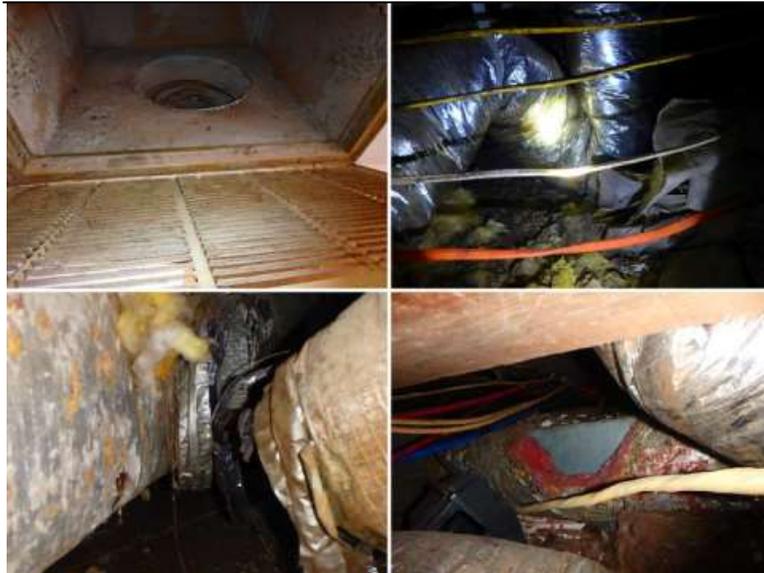
Clean all ductwork within the system as needed.
Install heat duct in the master closet.
Repair/replace all duct work in the crawl space as needed.
Remove all wood from under the crawl space duct work and strap properly to the floor joist.

A licensed and insured HVAC contractor should evaluate and make any further recommendations and repairs as needed to the ductwork system.

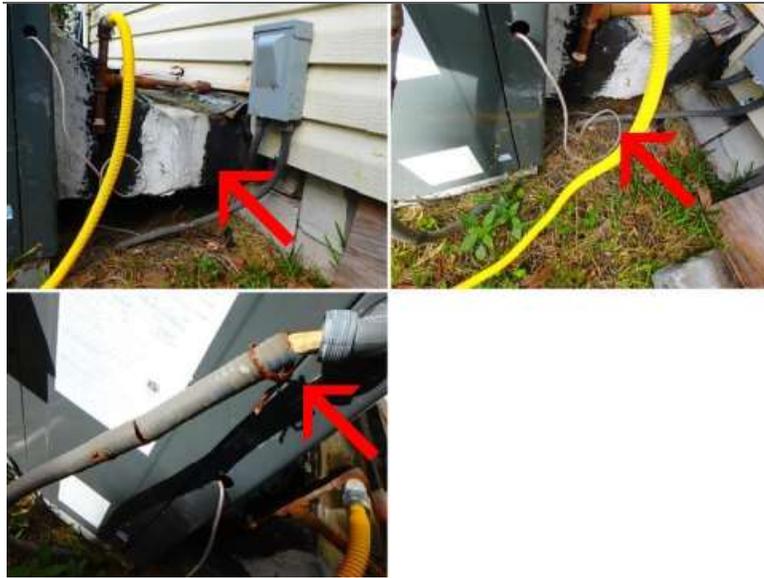
The advanced age and/or condition of this unit is such that you will likely need to replace it in the near future. Have a

licensed HVAC contractor to further evaluate, service the system and make any further recommendations as needed.

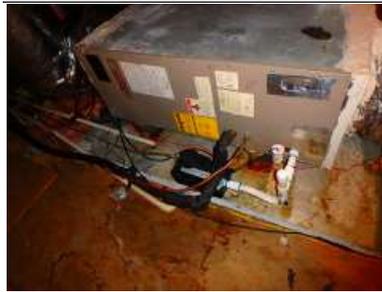
5.24 Type & Location:

The secondary unit is a Heat pump and is located in the attic and is powered by Electricity.

While the unit appears to be functioning, due to the outside temperature being over 65°, we are unable to determine the temperature differential.

Re-insulate the AC line as per standard to keep from sweating to prevent damage to the ceilings below.

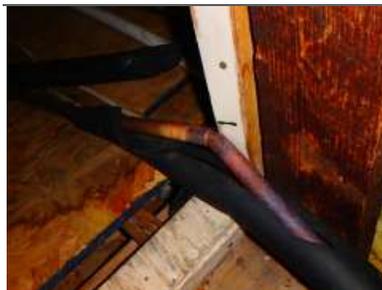
Missing rubber grommet at the AC line and unit.

Test the condensate pump to be sure it operated properly.

The advanced age and/or condition of this unit is such that you will likely need to replace it in the near future. Have a licensed HVAC contractor to further evaluate, service the system and make any further recommendations as needed.

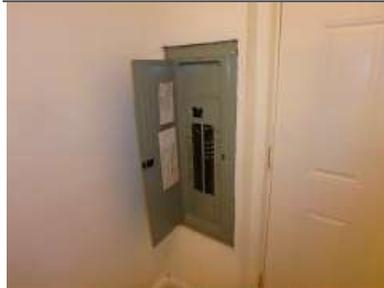
6.2 Panel Location

The main service entering the house is a 200 AMP breaker panel and is located in the kitchen foyer.

The panel box appears serviceable and was standard for the year it was installed with no issues noted.

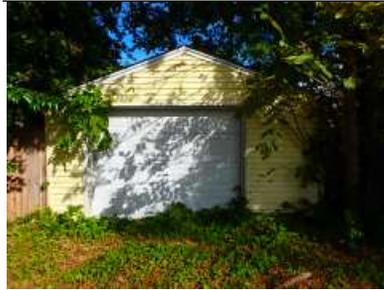
8.1 Type:

A one car garage is present on the property and is detached.

The shingles at the roof need to be replaced.

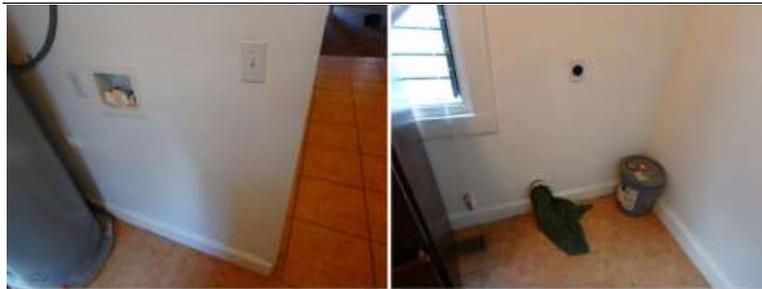
9.3 Location:

The laundry facility is located in the utility.

The drain system was not tested at time of inspection, since no units are present. It is important to clean and maintain the dryer venting to prevent a fire hazard.

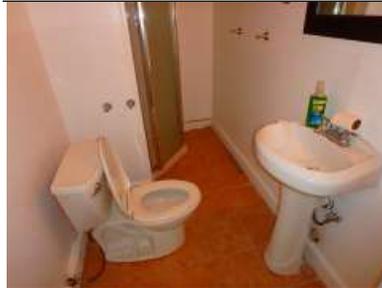
10.1 Bathroom Location:

Bathroom #1 is located downstairs in the hall.

A flex drain line is installed in bathroom #1. This is not a common practice and it is recommended to replace with solid piping.

The stopper is missing at the sink in bathroom #1, replacement is needed for proper function.

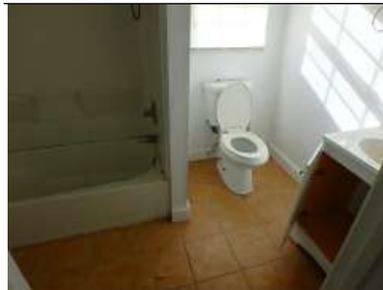
10.13 Bathroom Location:

Bathroom #3 is located upstairs in the Master bedroom.

There is no overflow hole noted at the bathroom sink(s) as per standard in bathroom #3.

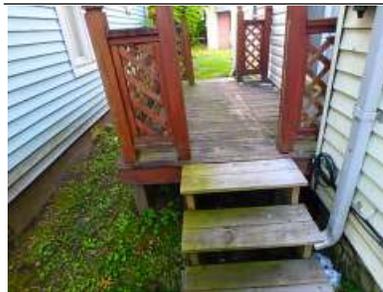
11.6 Decks:

The deck is composed of Wood
Concrete

Paint is peeling at the concrete front porch.
