South Norfolk
Historic & Architectural Review Board

November 7, 2019

Meeting Minutes
Historic and Architectural Review Board (HARB)
October 3, 2019
South Norfolk Memorial Library – 801 Poindexter St.

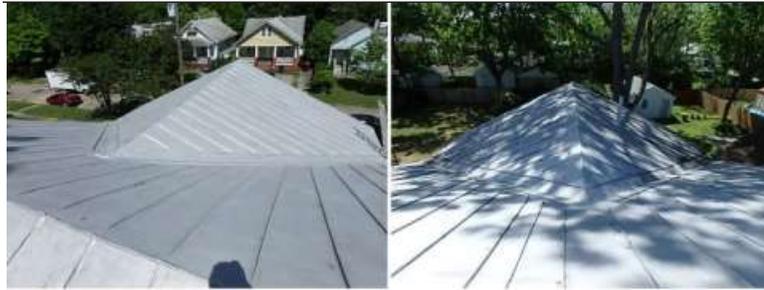
3.6 Roof Covering:
metal

Have a licensed and insured metal roofing contractor further evaluate and make any further recommendations or repairs as needed to the roofing system.

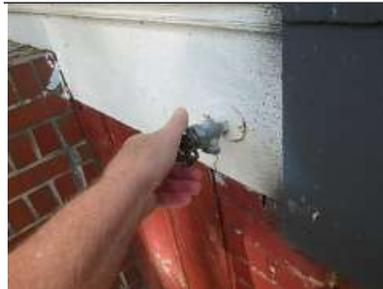
The rear exterior hose bib is not working, repair/find the shut off valve and inspect.

Have a licensed and insured plumbing contractor evaluate and make any further recommendations or repairs as needed to the plumbing system.

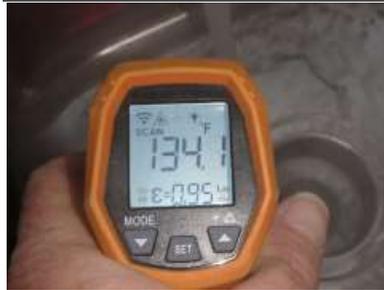
The pressure relief valve drain line ends prematurely, extend to 6" up off the ground as required to prevent accidental injury in the event of a discharge.

Have a licensed and insured plumbing contractor evaluate and make any further recommendations or repairs as needed to the plumbing system.

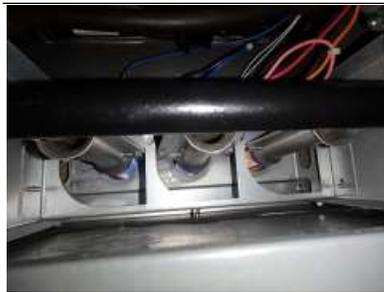
Inspect the air handler and condense lines, moisture is dripping and pooling on the soil in the crawl space.

The advanced age and/or condition of this unit is such that you will likely need to replace it in the near future. Have a licensed HVAC contractor to further evaluate, service the system and make any further recommendations on or prior to the PICRA.

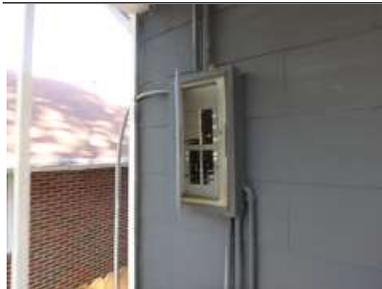
There are missing and/or improper sharp pointed screws in the panel cover, Have replaced to properly secure the panel to the wall and for safety.

The panel box is missing important information and needs to be labeled to determine what the breakers operate.

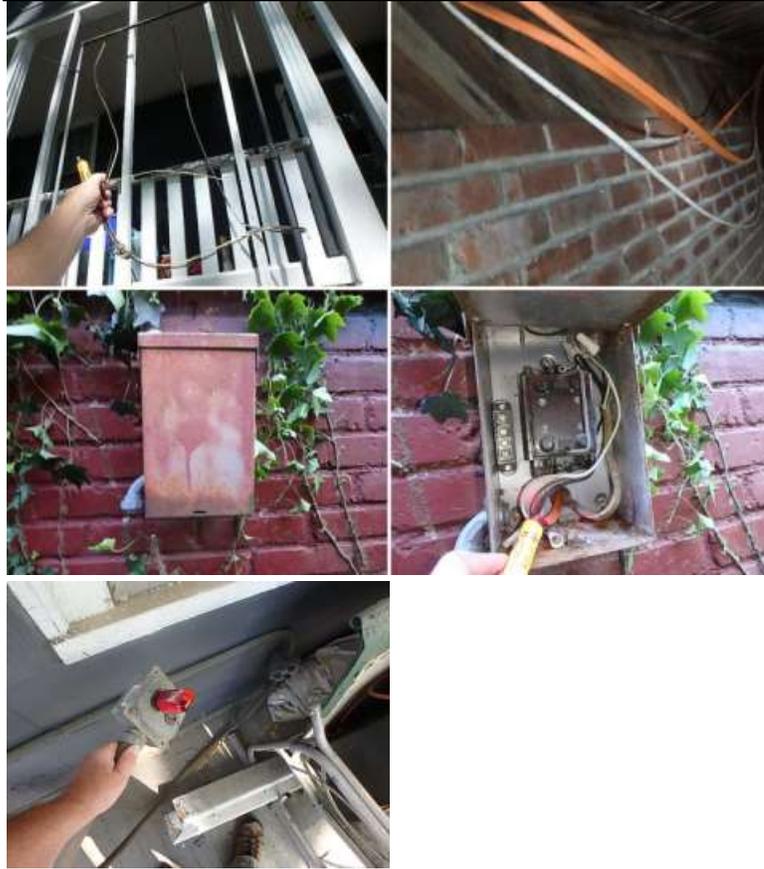
Hanging wires are noted at time of inspection under the rear porch.
Remove the floating wire at the rear off eh home.
Determine where the live disconnect box goes at the right exterior of the house, relocate as needed.
Remove the floating outlet boxes at the rear of the house/porch.

Have a licensed and insured electrical contractor further evaluate and make any recommendations and repairs as needed to the electrical.

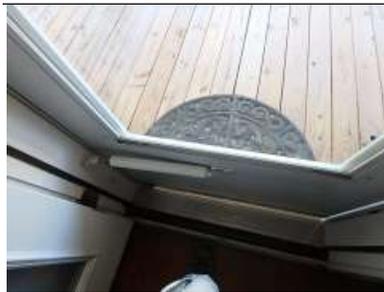
Have the storm door closure adjusted as needed for proper operation. The exterior door weather seals are damaged or deteriorated and should be replaced for a proper thermal barrier and so it is impenetrable to weather and insects.

Repair/replace the rear entry door as needed.

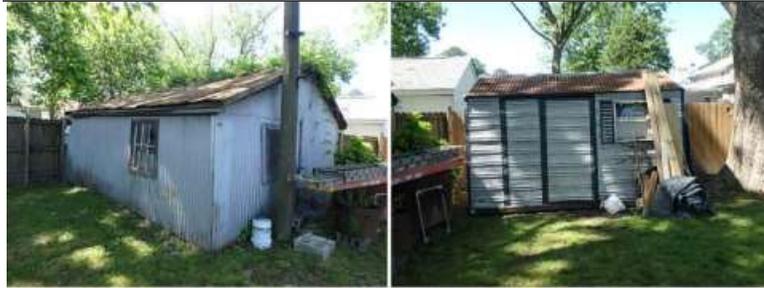
Major damage is noted to the shed structure. The damage is such that the shed should either be repaired or removed in order to prevent further damage and for safety. The shed is being phased in "AS IS" condition.

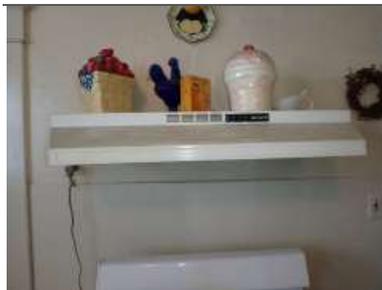
The vent filter needs to be cleaned in order to maintain proper function.

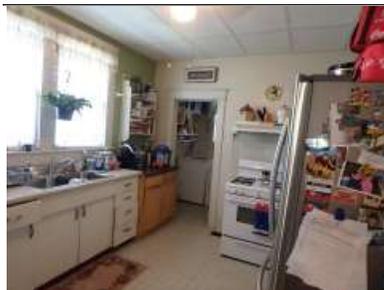
The interior components in the kitchen show typical wear at the counters and heavy wear at the cabinets. Secure the top to the cabinet as needed. Add support to the shelving as needed.

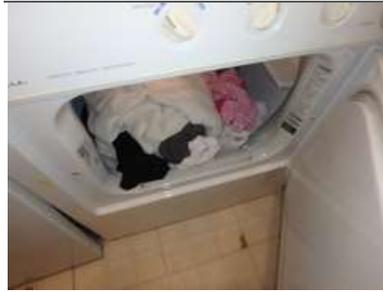
Secure the front to the washing machine as needed.

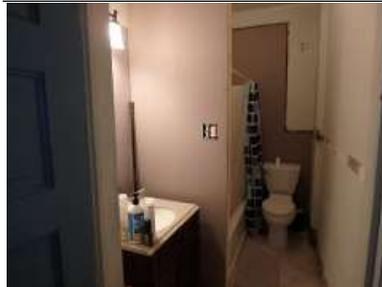
The tub/shower diverter is not functioning properly in bathroom #1 and should be repaired or replaced for proper function.

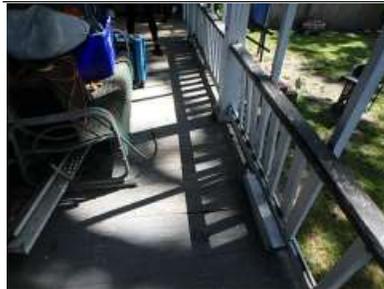
Repair or replace any moisture damaged steps, deck boards, posts and railings as needed to prevent further damage and safety.

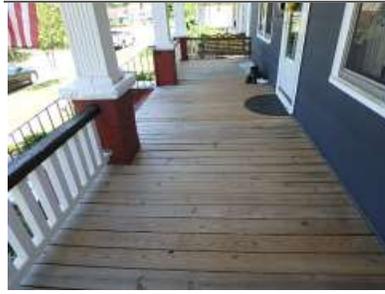
Signs of settling at the rear porch posts, have further evaluated and repaired as needed.
