Appendix A

Photographs

Figure A.1. Oak Grove Watershed - Photo Locations

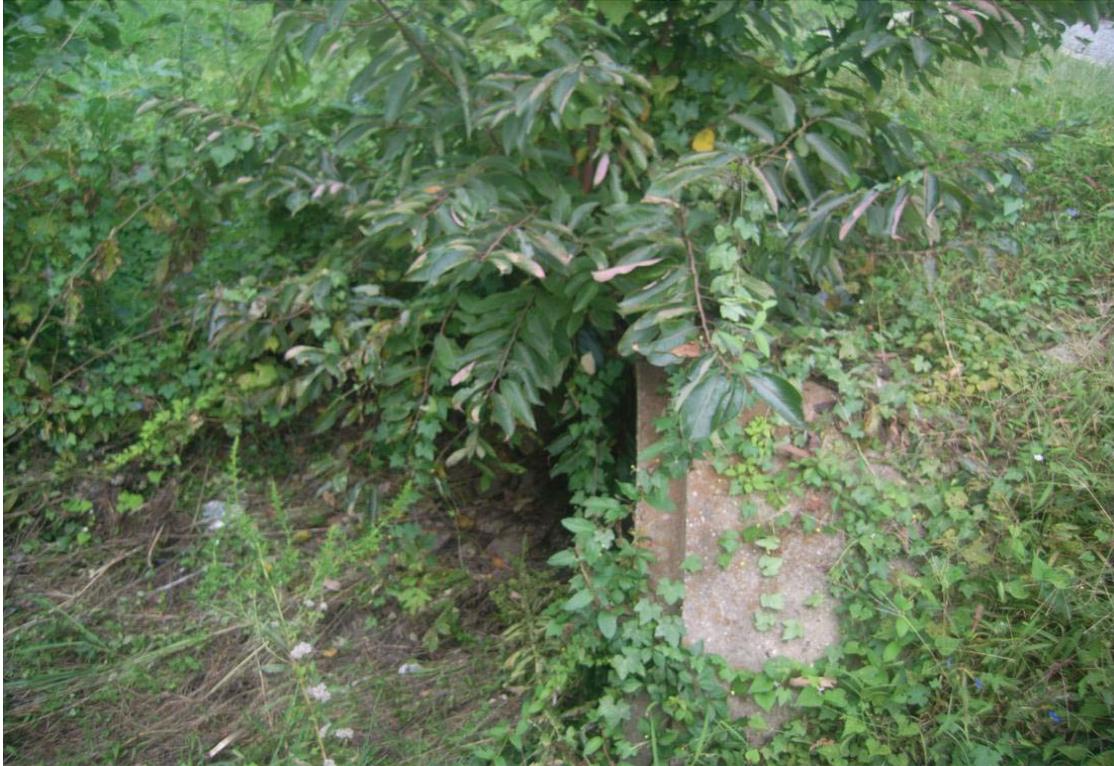
Photo 3. Node 151 - looking at culvert inlet

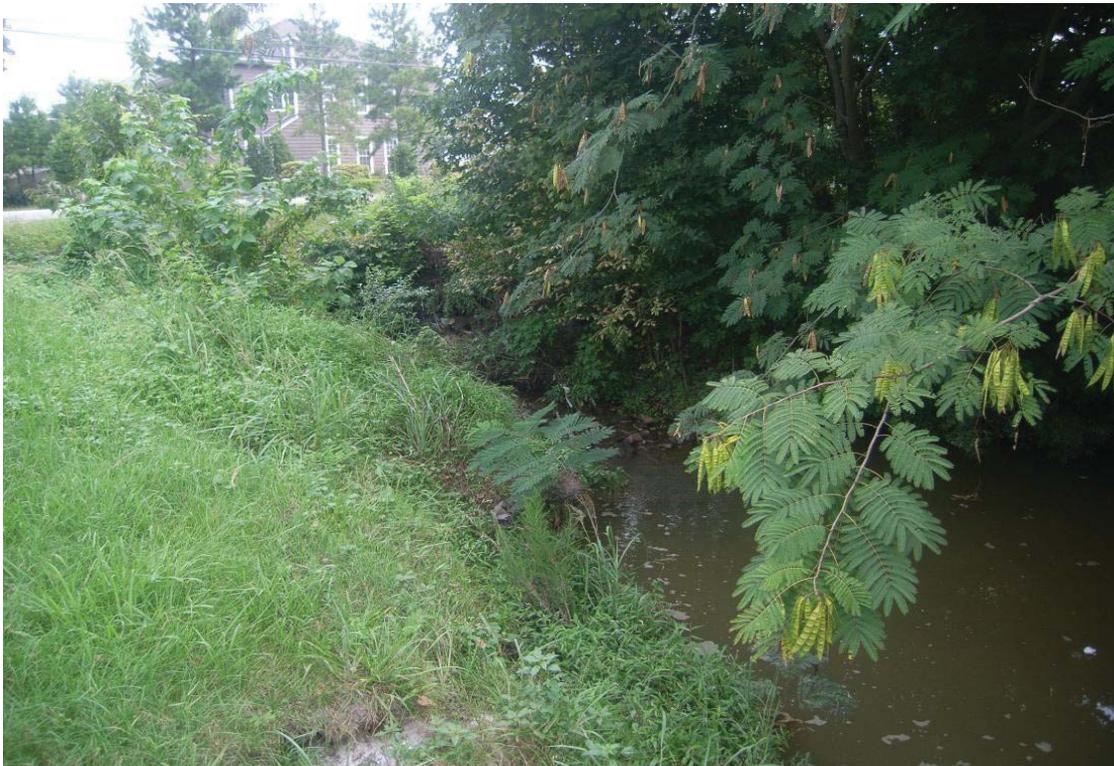
Photo 4. Node 151 - looking at ditch

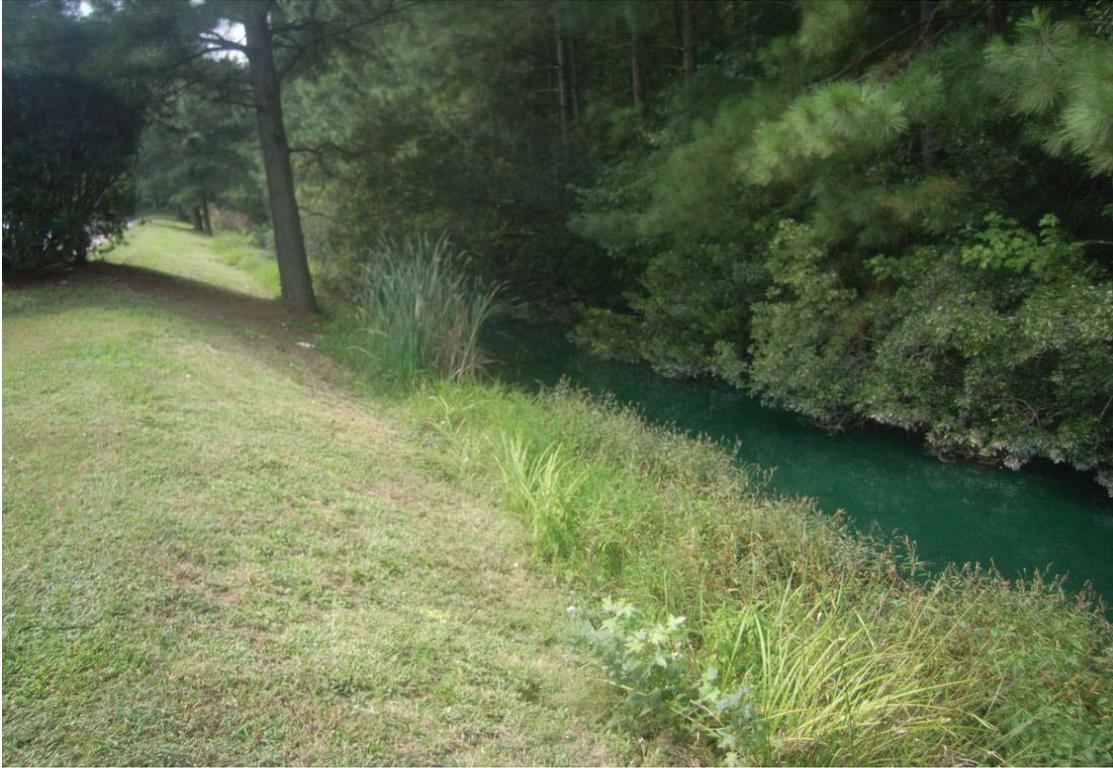
Photo 9. Node 207 - looking upstream

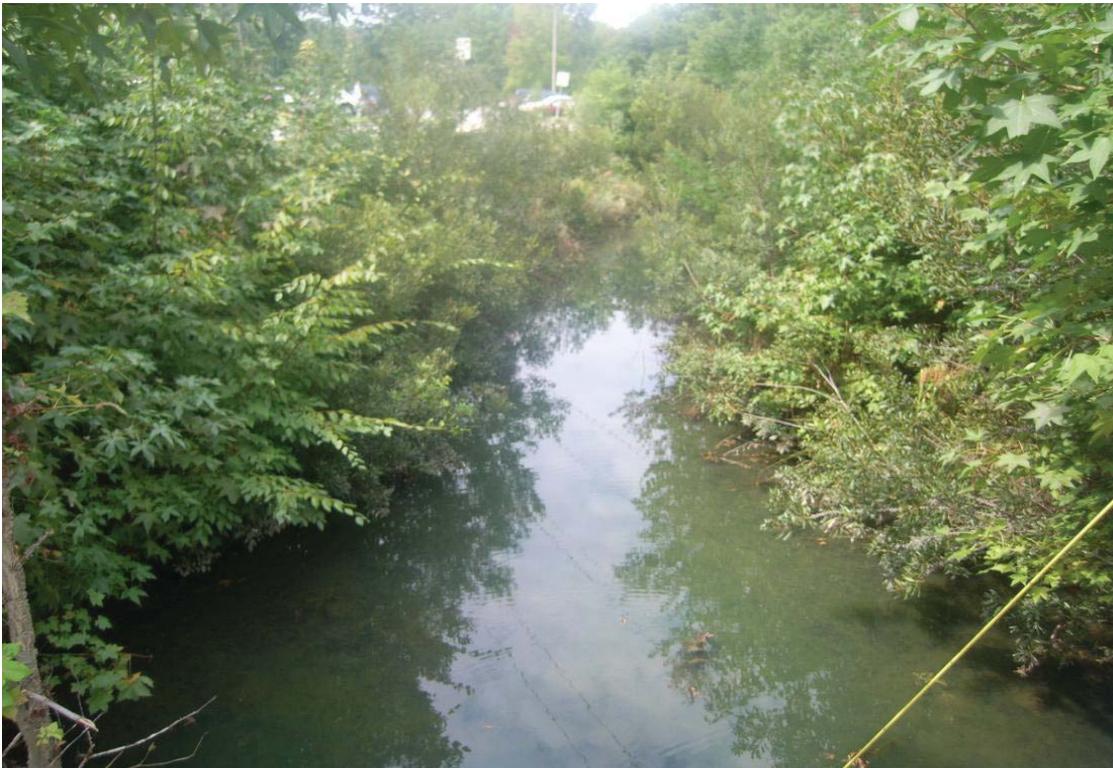
Photo 10. Node 212 - looking upstream

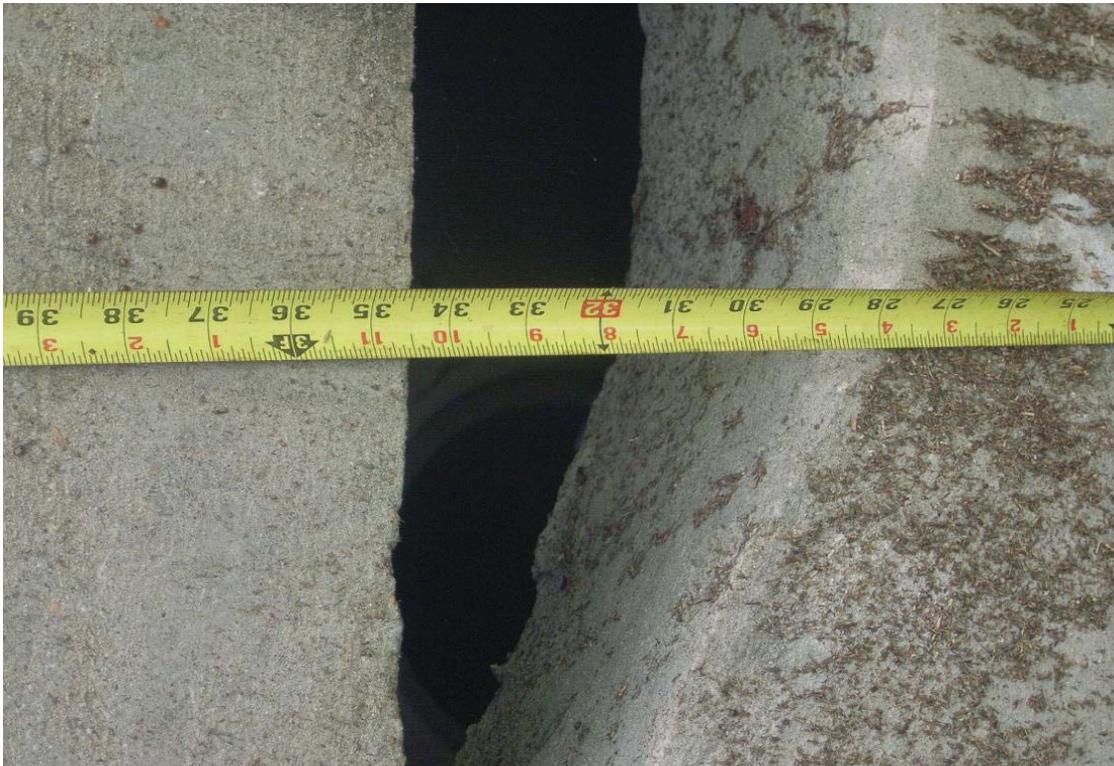
Photo 16. Node 225 - looking at outfall structure (2)

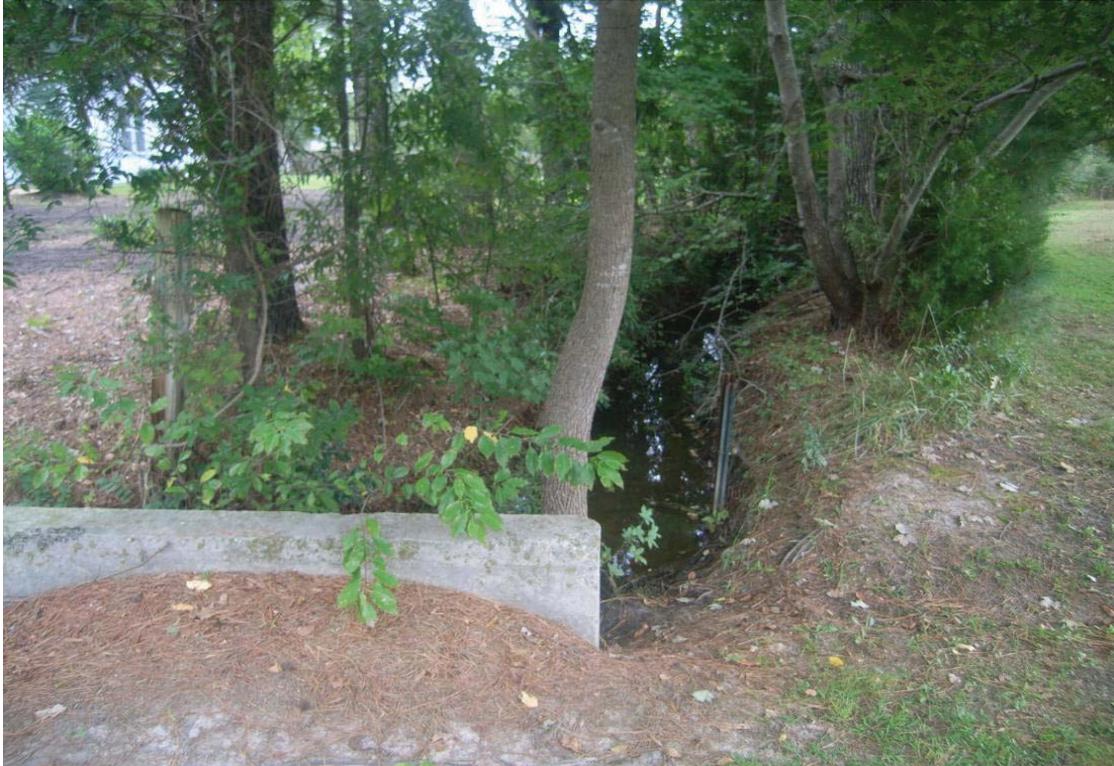
Photo 43. Node 409 - looking downstream

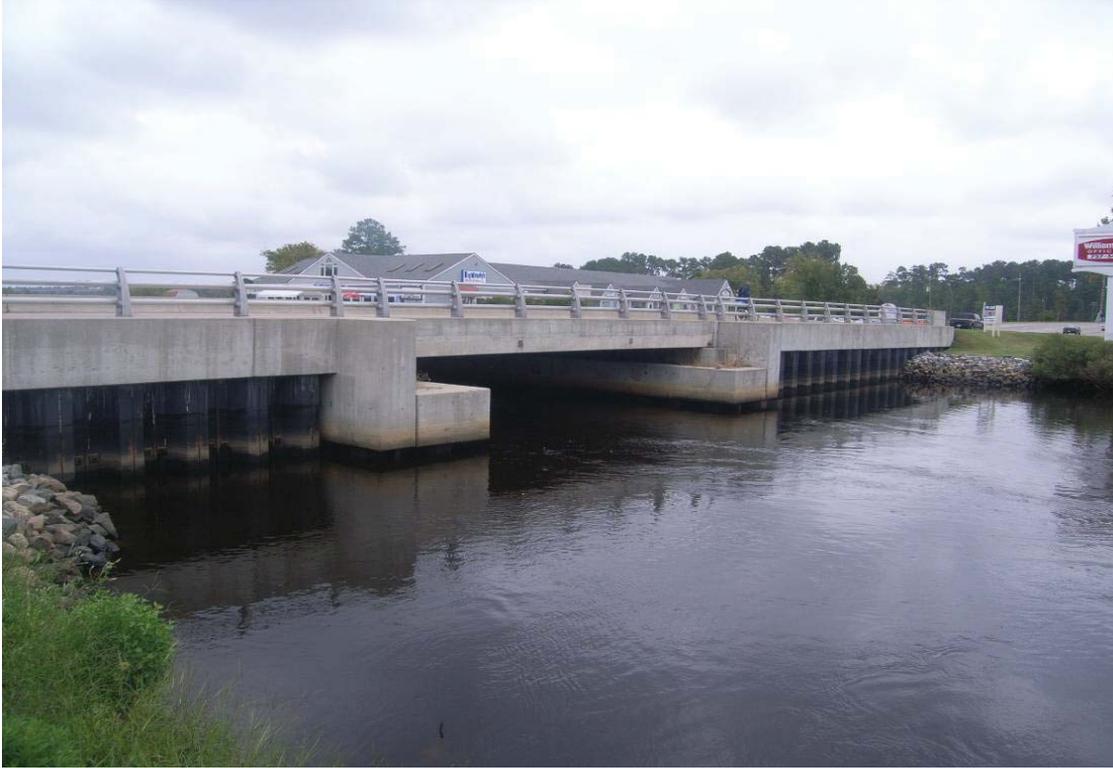
Photo 45. Node 424 - looking at bridge

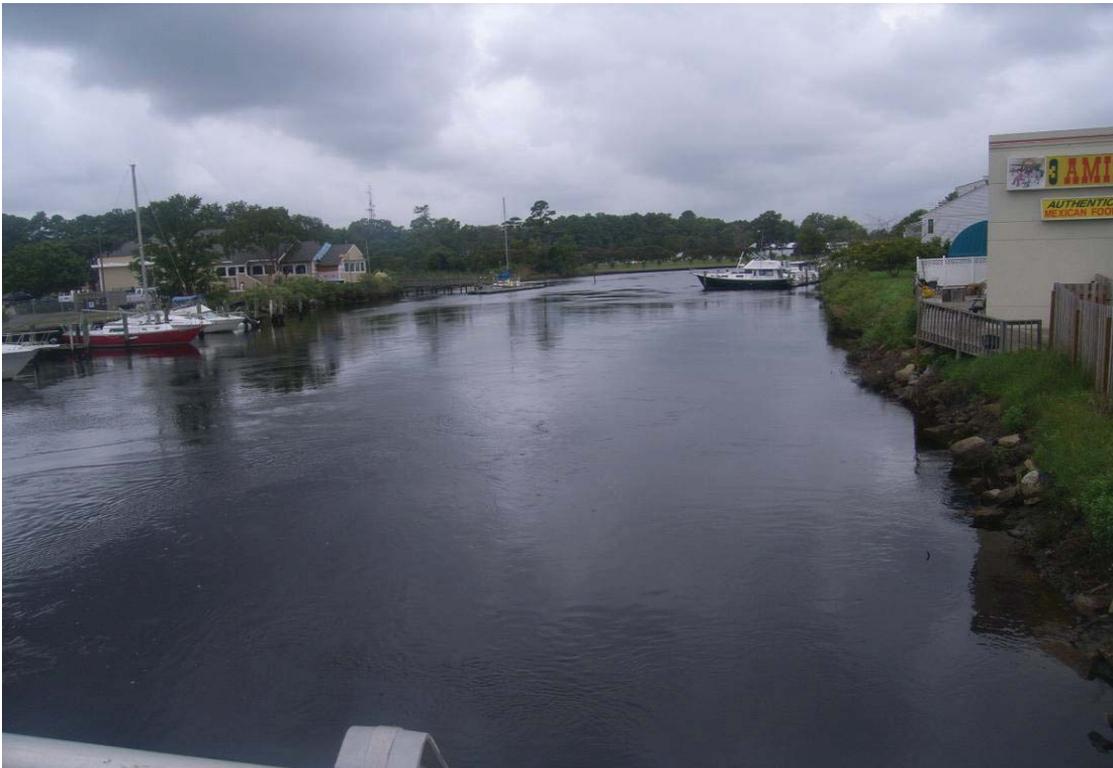
Photo 46. Node 424 - looking downstream

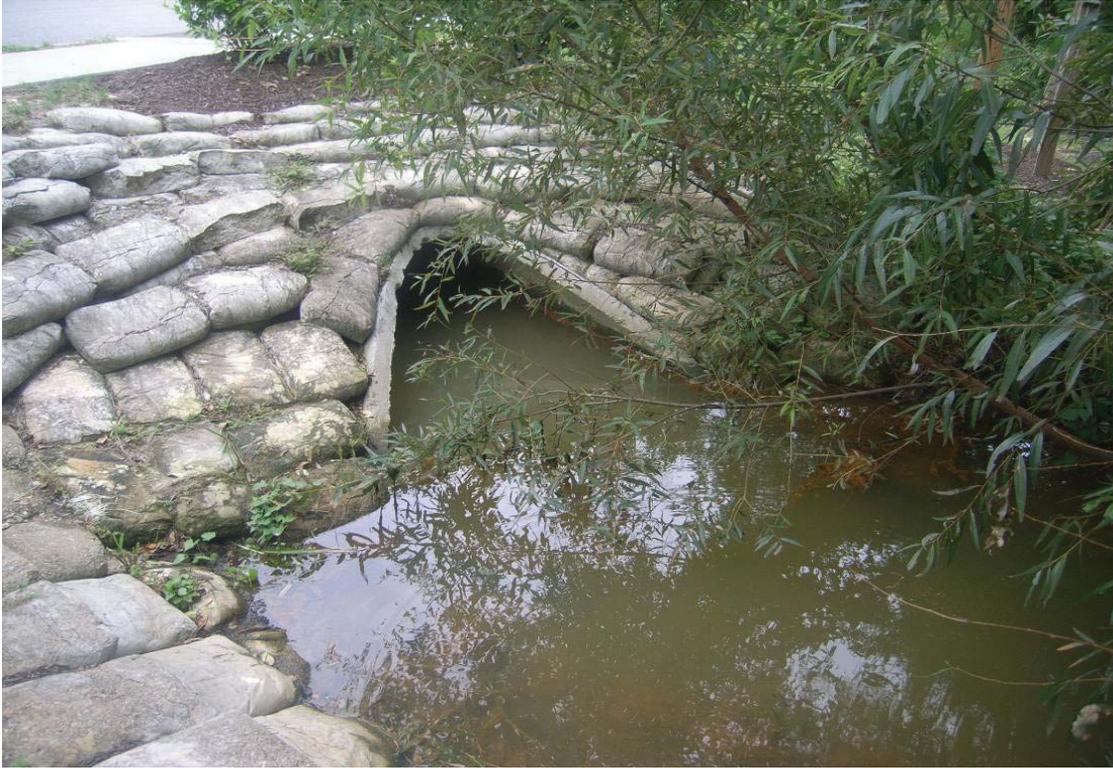
Photo 49. Node 485 - looking at pipe outlet

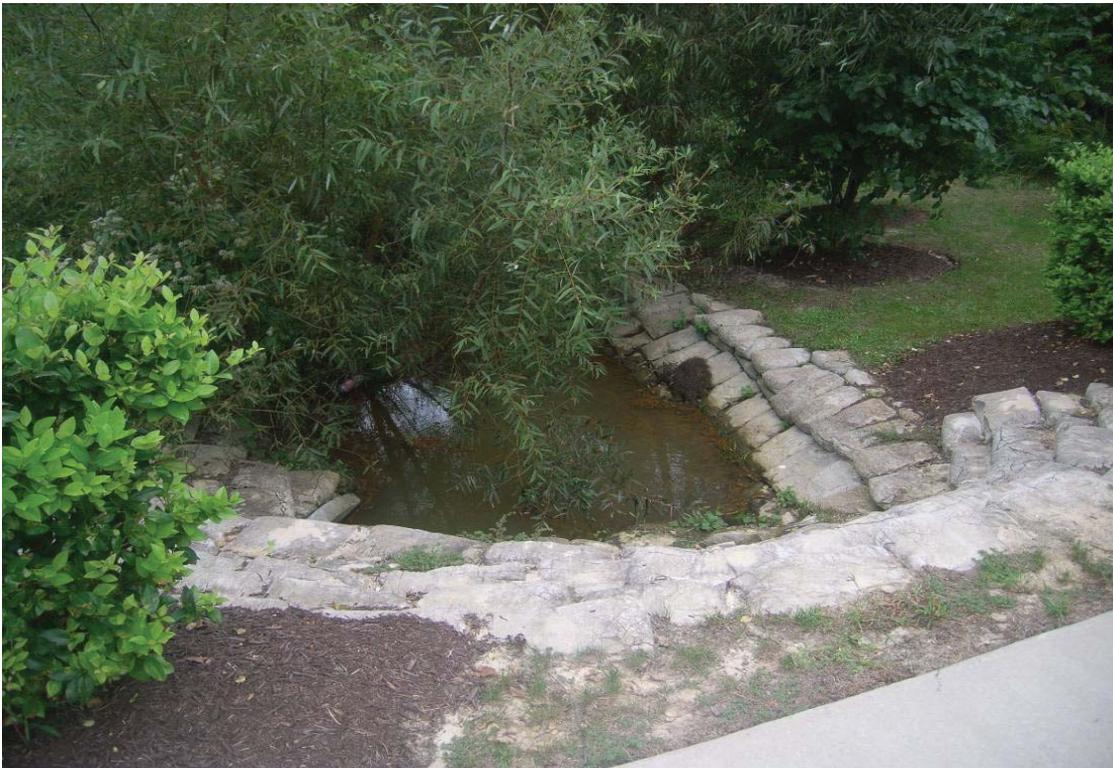
Photo 50. Node 485 - looking downstream

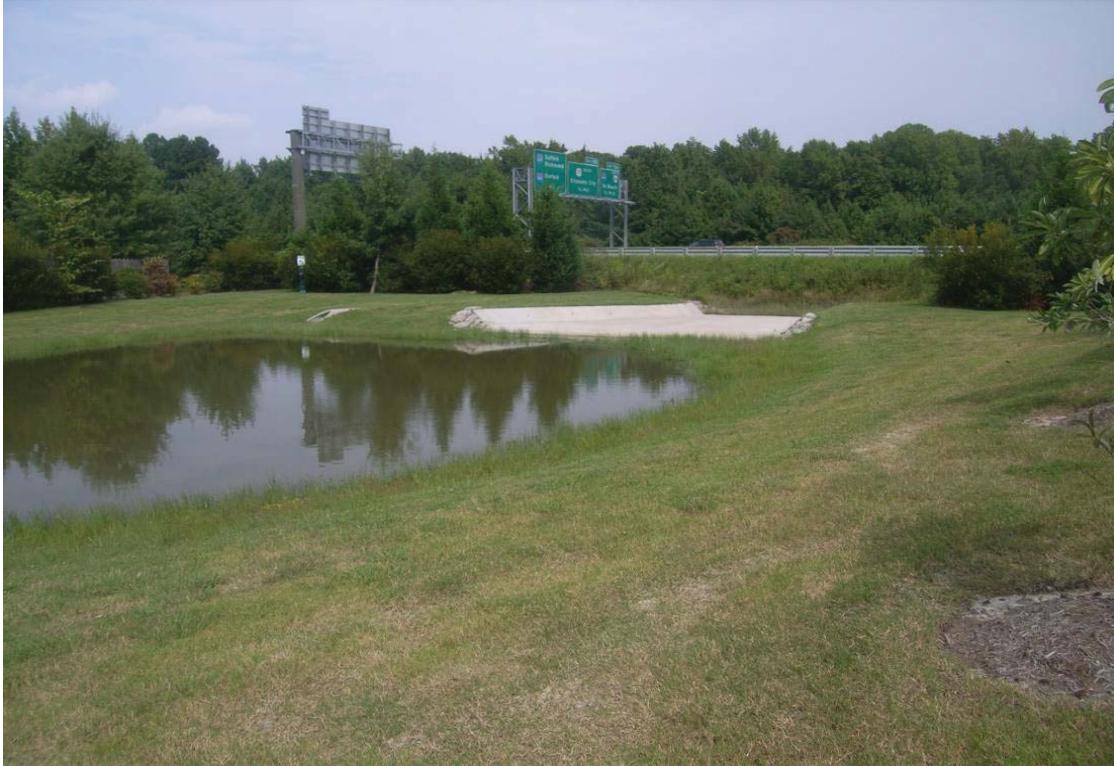
Photo 53. Node 517 - looking at BMP and outfall structure

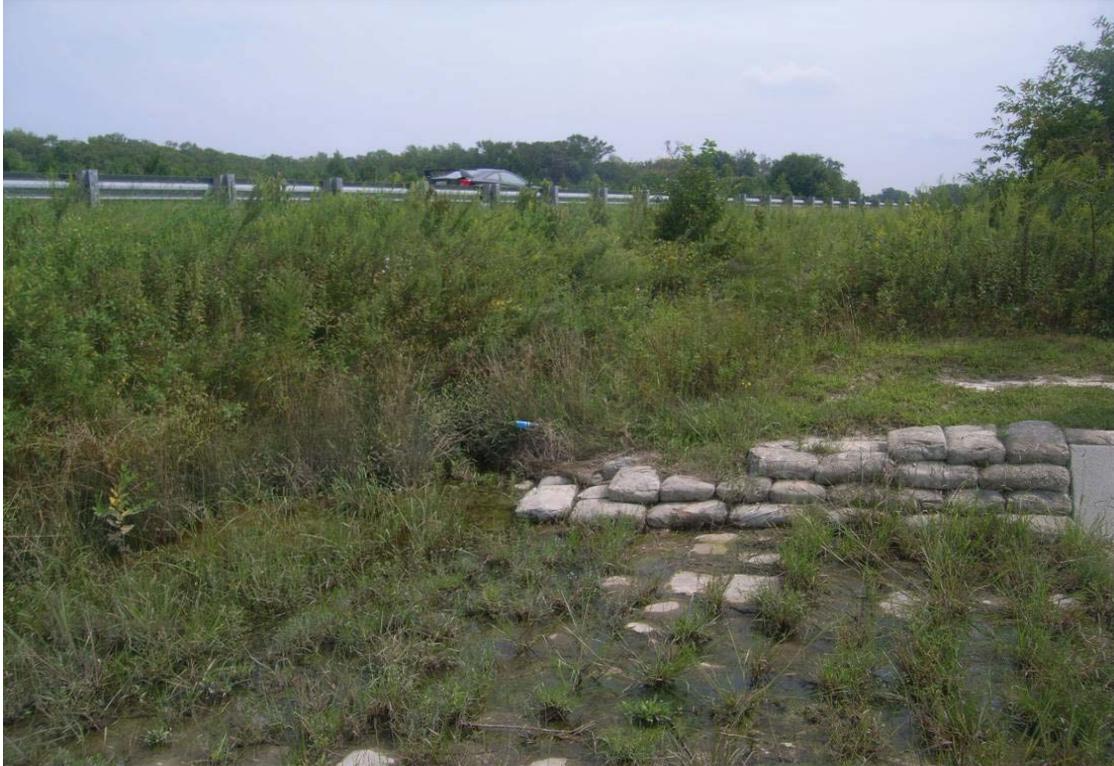
Photo 55. Node 519 - looking downstream

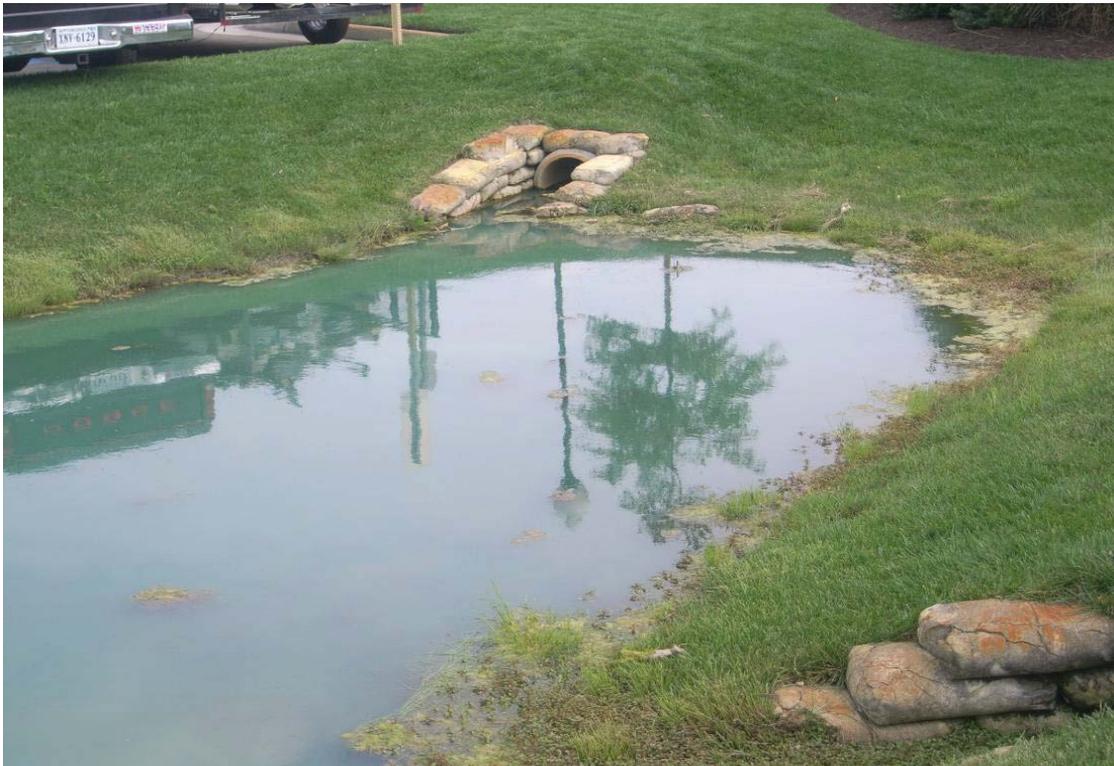
Photo 56. Node 523 - looking at outfall structure

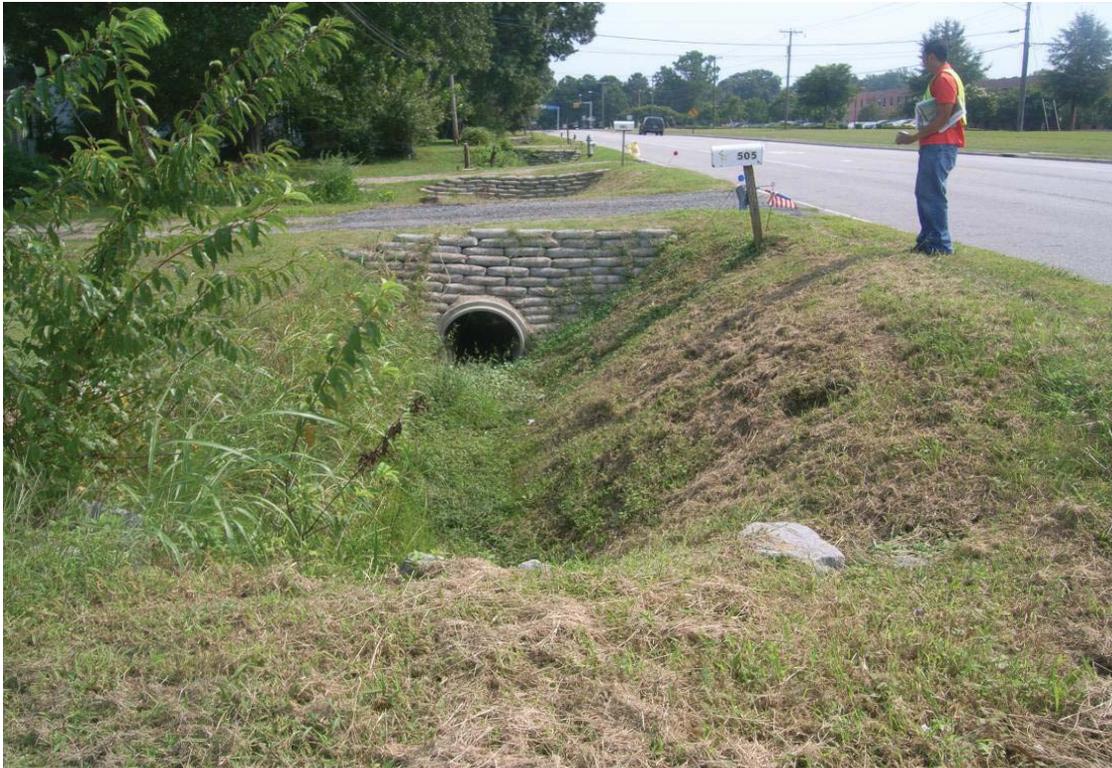
Photo 59. Node 537 - looking upstream toward Photo 1. Node 535

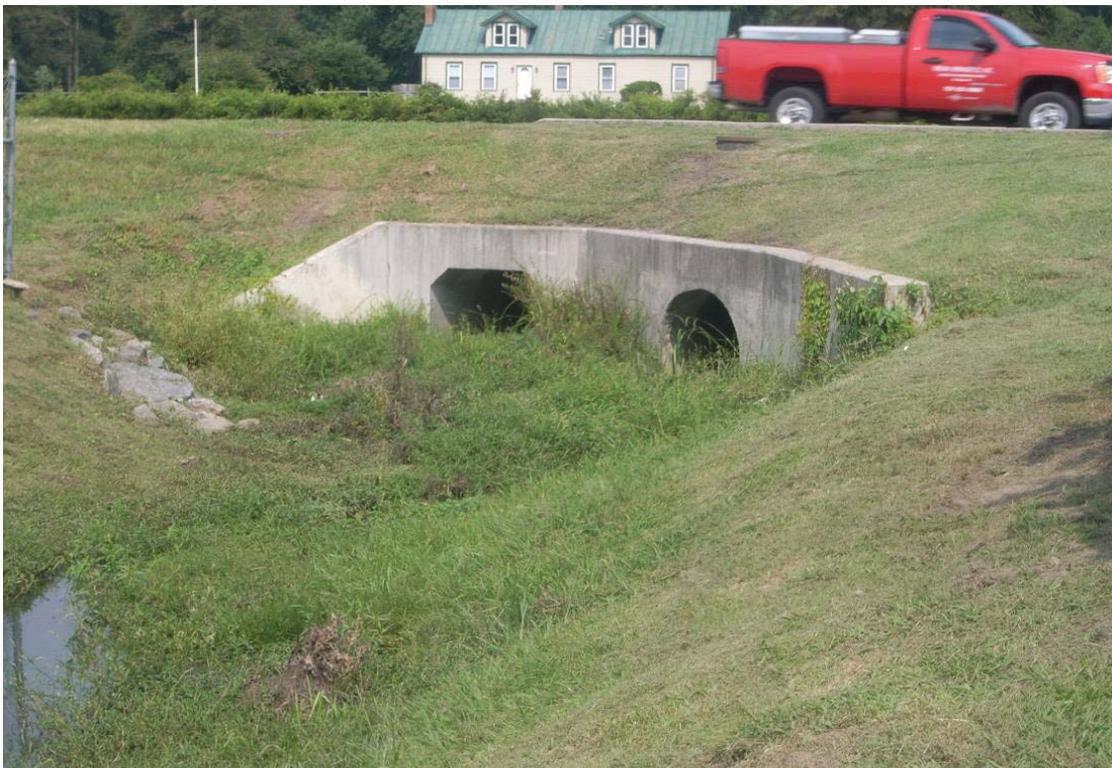
Photo 60. Node 545 - looking at culvert outlet

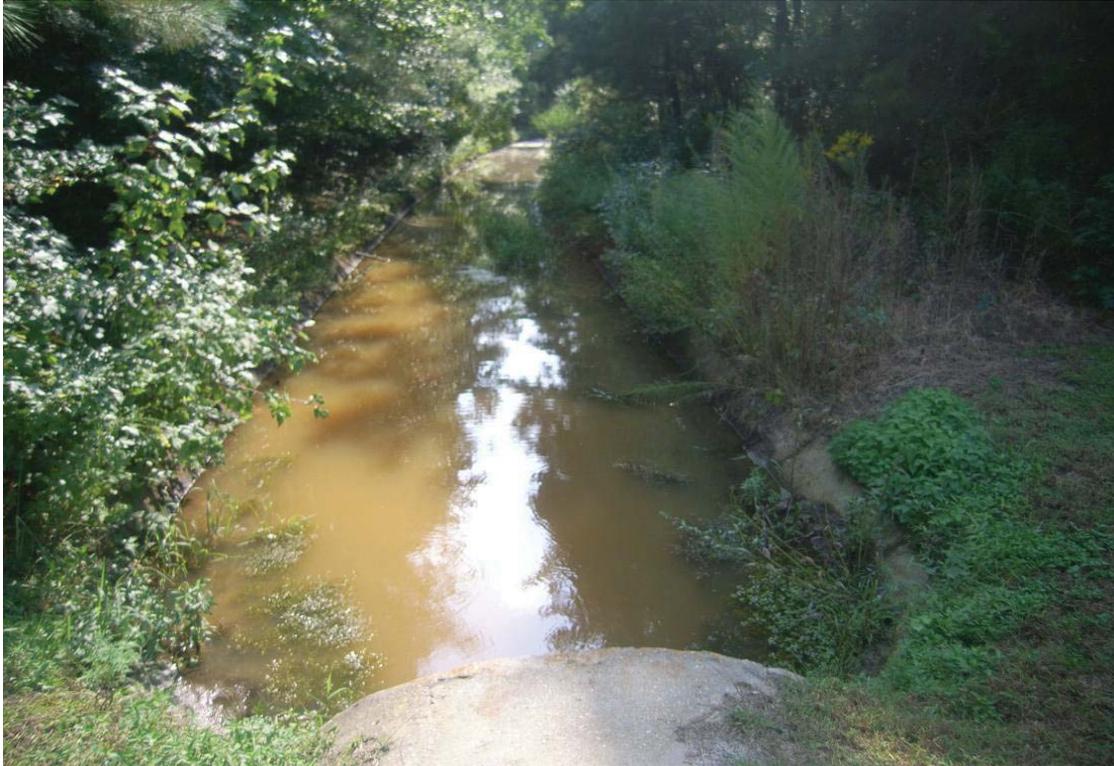
Photo 65. Node 618 - looking downstream

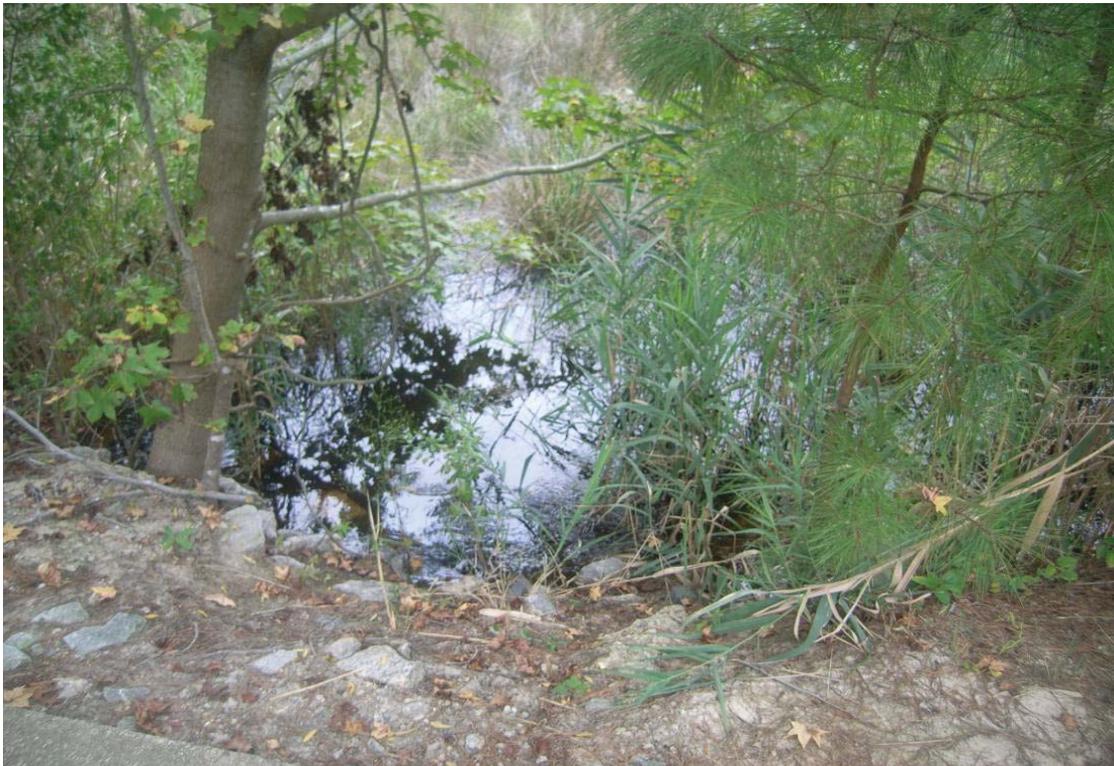
Photo 66. Node 688 - looking downstream (1)

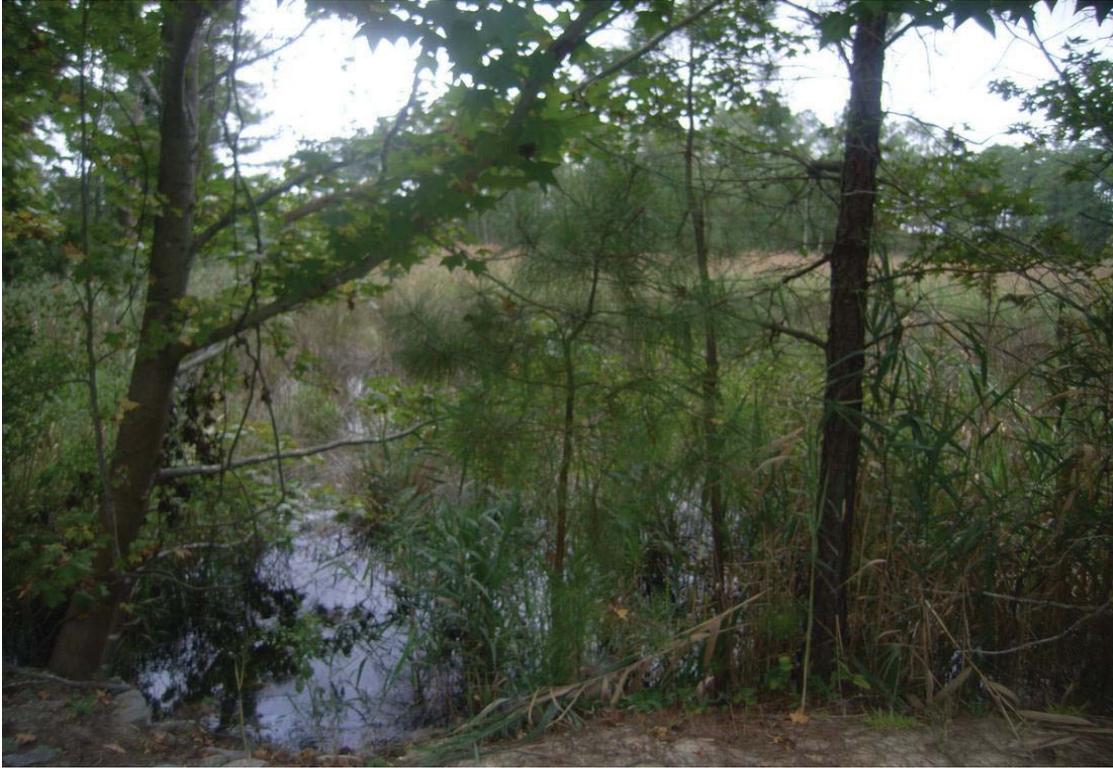
Photo 69. Node 688 - looking upstream at retention area (Photo 1. Node 685) (2)

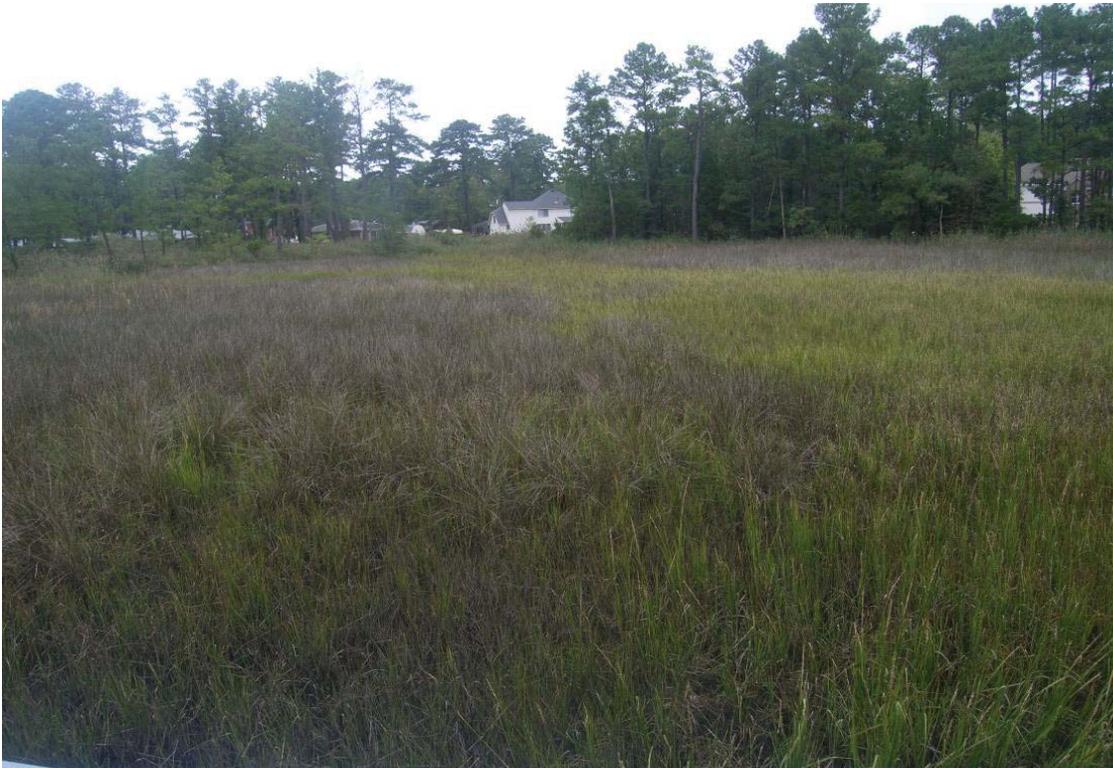
Photo 70. Node 708 - looking upstream

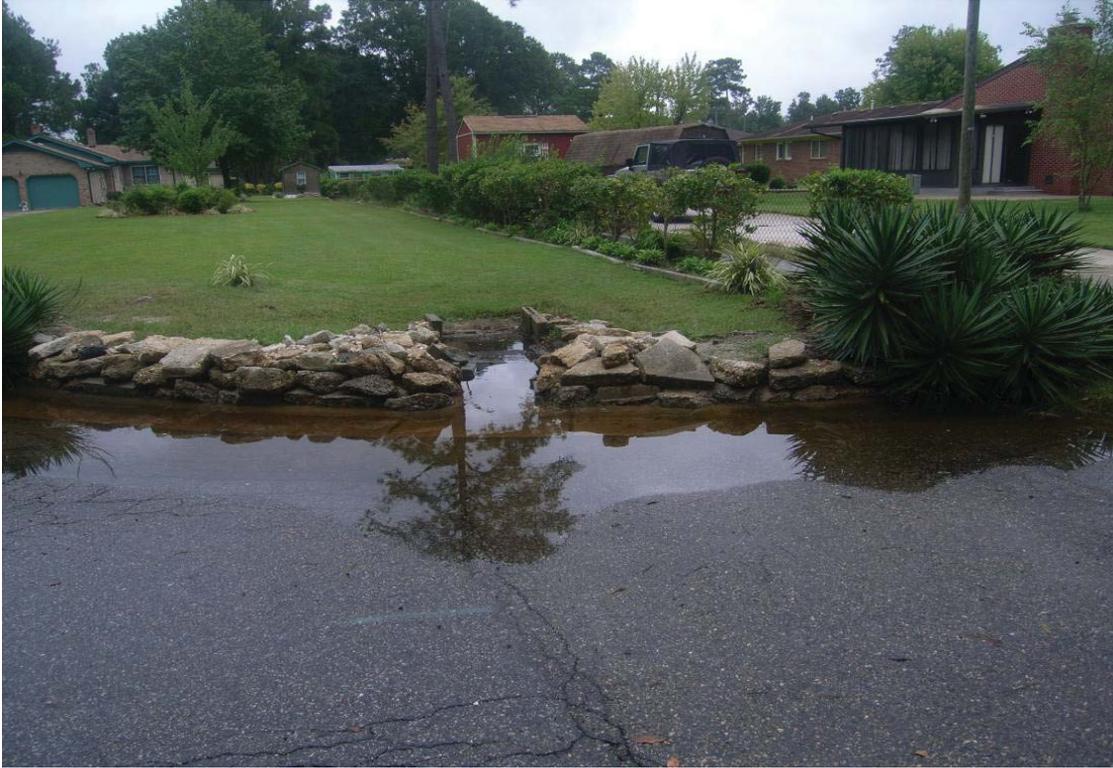
Photo 73. Node 728 - looking at a nearby submerged curb inlet

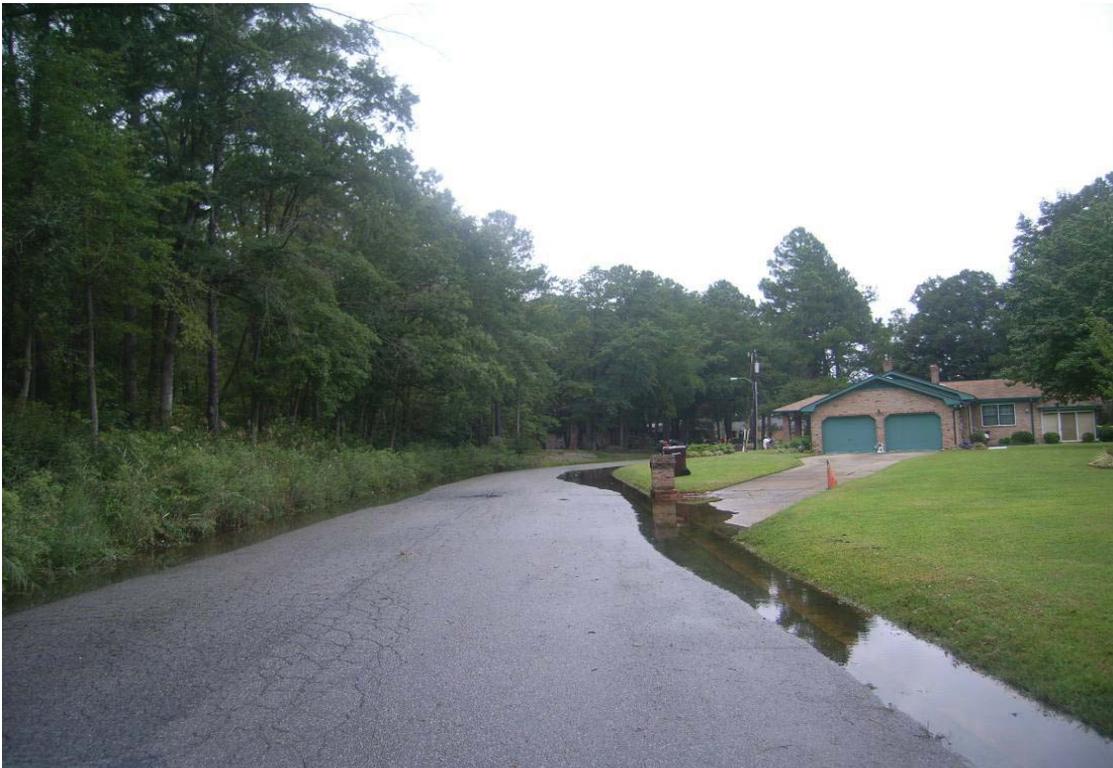
Photo 74. Node 728 - looking at road toward Photo 1. Node 734

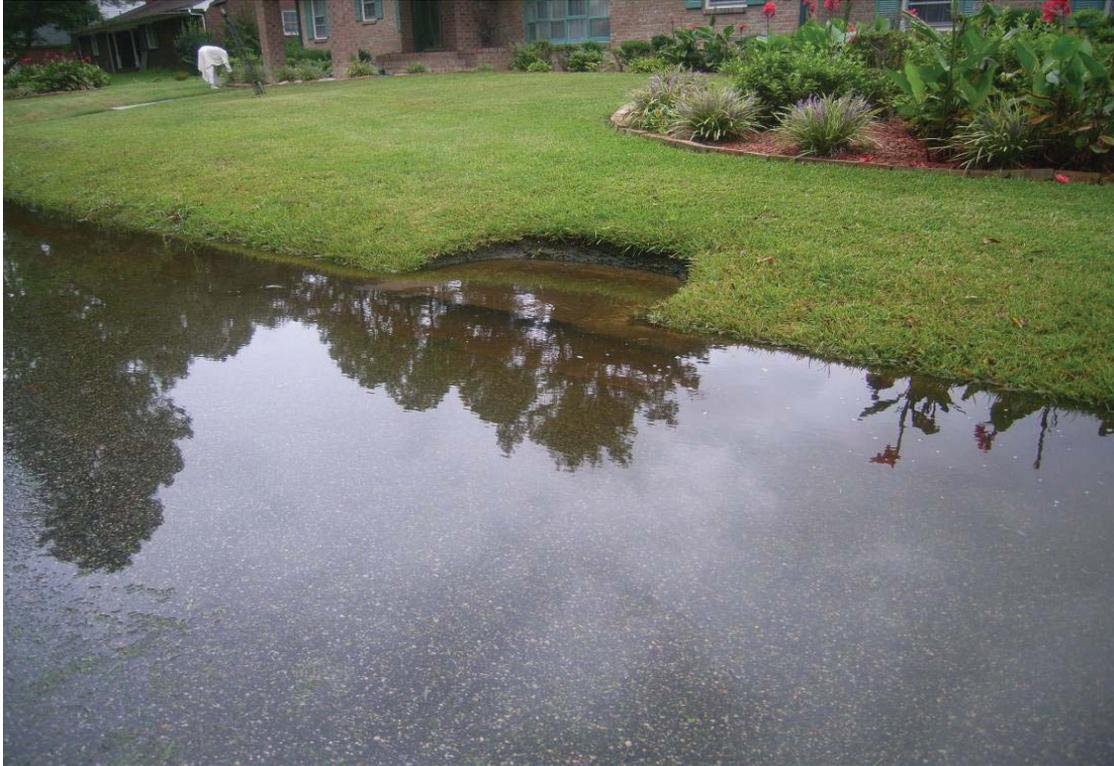
Photo 77. Node 734 - looking at submerged curb inlet

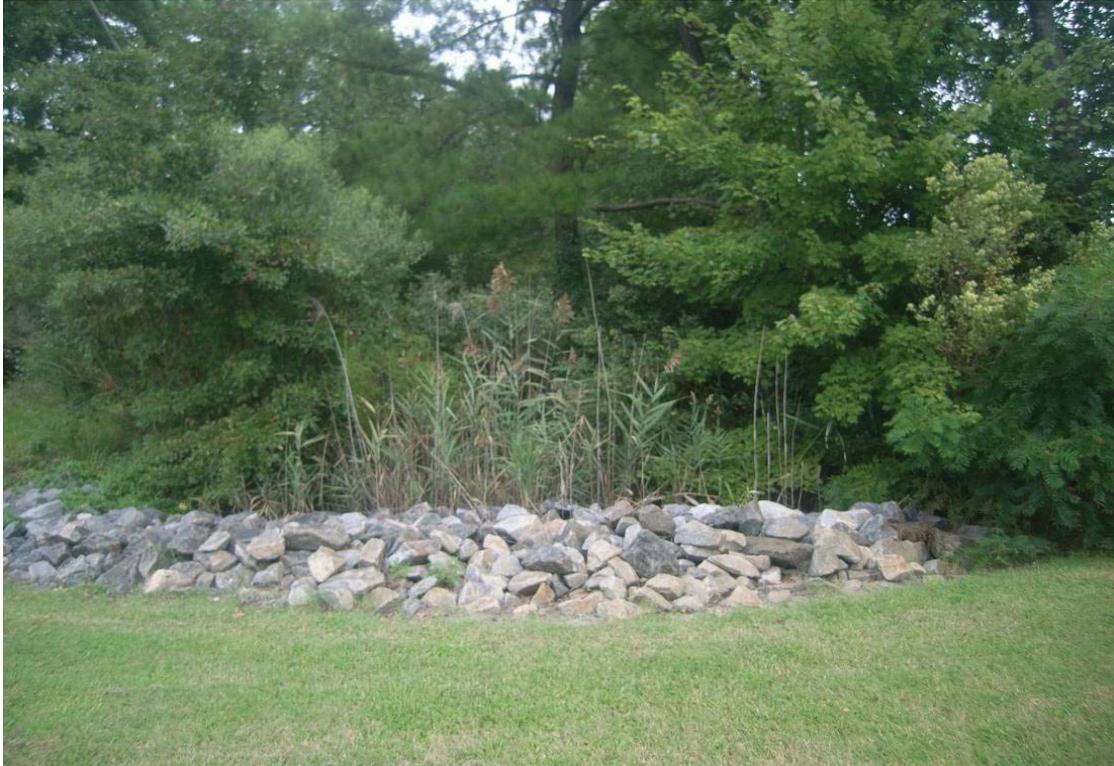
Photo 81. Node 754 - looking upstream (1)

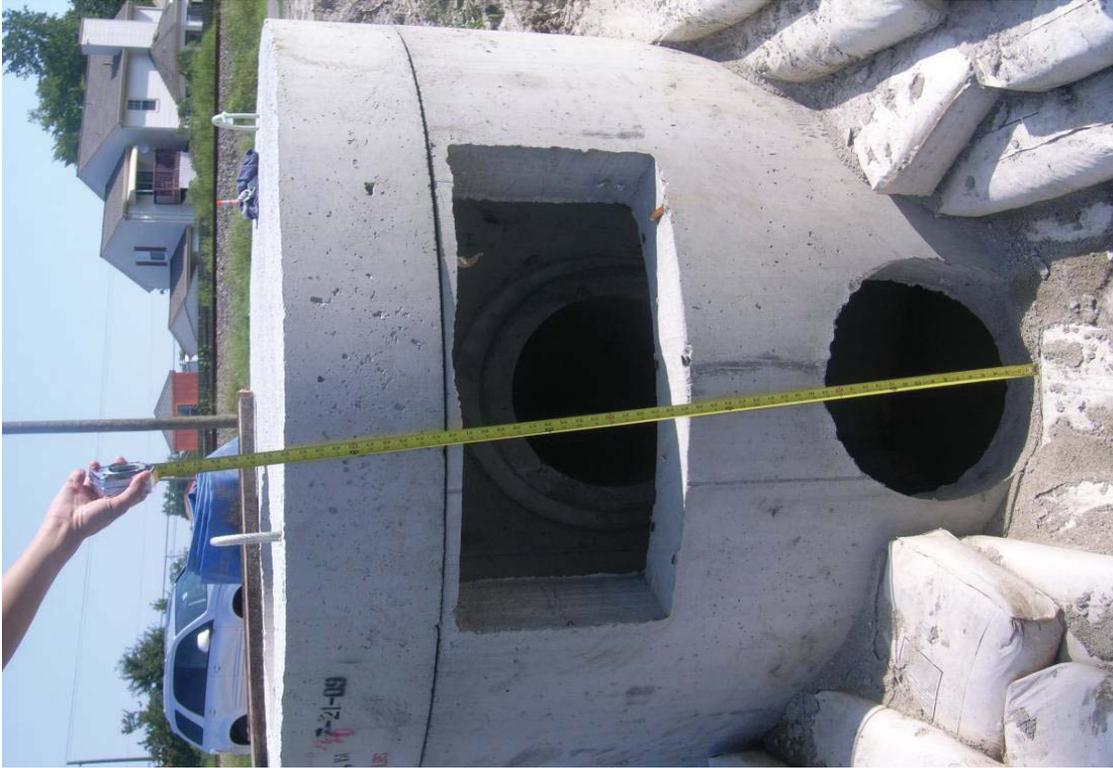
Photo 89. Node 835 - looking at outfall structure (1)

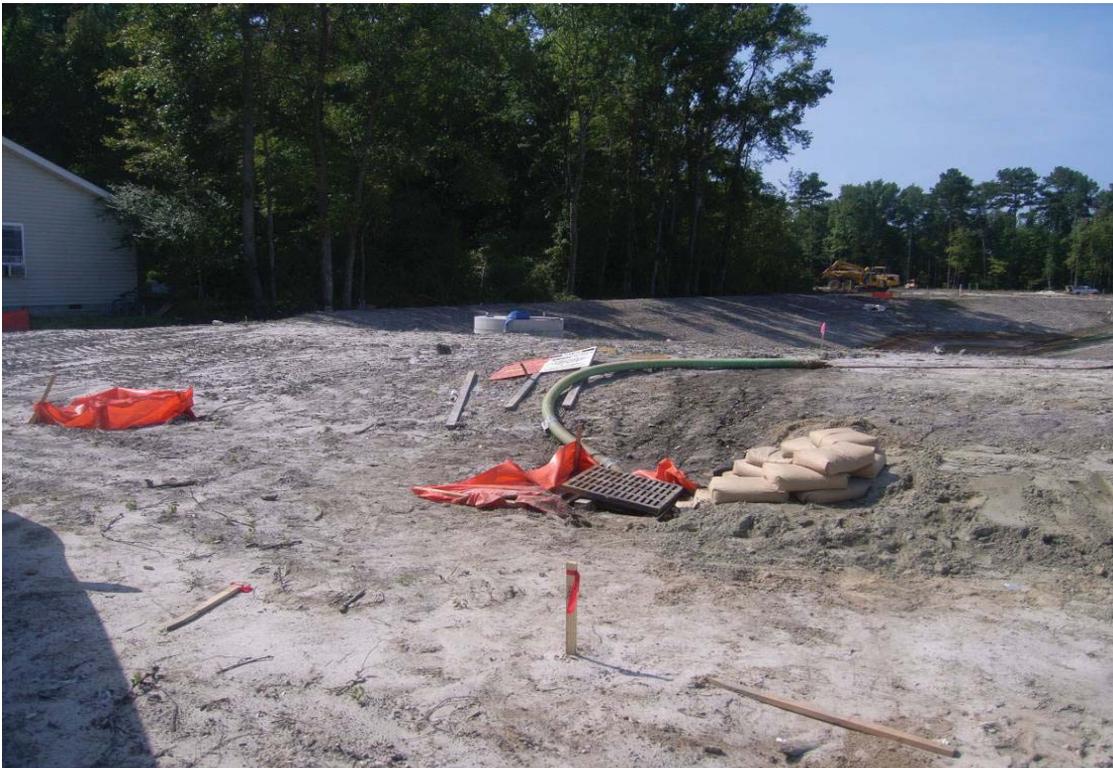
Photo 90. Node 835 - looking at unfinished BMP

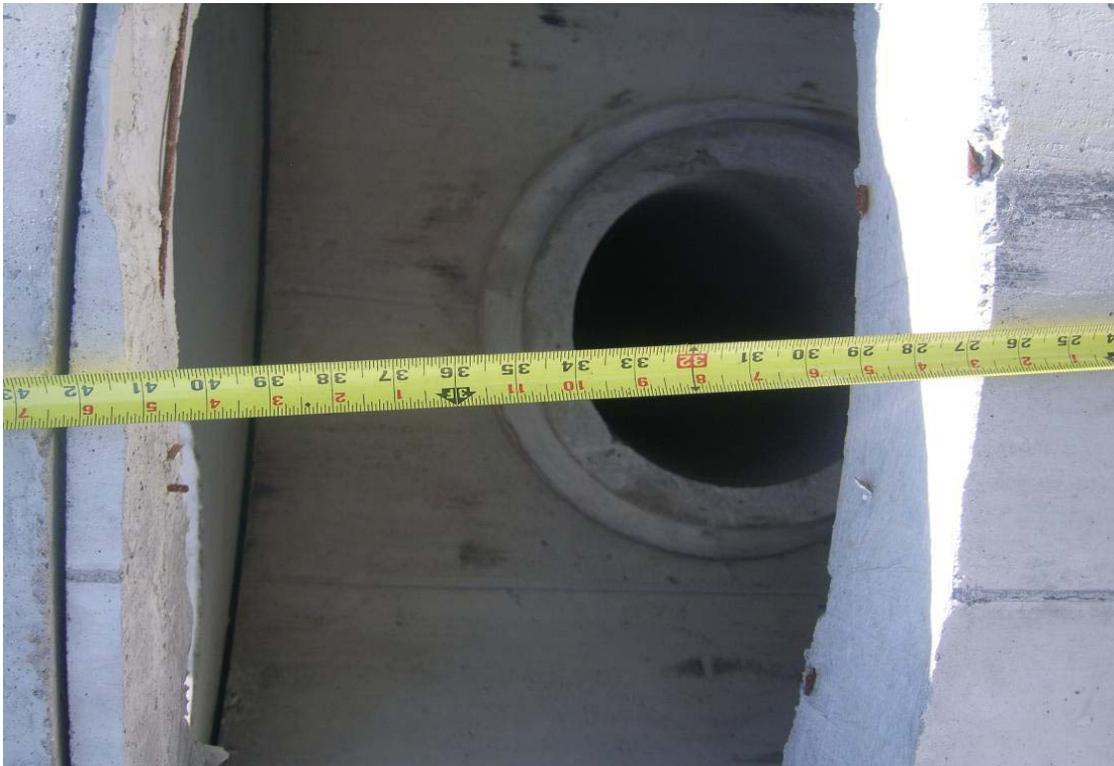
Photo 92. Node 835 - outfall structure (3)

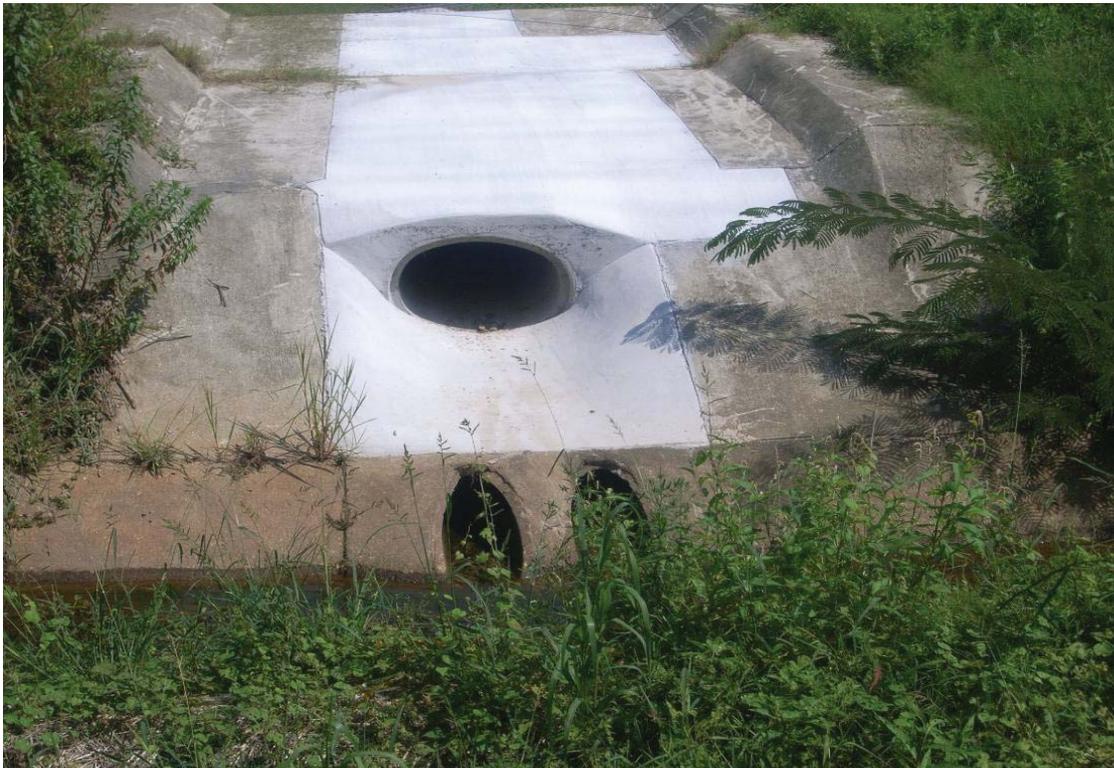
Photo 96. Node 874 - looking at outfall from Photo 1. Node 872
