Appendix A

Photographs

Figure A.1. Oak Grove Watershed - Photo Locations

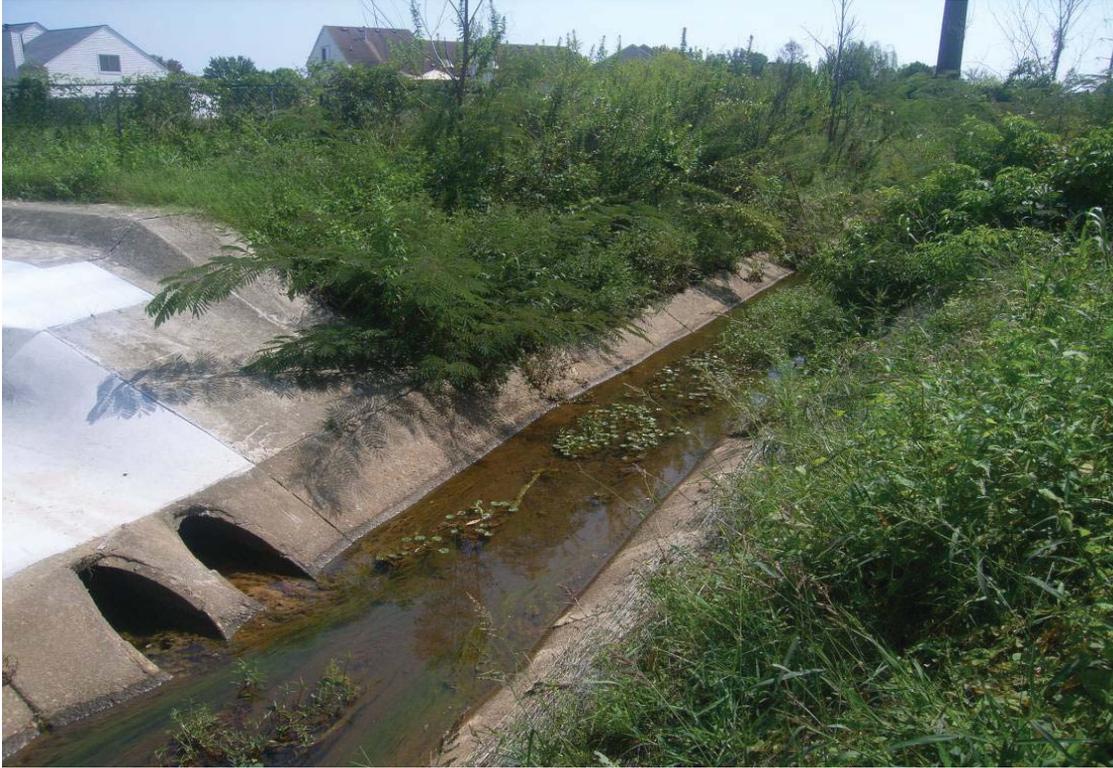
Photo 97. Node 874 - looking downstream

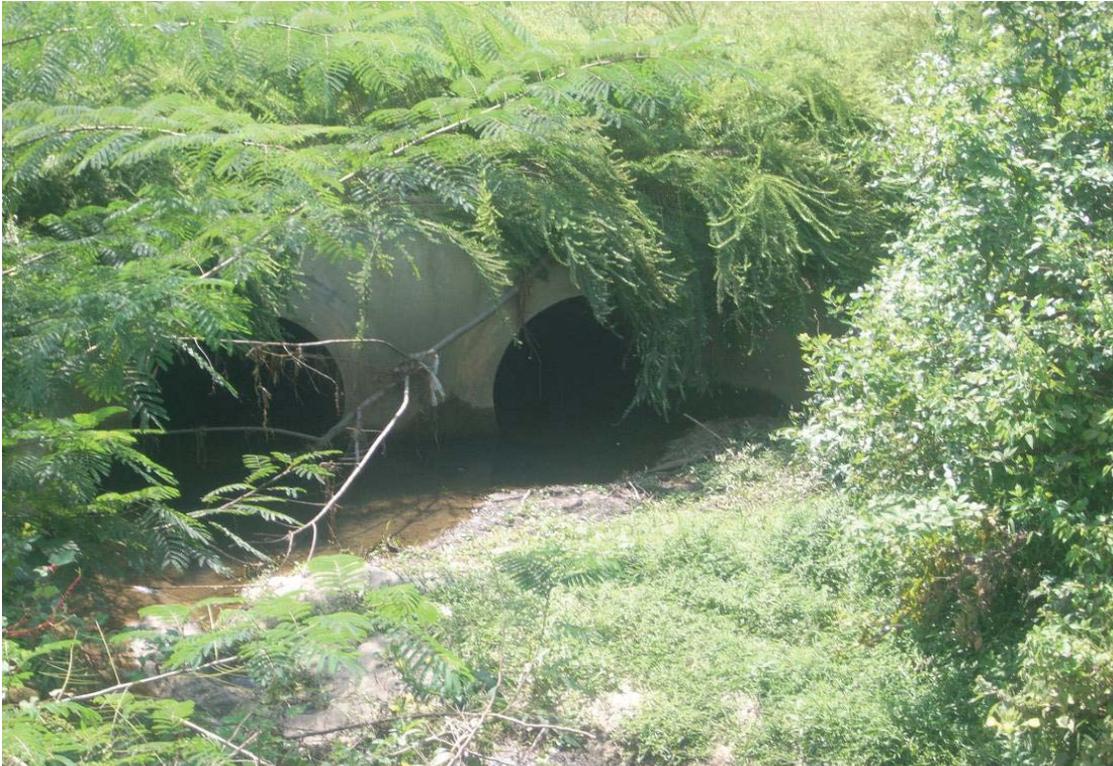
Photo 98. Node 881 - looking at culvert inlet

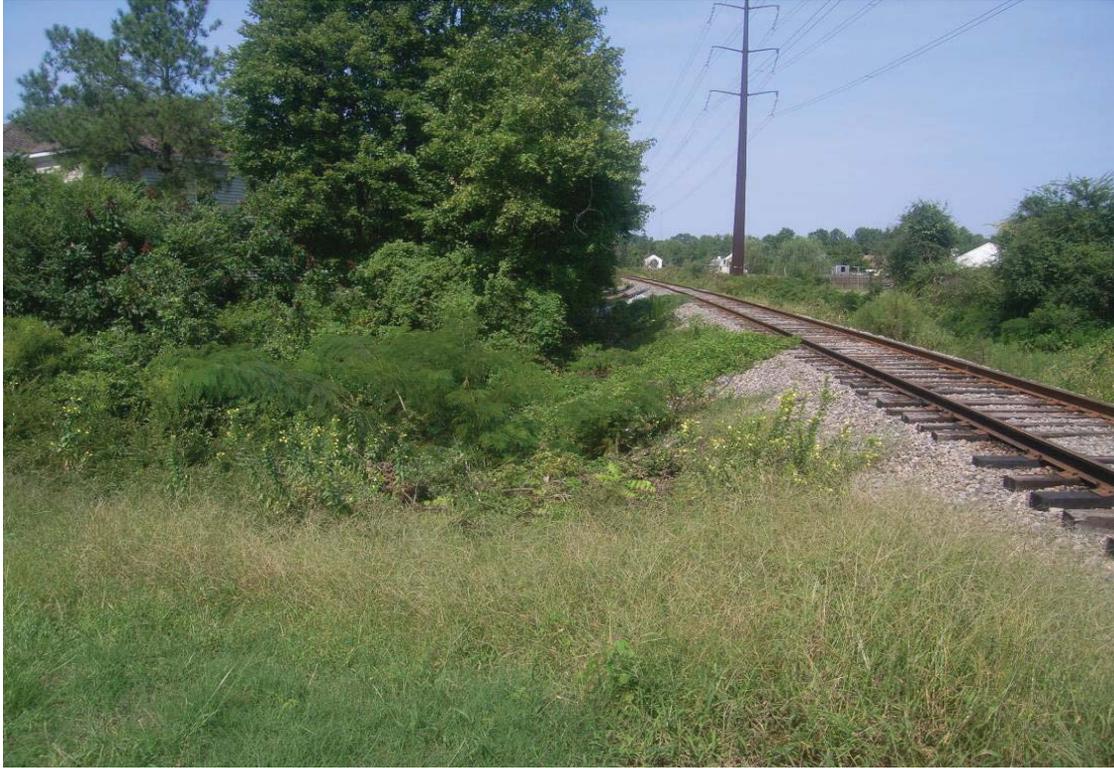
Photo 99. Node 881 - looking upstream

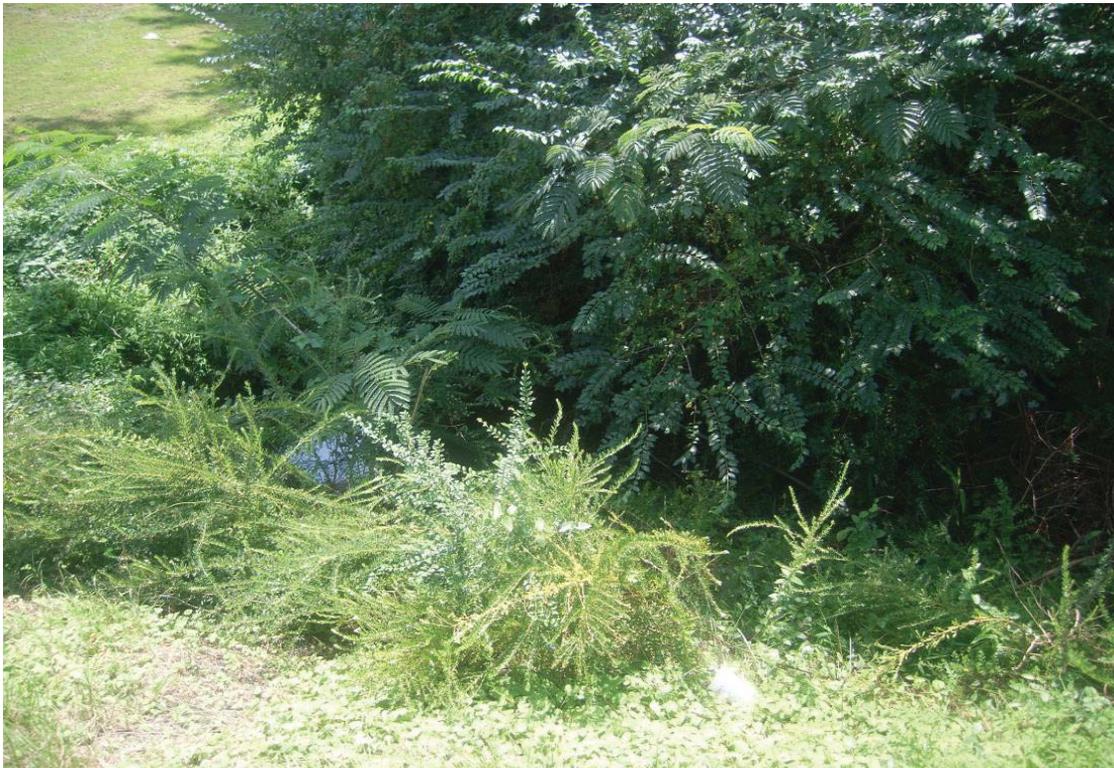
Photo 100. Node 882 - looking downstream

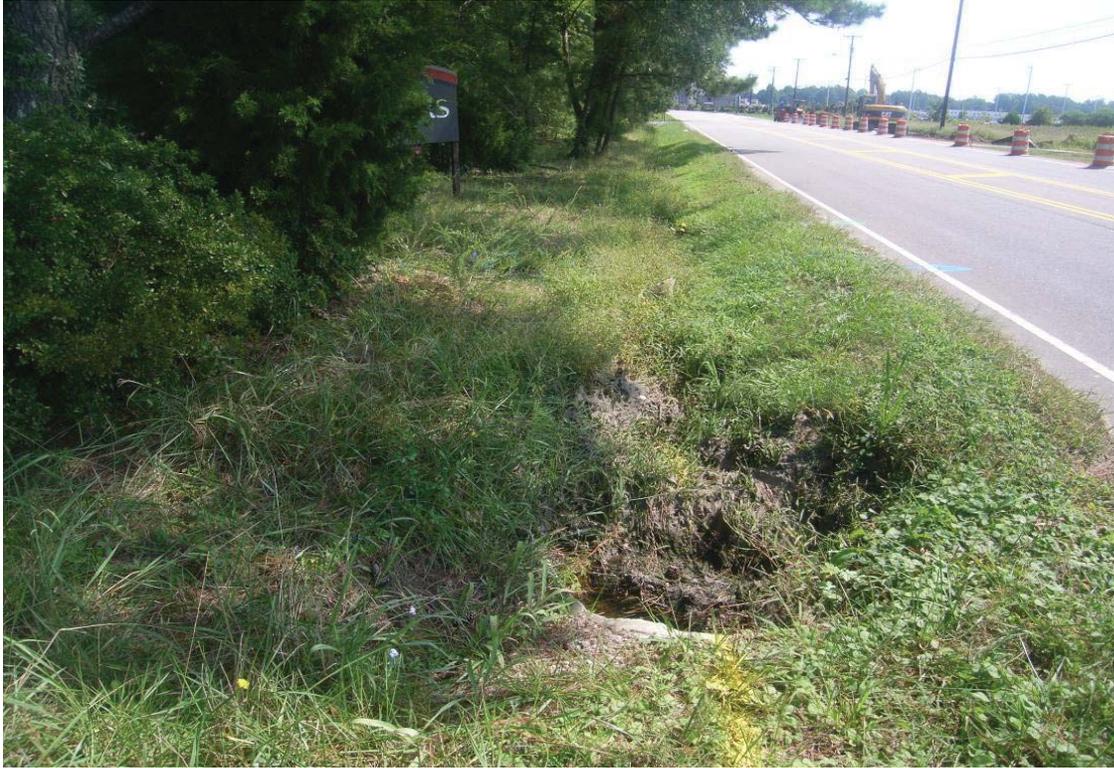
Photo 101. Node 896 - looking downstream
